FINAL REPORT

2019 Sewer Master Plan Update

Prepared for San Bernardino Municipal Water Department

March 2020

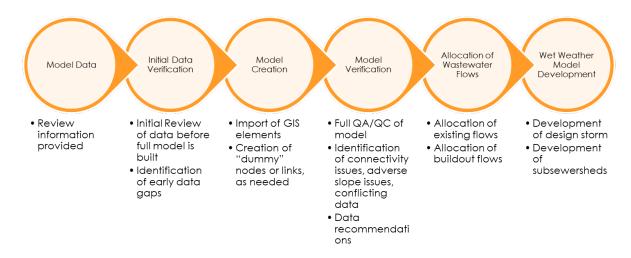
Figure ES-2 Overview of Model Development Process

Figure ES-2 shows an overview of the model development. The model development begins with review of data collection and initial data verification. The model is subsequently created and then verified to identify any connectivity issues, adverse slope issues, or conflicting data. After verifying the model, wastewater flows are then allocated for each scenario (existing and build out). Finally, the model is further prepared for wet weather analysis. Each of these steps will be discussed in the section.

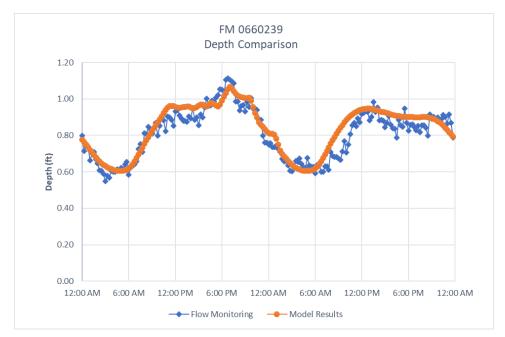
Figure ES-3 Example Calibration Plot

Figure ES-3 is an example calibration plot for the SMP Update. All calibration plots are presented in Appendix F.

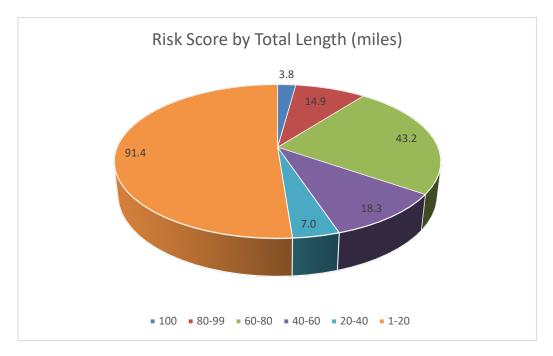
Figure ES-4 Risk Scores of Pipes with CCTV Footage

A breakdown of the scoring for pipes with CCTV records is shown in Figure ES-4. Over half the pipes received a score of less than 20, meaning they are of lower priority for rehabilitation or replacement.

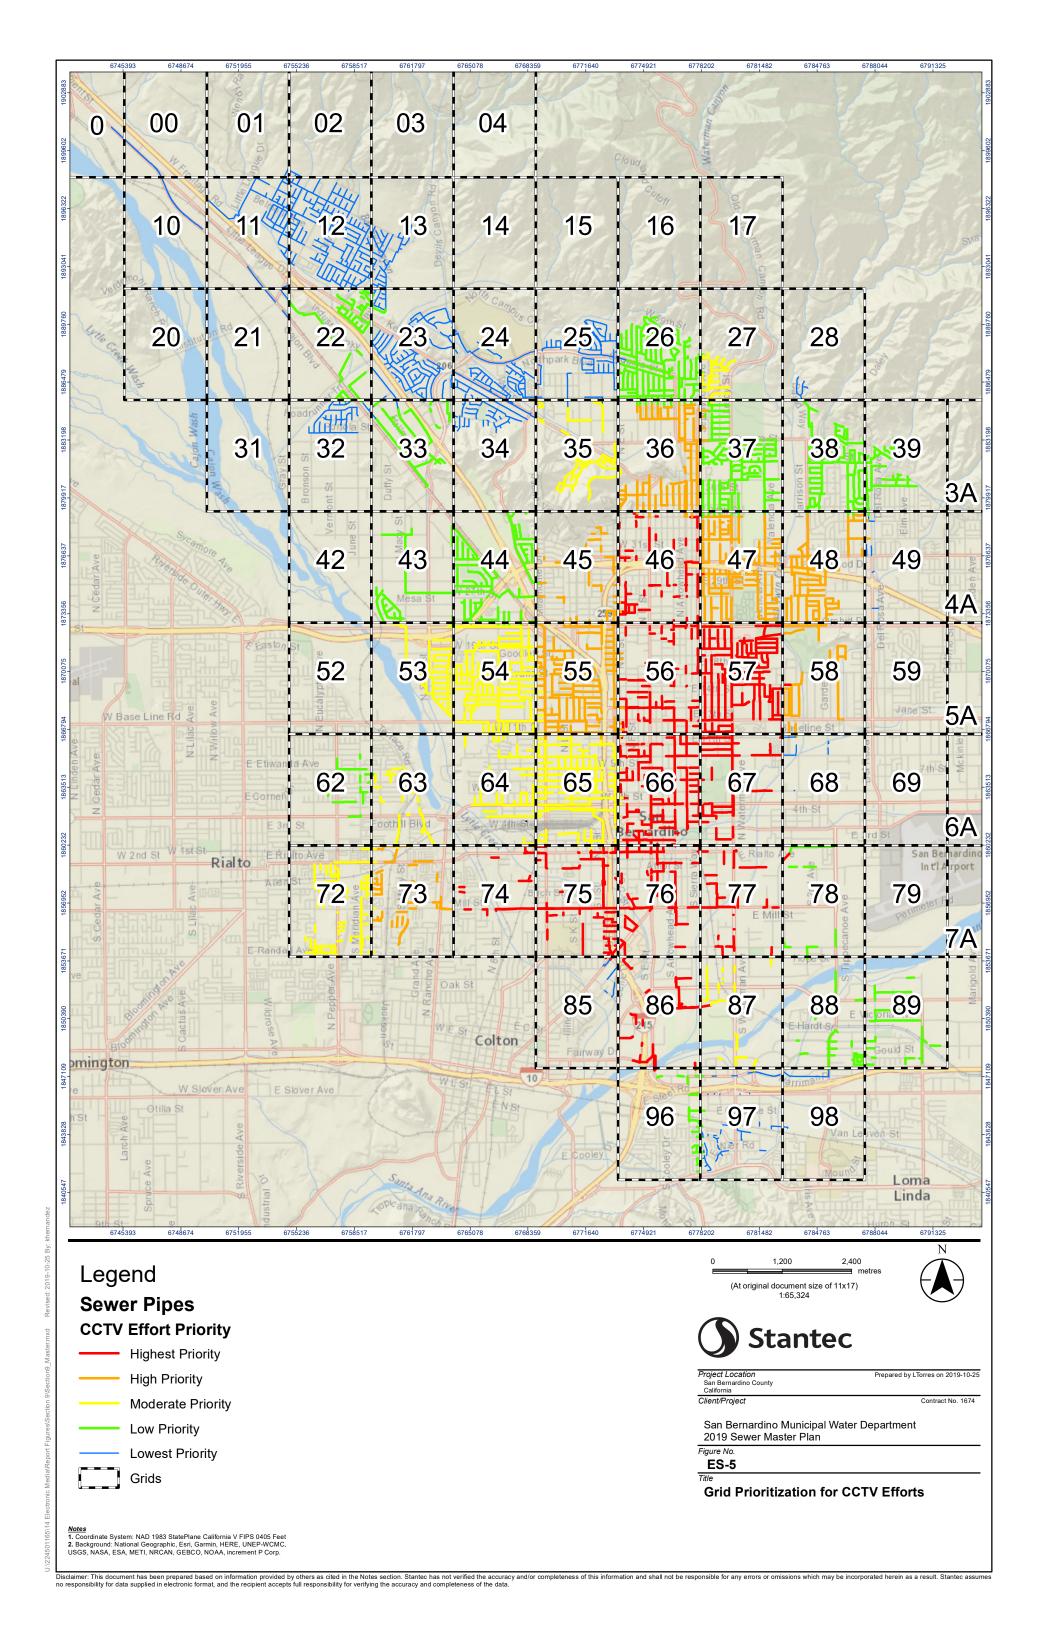
The 304 miles of pipe that do not have recent CCTV footage are spread across 59 grids in the SBMWD service area. Stantec averaged the adjusted risk score for all pipes within each of the 59 grids. Grids were ranked in order of highest average adjusted risk score in order to prioritize future televising efforts. Figure ES-5 shows the grids color coded by the 5 priority levels.

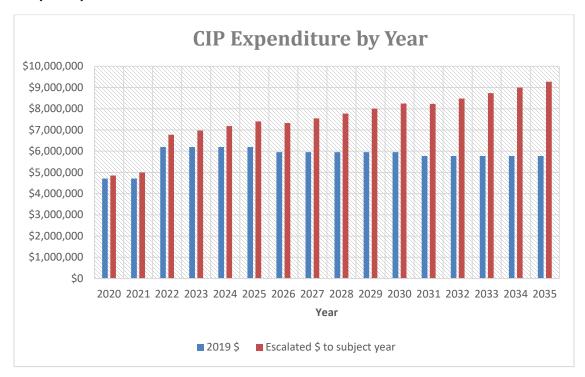
Figure ES-6: CIP Costs per Year

Figure ES-6 and Figure ES-7 summarize the CIP costs discussed in this section by year and by planning horizon, respectively. The total CIP cost is estimated at \$92.9M in 2019 Q1 dollars, and \$120.8M based on a 3 percent escalation year-to year.

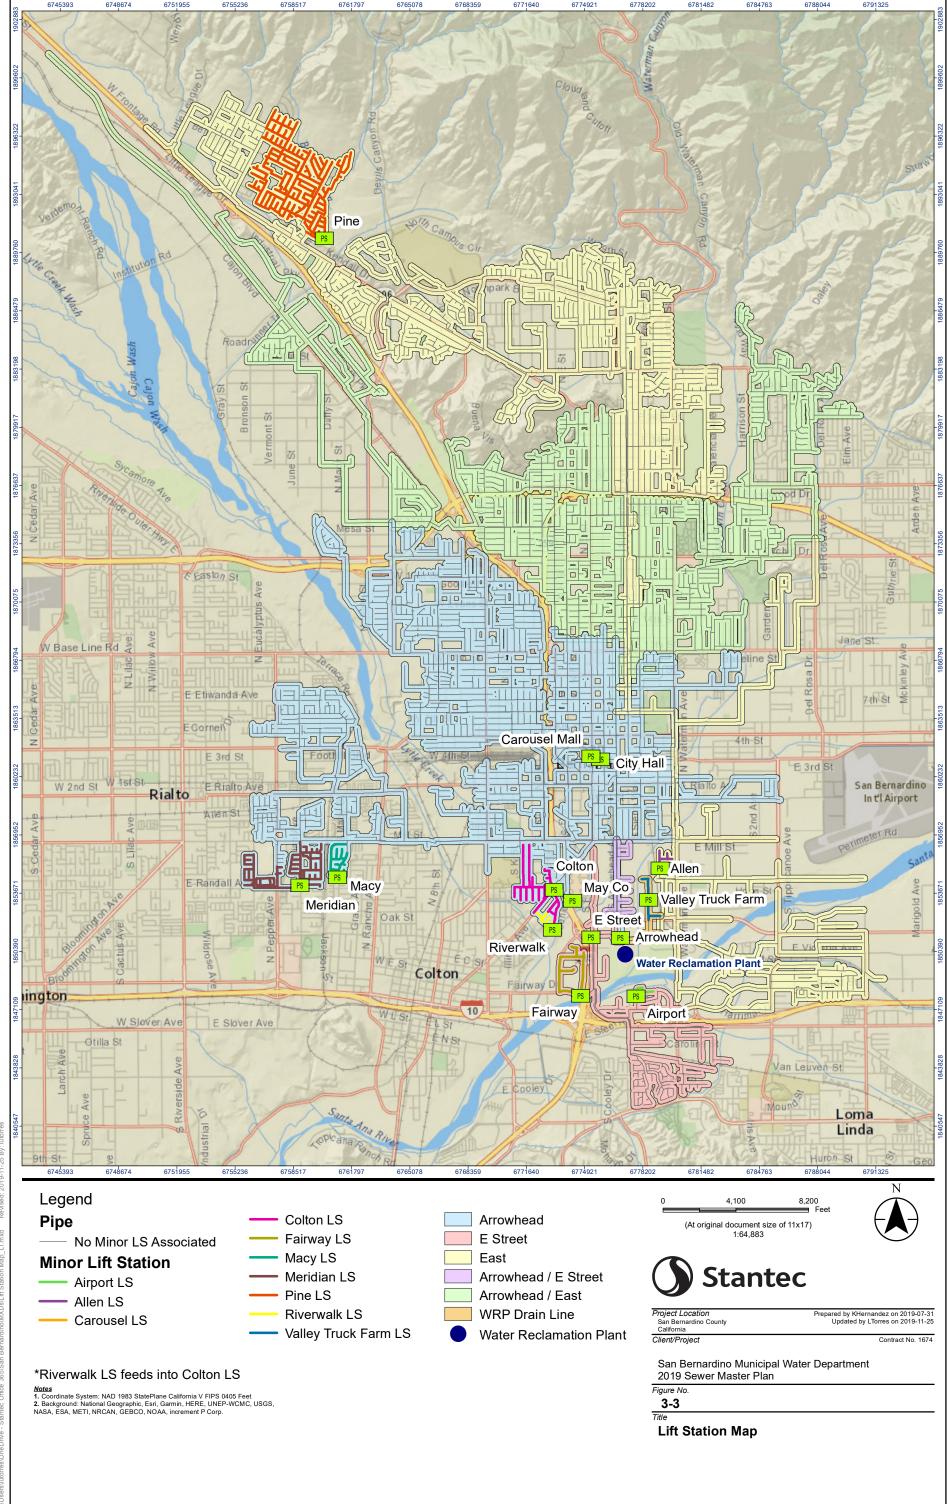
Where gravity flow is no longer possible, a pressurized system pumps flow from low points in the system to higher elevations. SBMWD currently operates 15 lift stations (LS) within its system. The locations of these lift stations are shown on Figure 3-3.

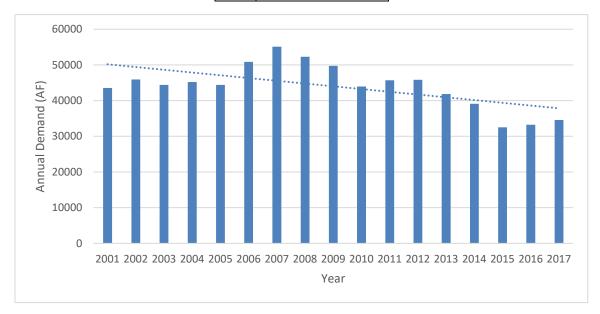
Figure 4-1 Historical Water Demand 2001-2017

<u>Year</u>	Water Demands (AF)
2001	43,566
2002	45,930
2003	44,397
2004	45,198
2005	44,384
2006	50,842
2007	55,135
2008	52,281
2009	49,725
2010	43,952
2011	45,694
2012	45,827
2013	41,844
2014	39,125
2015	32,529
2016	33,245
2017	34,583

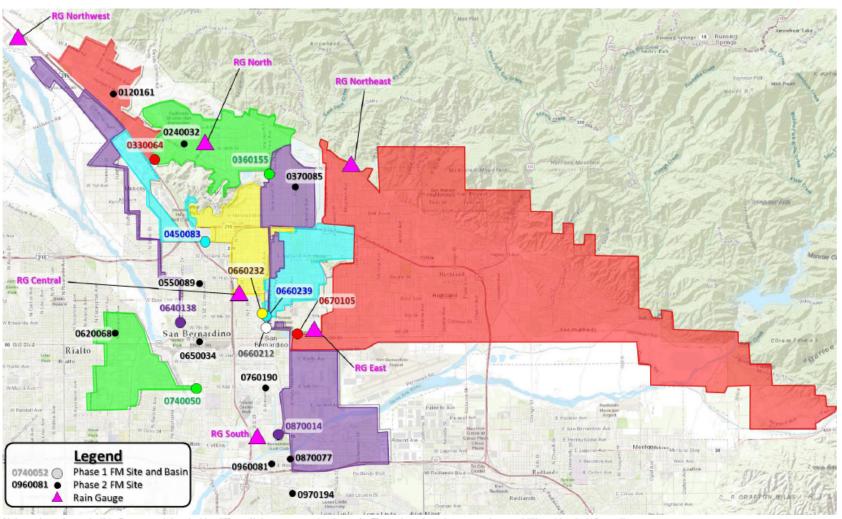
Figure 4-2 Map of Flow Monitoring Sites, Basins and Rain Gauges

Note: colors shown in this figure are intended to differentiate sewerage basins only. The colors do not represent any additional basin information. Per Department's request, East Valley Water District (EVWD) service area were included in FM 0670105 basin.

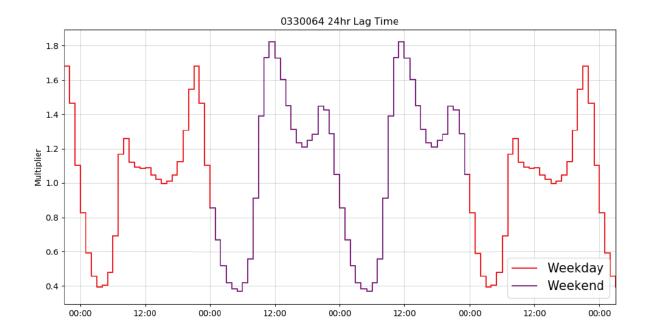
Figure 4-3 FM 0330064 Diurnal - with lag time

Diurnal curve patterns represent flow over a typical 24-hour period and are used in the model to modify average daily flows and represent variations in the average based on time of use. Diurnal patterns were created for each flow monitoring location during Phase I. Figure 4-3 shows an example of a diurnal curve pattern for flow monitoring point 0330064. Diurnal curves were created both with and without 24-hour lag time after rainfall events to confirm any differences immediately after a rain event. Diurnal curves for the remaining flow monitoring points, both with and without lag time, can be found in Appendix C. Lag time is defined as a period of time allowed for at end of a rainfall event before a diurnal curve is created, such that the after effects of the rainfall (inflow and infiltration which can be evident beyond the rainfall event itself) is no longer appreciable at the meters and the diurnal curve can be assumed to represent dry weather conditions.

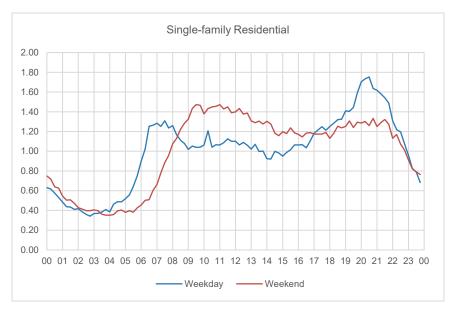
Figure 4-4 Diurnal Pattern for Single-Family Residential Land Use

Diurnal curves were also developed for each land use type based on the Phase II flow monitoring results. Figure 4-4 through Figure 4-7 below show the weekday and weekend diurnal curves for single-family residential, multi-family residential, commercial, and industrial areas. It should be noted that the higher increase in flows later at night is consistent with the diurnal curves in nearby areas.

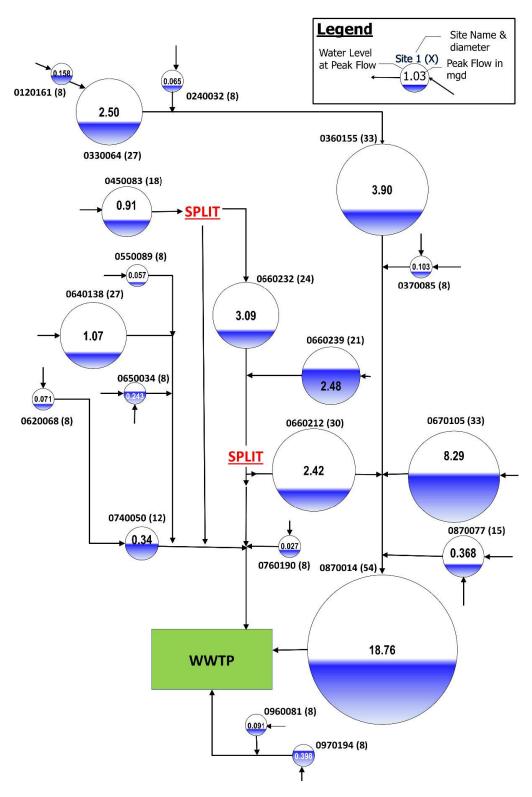
Figure 4-6 Peak Flow Schematic

Table 4.3 shows the peaking factors per the Flow Study, shown schematically on Figure 4.7. The peak flows and flow levels reported are from the measurements taken during the flow monitoring period. Per the Flow Study, the following capacity analysis terms are defined as follows:

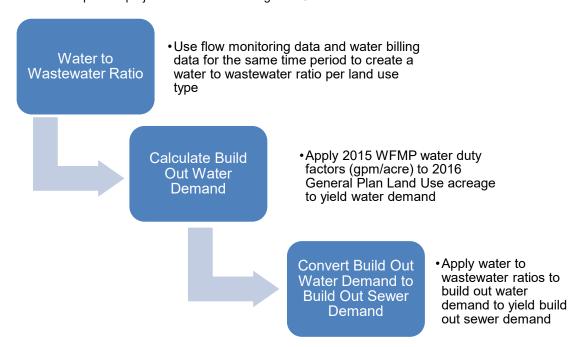
Figure 4-7: Future Projection Methodology

Build-out wastewater projections were developed for Year 2060. Wastewater projections were developed from water demand projections and duty factors presented in the UWMP and the 2015 SBMWD Water Master Plan. The process used to develop these projections is shown on Figure 4-8

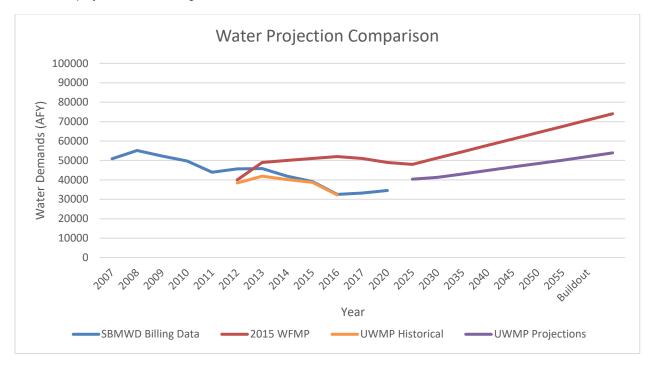
Figure 4-8 Historical Water Demand 2001-2017

A graphical comparison of the 2015 WFMP projects, SBMWD billing data, and the UWMP data can be found in Figure 4.8. It should be noted that there is a gap in data between the historical data provided by the 2015 UWMP and the UWMP projections, which begin in Year 2020.

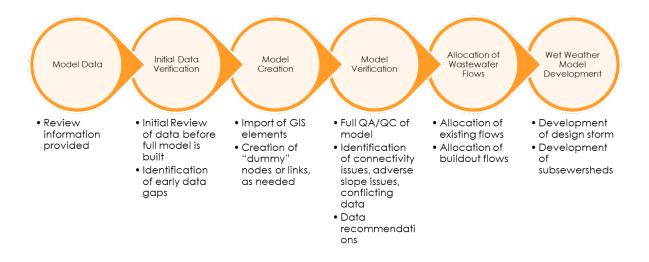
Figure 5-1 Overview of Model Development Process

Figure 5-1 shows an overview of the model development. The model development begins with review of data collection and initial data verification. The model is subsequently created and then verified to identify any connectivity issues, adverse slope issues, or conflicting data. After verifying the model, wastewater flows are then allocated for each scenario (existing and build out). Finally, the model is further prepared for wet weather analysis. Each of these steps will be discussed in the section.

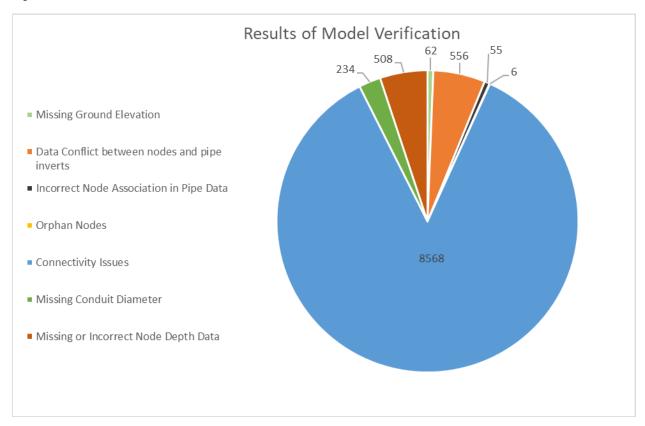
Figure 5-2 Results of Model Verification

The QA/QC process resulted in identification of several connectivity issues, along with conflicting data between nodes and pipes. The results of the QA/QC review, by type of issue and number of occurrences, is presented in Figure 5-2

The following subsections present examples of each issue and note the preferred solution methodology. It is noted that these assumptions add uncertainty to the final model and should be investigated for future model updates. Any deviations from SBMWD's original GIS was flagged using ICM's flagging tool which will aid in identifying any assumptions made during future updates.

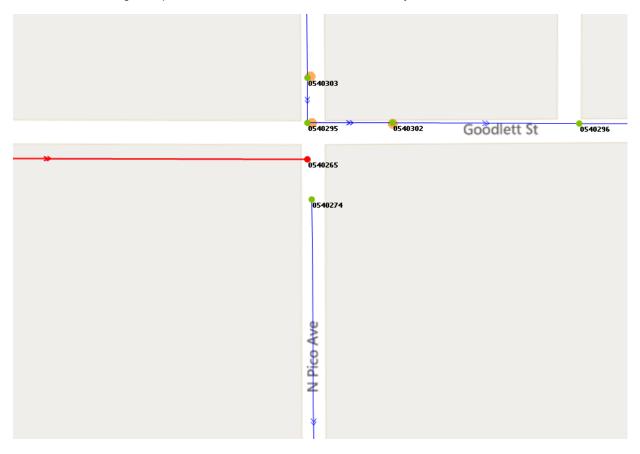
Figure 5-4 Missing Pipe Connectivity Issue

Figure 5-4 shows the pipe flowing east and coming to a dead end. This creates a subnetwork that is unconnected to the main network, and thus not connected to an outfall. In total, there were 36 subnetworks identified. The orange circles in Figure 5-4 represent TKE survey data points. Results of the TKE survey were used to help resolve potential connectivity issues where available. These issues were resolved manually for each subnetwork. All subnetworks were connected through this process and all flow in the model flow to the system outfalls.

Connectivity issues made up the majority of the identified issues during model verification. Connectivity issues were often solved on a case-by-case basis. Figure 5-3 and Figure 5-4 show two different types of connectivity issues. Figure 5-3 shows a pipe-to-pipe connection; the model requires all pipes to be connected through nodes. As a result, a dummy maintenance hole was added to fix this connectivity issue.

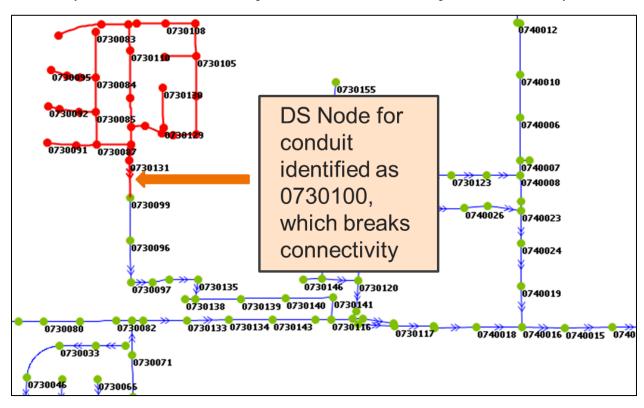
Figure 5-5 Incorrect Node Association within Pipe data

Incorrect node association within the pipe attributes can also result in connectivity issues. Figure 5-5 shows an example of incorrect node association. The pipe called out has the downstream node identified within the pipe data as SMH 0730100, however from the network it shows that the downstream node should actually be SMH 0730099. Incorrect node association can also cause connectivity issues when the modeling software assigns connections automatically. These errors are resolved through manual review and reconnecting elements on a case-by-case basis.

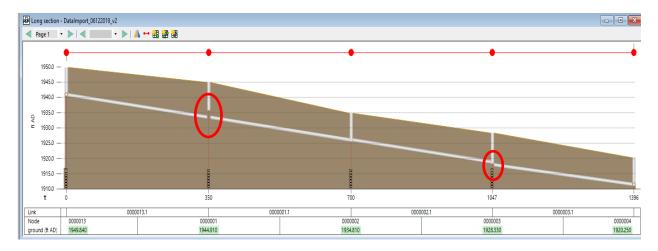
Figure 5-6 Data Conflict between Maintenance Holes and Pipe Inverts

The next most prevalent data conflict was data conflicts between the maintenance hole and pipe invert layer. Figure 5-6 shows an example of two locations where the maintenance hole invert and the pipe invert do not align. These instances were resolved according to whether maintenance hole or pipe data were more consistent with neighboring infrastructure (i.e. maintain a constant slope or downhill flow trajectory).

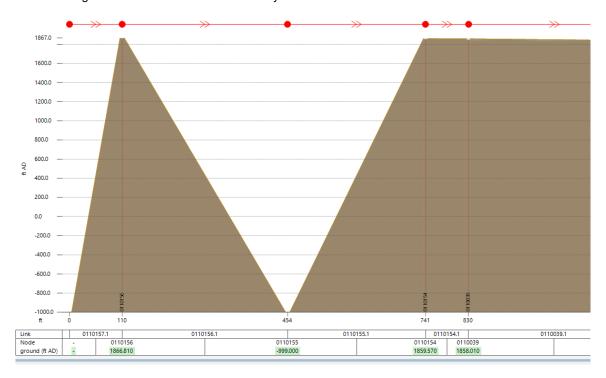
Figure 5-8 Missing Ground Elevation

As indicated in Table 5-1, LiDAR data was used to interpolate ground elevation when it was absent. Figure 5-8 shows an example of a node with missing ground elevation. The maintenance hole locations were overlaid onto the LiDAR data to obtain the ground or rim elevation. The rim elevation was cross-checked with surrounding ground elevation per GIS and Google Earth to confirm relative accuracy.

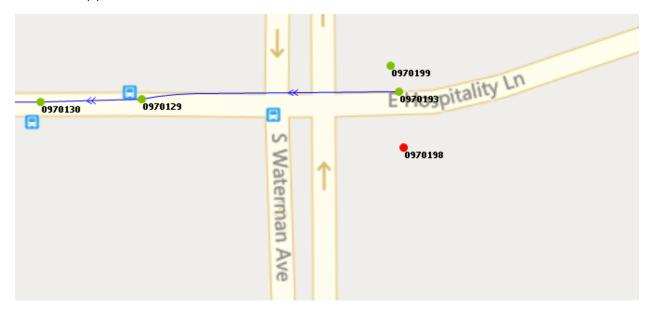
Figure 5-9 Orphan Nodes

Orphan nodes were examined to determine if connectivity should be modified. Figure 5-9 shows an example of two orphan nodes identified during model verification. Many of the orphan nodes were cleanouts; any cleanouts not connected to pipes were removed from the model.

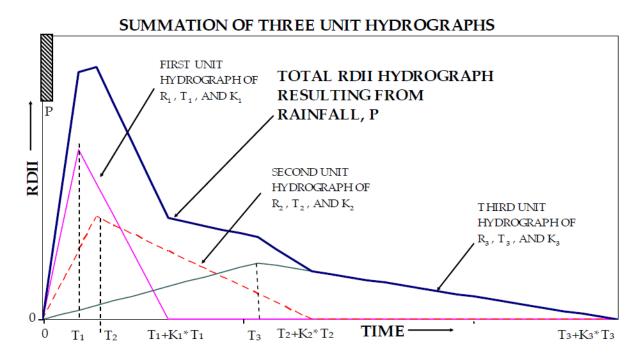
Figure 5-11 Wet Weather Response Unit Hydrographs

EPA Sanitary Sewer Overflow Analysis and Planning (SSOAP) Toolbox was used to determine the R-value. Figure 5-11 illustrates how wet-weather responses were calculated using the three-unit hydrographs in this toolbox.

Using the SSOAP Toolbox, Stantec estimates that approximately 0.5% of rainfall volume enters into the sewer system. Almost all of the rainfall volumes entering into the sewer system can be classified as fast response (inflow / first unit hydrograph). There is no evidence any significant rainfall derived infiltration occurring within the sewer system during the flow monitoring period.

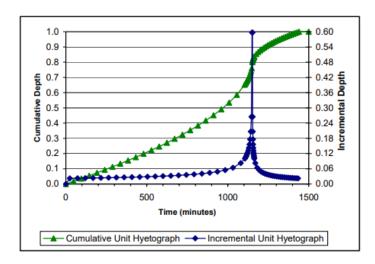
Figure 5-12 Cumulative Unit Hyetograph per LA County DPW Hydrology Manual

The LA County's 24-hour cumulative unit hyetograph (Figure 5-12) was converted into a 15-minute interval hyetograph by interpolating the incremental rain values.

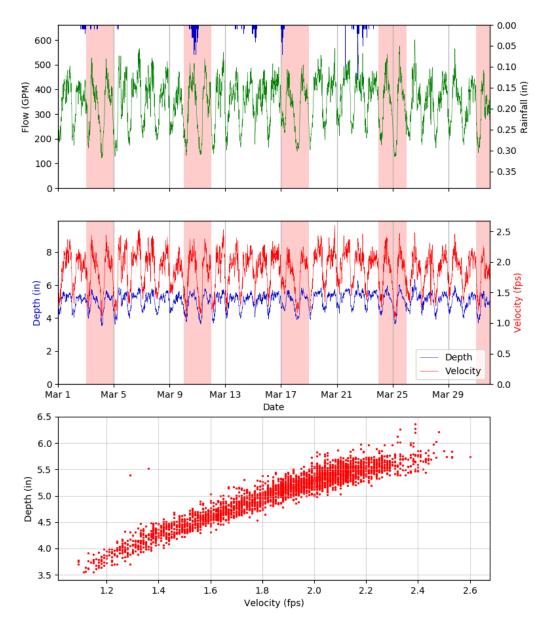
Figure 6-1 Flow Meter 0450083 March Results

The scatterplot (bottom plot of Figure 6-1) depicts velocity along the x-axis and depth measurement along the y-axis. The relationship between velocity and depth for a given flow meter can be estimated from the Manning's curve, which shows how the distribution of this scatterplot should look like under uniform flow conditions. When the scatter plot deviates from the Manning's line, it may indicate that the system is operating outside of uniform flow. This scatterplot also shows the consistency of flow behavior at the flow monitoring location.

Days that experienced rainfall or any unexpected patterns were removed, and average diurnal curves were created for both a standard weekday and weekend for each flow meter. This was done for dry weather calibration to ensure that there was no rainfall data influencing results.

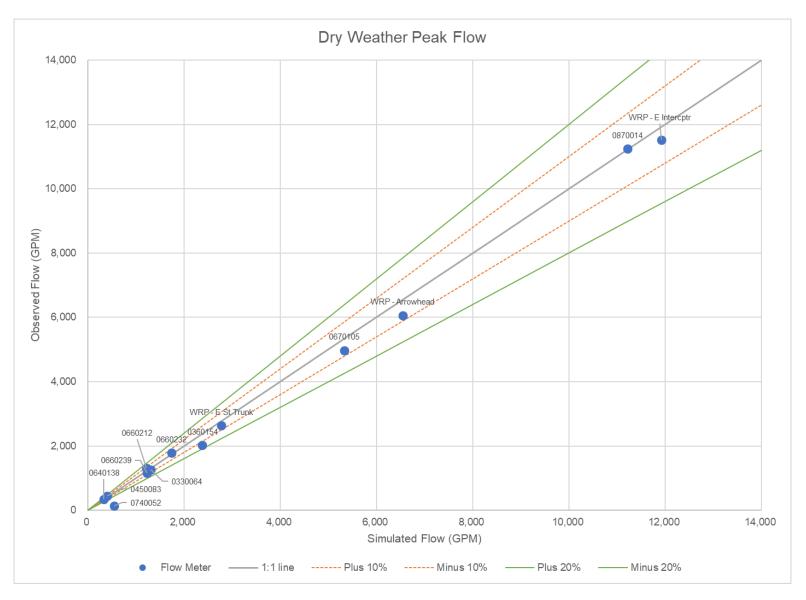
Figure 6-2 Summary of Dry Weather Peak Flow Calibration Results

Figure 6-2 through Figure 6-4 show a summary of the calibration results for dry weather peak flow, depth and velocity. The gray line in these figures represent a one-to-one relationship between the modeled and observed data, i.e. when the model results are identical to the observed results. The dashed orange line shows a +/- 10% difference between the observed and modeled results. The green solid line represents a +/- 20% difference between the observed and modeled results. Figure 6-2 shows a total of 13 calibration points, 10 from the flow monitoring data and an additional 3 calibration points for the three influent lines to the WRP. The three influent lines to the WRP were used only for flow calibration, as depth (Figure 6-3) and velocity (Figure 6-4) data was not available from these datasets. Calibration to the overall WRP influent lines aids in confirming total system demand from each part of the system to a certain extent as there are flow splits that can direct sewer flows to multiple WRP influent lines.

- 1. Most of the modeled peak flow results (Figure 6-2) are within the 10% of the observed peak under dry weather conditions with two exceptions (FM 0360154 and FM 0740052). Detailed calibration plots for each flow monitoring location can be found in Appendix F. Stantec reviewed the two exceptions and concluded that the model is calibrated and adequate to support the master planning. Section 6.1.1 documents the contributing factors behind these two data outliers.
- 2. Most of the modeled peak depth results (Figure 6-3) are within the 10% threshold or exactly on the 10% threshold line, except for outlier FM 0740052 (See Section 6.1.1).
- 3. Most of the modeled velocity results (Figure 6-4) are within the 10% threshold, with the exception of dry weather flow at FM 740052 (See Section 6.1.1).

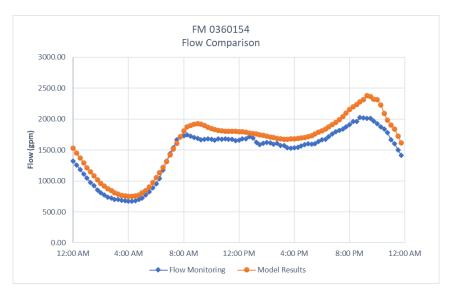
Figure 6-5 FM 0360154 Peak Flow Comparison

FM 0360154 exceeds the 10% calibration threshold for peak flow but does fall within the 20% difference. Figure 6-5 shows a comparison between model simulation results and observed data. The model results for dry weather peak flow are slightly higher than the observed flows for hours 20:00 to 24:00. However, the modeled and observed data are extremely similar for the low flow conditions occurring between 4:00 to 8:00 AM. Additional calibration modifications to FM 0360154 would result in too little modeled flow earlier in the morning. While the flow does not fall into the 10% calibration threshold, the model was an 89% match compared to observed flows when averaging all 15-minute reporting data. As such, calibration could not be improved further, and Figure 6-5 represents the final calibration of this meter. The results of the calibration were discussed with SBMWD staff to communicate the reasons for not adjusting flows further.

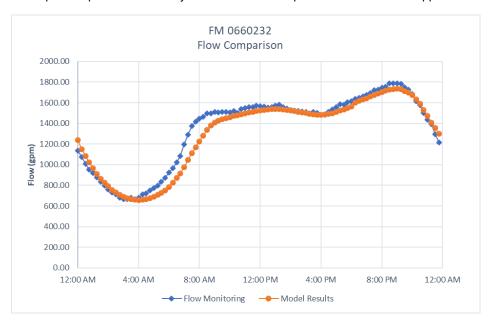
Figure 6-6 FM 0660232 Flow Comparison Plot

This subsection shows the comparison of model and flow monitor data at one calibration point for the dry weather calibration process. Figure 6-6 through Figure 6-8 show an hourly comparison between the model and the observed flow monitoring results for FM 0660232. This calibration point was chosen as an example because it shows how calibration involves consideration of all the parameters for a flow monitoring location and deciding upon a final result that optimizes all three plots. Figure 6-6 and Figure 6-8 show that the flow and velocity were very similar between the model and the flow monitoring results. Further modifying this calibration point to obtain closer modeled results for total depth would yield less accurate calibration results for flow and velocity. As such, the depth was not adjusted further. Detailed comparison plots for the all dry weather calibration points can be found in Appendix F.

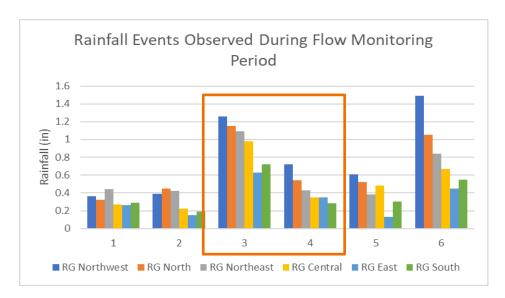
Figure 6-9 Rainfall Events Observed During Flow Monitoring Period

Events 1 and 2 were not selected as the rainfall was not significant enough across all gauges for there to be a substantial flow response. For the smaller storm event, event 4 was chosen over event 5 as the Rain Gauge East had minimal flow during event 5. For the larger storm calibration, event 3 was chosen instead of event 6 as the rainfall had a more even distribution across the system. Event 6 showed a concentration specifically in the Northwest part of the system, with minimal rainfall in east and south. The distribution of rainfall per event is shown on Figure 6-9. Location of the rain gauges during the flow monitoring period is shown on Figure 6-10.

The six rainfall events were classified as less than 1-year rainfall events for San Bernardino based on the National Oceanic and Atmospheric Administration (NOAA) Rainfall Frequency Atlas. Even though the events collected during the monitoring period were less than a 1-year rainfall event, they were enough to elicit response from the flow monitoring sites and were therefore adequate for model calibration to wet weather flow conditions.

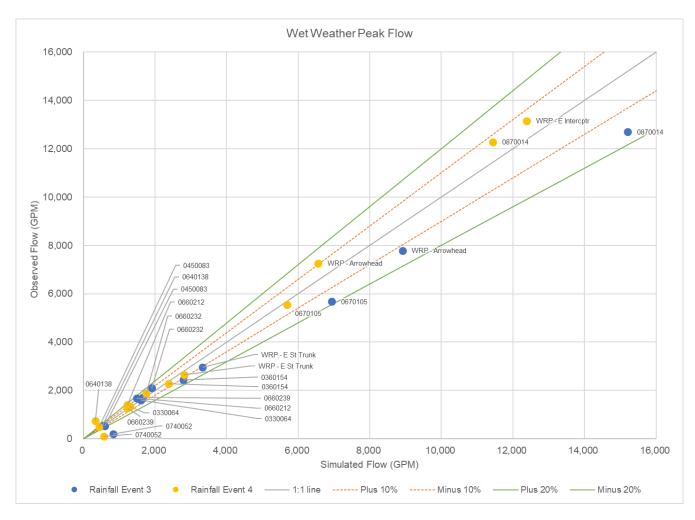
Figure 6-11 Summary of Wet Weather Peak Flow Calibration Results

Figure 6-11 through Figure 6-13 show the calibration plots for wet weather peak flow, depth, and velocity. While dry weather calibration results aim to achieve less than a 10% difference between modeled and observed results, the industry standard for wet weather calibration is within 20%. The main objective during wet weather calibration and analysis is to capture the peak values for flow, depth, and velocity and ensure the system can cope with these extremes. Thus, if the overall model results are within 20% of the observed results, assuming the peak is captured properly, the calibration is deemed acceptable.

- 1. Figure 6-11 shows a summary of the wet weather peak flow calibration results. FM 0740052 is outside the 20% difference, and was deemed unsuitable for calibration, per the discussion in Section 6.1.2. The other calibration point outside of the 20% threshold is FM 0640138, specifically during rainfall event 4. This location is discussed further in Section 6.2.4. The remaining flow monitoring points are within the 20% threshold applicable for wet weather calibration and adequately represent peak conditions.

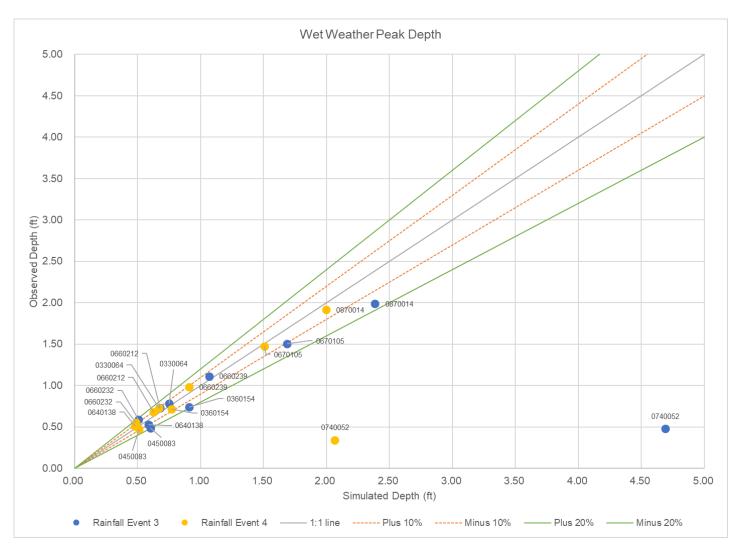
Figure 6-12 Summary of Wet Weather Peak Depth Calibration Results

- Figure 6-12 shows a summary of wet weather peak depth calibration results. The two wet weather events at FM 0740052 are outside of the 20% wet weather calibration threshold. All remaining calibration points for the two wet weather events are within a 20% difference for modeled and observed results and adequately represent peak conditions.

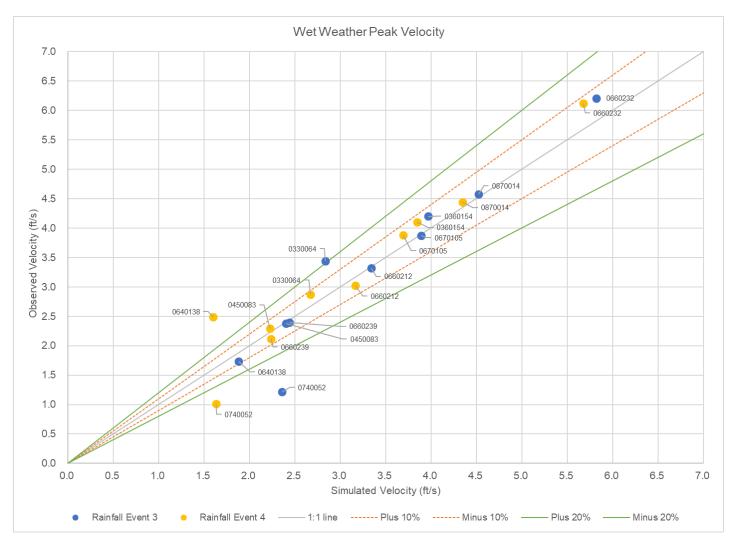
Figure 6-13 Summary of Wet Weather Peak Velocity Calibration Result

- 3. Figure 6-13 shows a summary of the wet weather peak velocity calibration results. Similar to the flow and depth results, the velocity comparison for FM 0740052 is outside of the 20% threshold for both rain events. Additionally, FM 0640138 is also outside of the 20% threshold for velocity during rainfall event 4. The remaining calibration points are within the 20% threshold and match peak conditions.

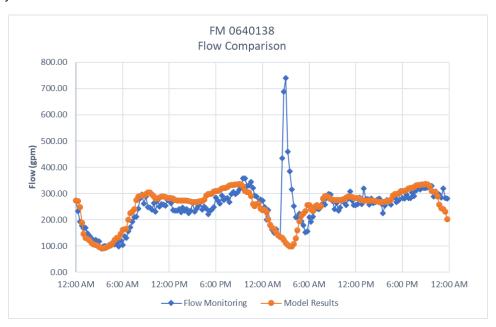
Figure 6-14 FM 0640138 Flow Comparison

As discussed in Section 6.1.2, FM 0740052 was an outlier for the flow, depth, and velocity calibration plots for wet weather due to partial blockage in a pipe. In addition, FM 0640138 was outside of the 20% criteria for both the flow and velocity calibrations for rainfall event 4. Figure 6-14 shows the modeled results and the observed flow monitoring results for FM 0640138 during rainfall event 4. The observed flow monitoring results show a peak of flow occurring on March 15th, between 2:30am and 4:30am. This extreme peak was compared to the nearest rain gauge to this flow monitoring point, the central rain gauge. After looking at the rainfall data collected at the central rain gauge, only 0.2 inches of rain occurred between 2:30am to 4:30am. The remaining rain gauges across the system experienced similar amounts of rainfall during this time. As such, it was determined that the peak flow occurring between 2:30-4:30am was due to a localized flow event and was not reflective of wet weather flows. This location was not calibrated any further.

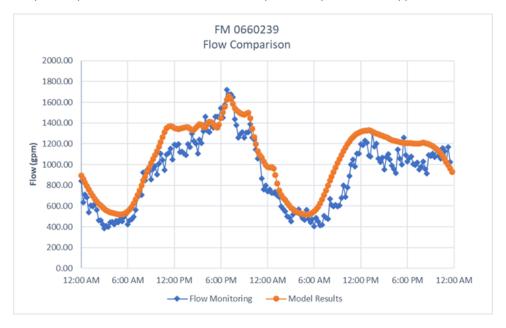
Figure 6-15 FM 0660239 Flow Comparison

This subsection shows the comparison plots for flow, depth, and velocity for one flow monitoring (FM 0660239) point during wet weather calibration. FM 0660239 is located in West 9th St. between N Arrowhead Ave and N Mountain View Ave, in the east side of the system. These plots highlight the goal of wet weather calibration, which is to capture the peak flow, depth, or velocity. Figure 6-15 shows the flow comparison between modeled and observed results for FM 0660239 during rainfall event 3. The peak flow in the observed results matches the peak simulated by the model. While the simulated flow may be larger than the observed flow during 6:00 am to 12:00pm, this calibration was deemed acceptable as the peak was captured and the overall match between simulated and observed results were within 20%. Comparison plots for all wet weather calibration points are presented in Appendix F.

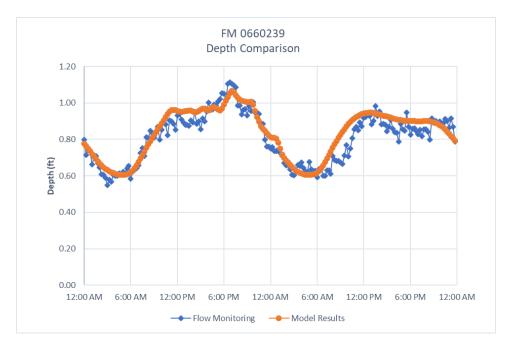
Figure 6-16 FM 0660239 Depth Comparison

Figure 6-16 shows the depth comparison between the modeled results and the observed flow monitoring results for FM 0660239. The peak depth was a close match between the modeled results and the observed flow monitoring results. In addition, the peak depth observed in the flow monitoring results was well represented in the modeled results.

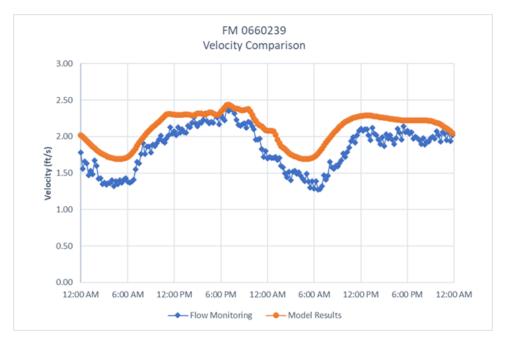
Figure 6-17 FM 0660239 Velocity Comparison

Figure 6-17 shows the peak velocity comparison between the model results and the flow monitoring data. As previously noted, the main goal of wet weather calibration is to confirm that the model matches the peak flow, depth, or velocity observed in the flow monitoring results. The model results in Figure 6-17 do capture the peak velocity observed during the flow monitoring results for rainfall event 3. The overall model results are higher than the observed results, though the average difference between the model and the flow monitoring results are within the 20% threshold. Because the model reflects the peak experienced during velocity seen in flow monitoring data well and the overall difference is within accepted limits, the calibration of this flow monitoring point was deemed acceptable.

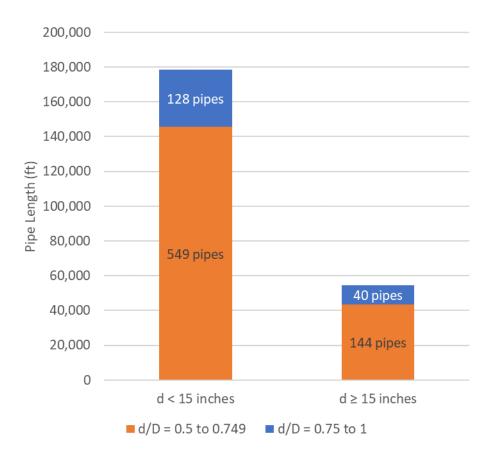
Figure 8-2 Existing Dry Weather Capacity by d/D ratio and Diameter

Results for the existing dry weather analysis showed that 168 pipes reached a capacity of 75% or above under peak dry weather conditions. Figure 8-1 displays a system map with location of these pipes shown in red. Figure 8-2 shows a chart of the total length and number of pipes with a d/D ratio greater than or equal to 0.75 for small (less than 15 inches in diameter) and large (15 inches or greater in diameter) pipes as well as pipes with a d/D ratio between 0.50 and 0.75. It is noted that 2 of the 168 pipes with a d/D ratio greater than or equal to 0.75 are upstream of the SNRC diversion on the East Trunk Sewer and are planned to be transferred to EVWD after construction of the recycling facility.

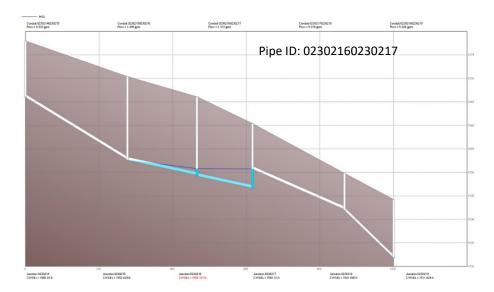
Figure 8-3 Example of Suspected GIS Issue

1. **Suspected GIS data issue**: While the pipe shows a d/D greater than or equal to 0.75, the limit in capacity is likely due to a suspected GIS issue, not a physical limitation in capacity. This cause was determined when the profile showed adverse slopes that could not be confirmed, unconfirmed pipe offsets, or pipe slopes that were abnormally steep. Figure 8-3 shows an example of a suspected GIS issue in the model.

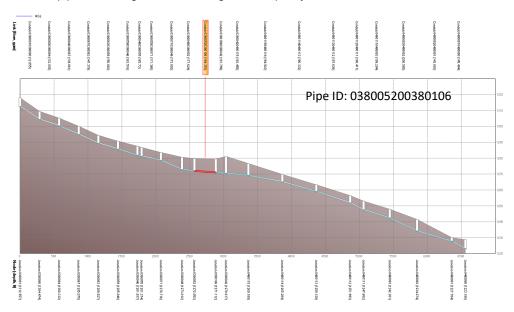
Figure 8-4 Example of True Capacity Issue

2. True capacity issue: If no immediate upstream or downstream GIS issues were identified, an extended profile of the pipe was reviewed, usually covering roughly half of a mile from upstream to downstream. If, after examining the extended profile, no suspected GIS issues can be identified it is deemed a "true" capacity issue. Figure 8-4 shows an extended profile of Pipe ID 038005200380106. After examination of this profile, this pipe was categorized as having a true capacity issue.

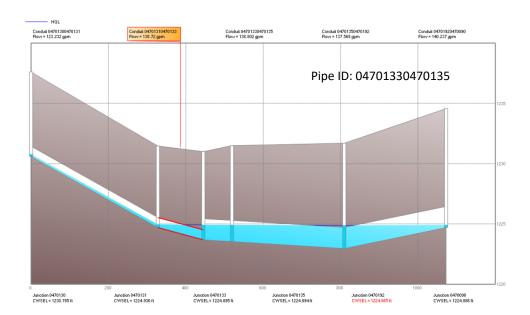
Figure 8-5 Example of Pipe Constriction Issue

3. **Pipe constriction issue**: A pipe constriction issue is a specific type of the suspected GIS issues. When the profile shows significant reduction in pipe diameter (more than 1 ft), it is categorized as a pipe constriction issue. Figure 8-5 shows an example of this type of model result.

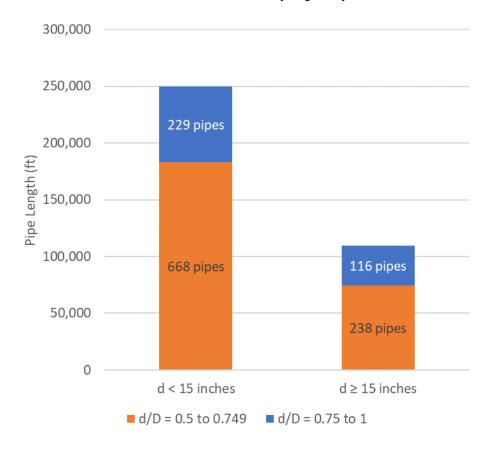
Figure 8-6 Existing Wet Weather 2-Year Storm Capacity by d/D Ratio and Diameter

Figure 8-6 displays a chart of the total length and number of pipes with a d/D ratio greater or equal to than 0.75 for small (less than 15 inches in diameter) and large (15 inches or greater in diameter) pipes, as well as pipes with a d/D ratio between 0.50 and 0.75. Figure 8-7 shows the 345 pipes with d/D ratios greater than or equal to 0.75, as well as the seven flooded nodes (maintenance holes) during the two-year storm simulation. One of the flooded nodes and 33 of the 345 pipes with d/D ratios greater than or equal to 0.75 are upstream of the SNRC diversion and are planned to be transferred to EVWD after construction of the recycling facility.

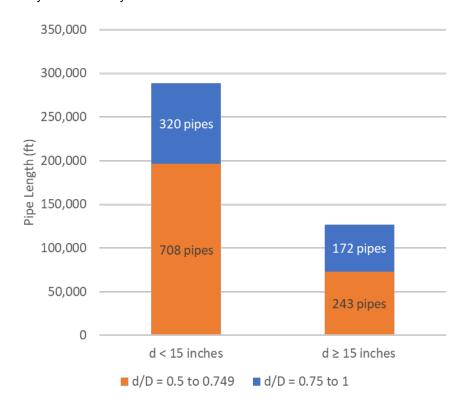
Figure 8-8 Existing Wet Weather 10-Year Storm Capacity by d/D Ratio and Diameter

Figure 8-8 displays a chart of the total length and number of pipes with a d/D ratio greater than or equal to 0.75 for small (less than 15 inches in diameter) and large (15 inches or greater in diameter) pipes, as well as pipes with a d/D ratio between 0.50 and 0.75. Figure 8-9 shows in red the location of these pipes as well as the 15 nodes that are flooded during the 10-year storm analysis.

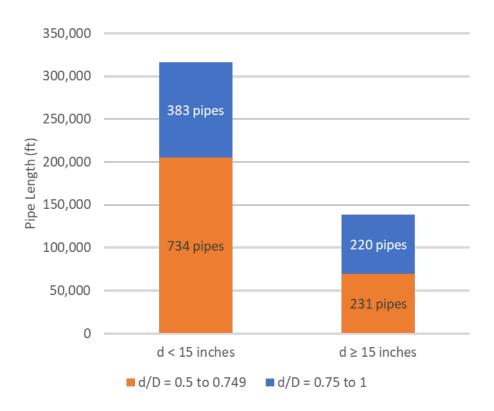
Figure 8-10 Existing Wet Weather 25-year Storm Capacity by d/D Ratio and Diameter

The 25-year storm results for the existing scenario show a total of 603 pipes with d/D greater than or equal to 0.75 and 25 total nodes that are flooded. 68 of the 603 pipes with d/D greater than or equal to 0.75 and four of the flooded nodes are upstream of the SNRC diversion. Figure 8-10 displays a chart of the total length and number of pipes with a d/D ratio greater than or equal to 0.75 for small (less than 15 inches in diameter) and large (15 inches or greater in diameter) pipes, as well as pipes with a d/D ratio between 0.50 and 0.75. The flooded nodes consisted of the seven nodes which exhibited flooding during the two-year storm, eight nodes that exhibited flooding during the ten-year storm, and 10 additional nodes that showed flooding at the 25-year storm. The maintenance hole IDs for the ten new nodes exhibiting flooding are:

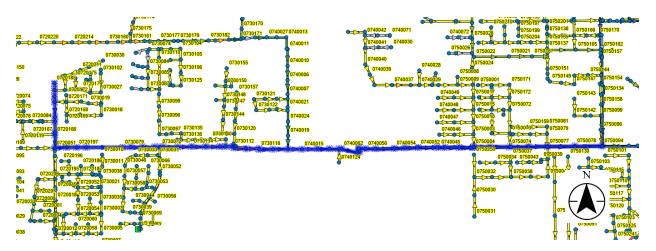
Figure 8-16 Area of Concern 1 – Part of Special Area Study

Although 31 pipes were identified as needing capacity improvements for the existing dry weather scenario, only 18 pipes pertaining to existing dry weather capacity issues are shown in Table 8-1. The remaining 13 pipes all fell into the West Residential area previously discussed in Section 6. Figure 8-16 and Figure 8-17 show the stretch of pipe in question. While there are GIS issues present within the highlighted pipe segments, there were also pipes that seemed to have actual capacity issue. Upon further discussion with SBMWD, it was agreed that a special area study would be conducted for this area, assuming investigation of approximately 100 maintenance holes to confirm invert elevations and flow monitoring at three locations to confirm the quantity and pattern of flow in this area.

After discussion with SBMWD, it was determined that no improvements for build out scenario capacity deficiencies would be recommended. Capacity improvements were not recommended as the model shows significant data inconsistency which will require additional field confirmation. The build out scenario also assumes multiple large developments, many of which are in the early planning stages and may change significantly. Additionally, there is a significant length of time until the build out scenario is expected to occur, and many of the improvements would likely be obsolete by the time build out demand is realized in the service area. In place of specific projects, areas of concern are identified for the build out system based on the capacity deficiencies identified. Figure 8-16 and Figure

8-17 show these areas of concern, and a table of all pipes with limited capacity (summarized by grid) can be found in Appendix G. It is recommended that SBMWD continue to monitor these pipes and reference this list when new development or significant changes in wastewater generation occur in specific regions of the service area.

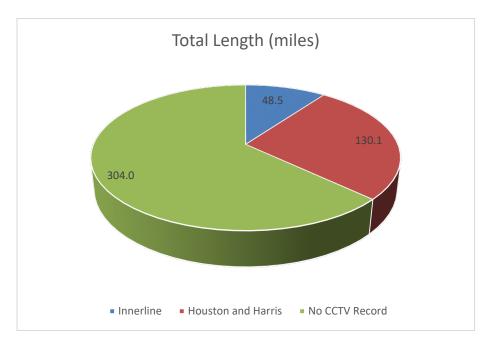
Figure 9-1 Pipe Lengths by CCTV Records

As part of the contract to update SBMWD's sewer master plan, Stantec and Innerline delivered a CCTV and cleaning program of pipelines 12 inches and greater in diameter not previously addressed by H&H. In addition to this work, SBMWD provided Stantec with videos and reports from the H&H CCTV program conducted previous to the update; this effort was conducted by H&H under contract with the City of San Bernardino and prior to the transfer to the Department. Stantec used the findings from these efforts, including review of CCTV video; analysis of PACP and risk scoring; review of reports and pictures; and conversations with SBMWD staff to complete the system-wide condition assessment of pipe condition. Figure 9-1 summarizes the length of gravity mains where CCTV was available. Pipe with CCTV footage are mapped on Figure 9-2. A small number pipes from the historical H&H data were not able to be located based on the provided pipe reference data (i.e. the pipe identifications could not be matched to the SBMWD GIS) or were excluded as Innerline had more recent inspection data for sewer pipes. All videos, reports, tracking, and pictures from Innerline's work as part of this project effort have been submitted to SBMWD for reference.

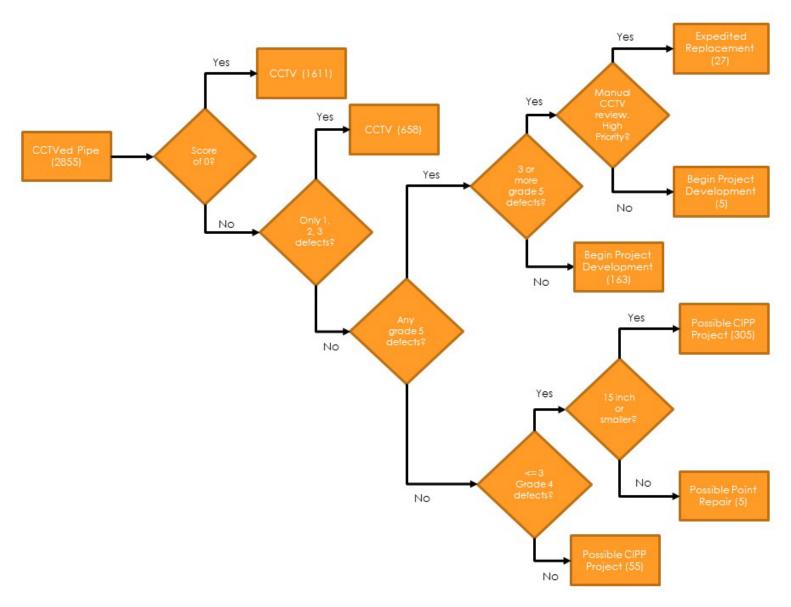
Figure 9-3 R&R Action Decision Tree

The risk scores for pipes with CCTV footage help establish pipe prioritization but are not designed to be used for determining replacement or rehabilitation actions for individual pipes. To determine the action, the CCTV records were analyzed using the decision tree shown in Figure 9-3. The following criteria are key assumptions for the decision tree:

- 1. Any pipe that has no defects or no greater than a grade 1, 2, or 3 defect are recommended for reassessment via CCTV after high risk pipes are addressed.
- Any pipe with a grade 5 defect will be recommended for project development to begin for replacement or rehabilitation. Pipes with three or more grade 5 defects were individually reviewed by Stantec to determine which pipes warrant expedited replacement.
- 3. Where the most severe defect for a pipe is grade 4, rehabilitation through possible CIPP is recommended. This recommendation changes to possible point repair if there are three or less grade 4 defects and the pipe is larger than 15 inches.

The rehabilitation and replacement action assigned to each pipe through the decision tree presented in Figure 9-3 are summarized in Table 9.2. The majority of pipes are recommended for future CCTV and 27 are recommended for expedited replacement based on the review of the pipes with three or more grade 5 defects. The result of this manual CCTV review to determine the high priority pipes is summarized in Table 9.3, with the pipes identified as "high" or

Using the decision tree shown in Figure 9-3 in Section 9, either CCTV, CIPP, point repair, or replacement was recommended for pipes with CCTV records. If a pipeline had a score of zero or had defects with a grade of 1, 2, or 3, it was recommended for future CCTV and included in the non-CCTV pipes recommendations discussed in Section 9 and in subsection 10.7. Pipelines with grade 5 defects are the most pressing for SBMWD and to properly assign a rehabilitation and replacement action, the videos and reports from the 36 worst pipeline (having 3 or more grade 5 defects) were reviewed and are discussed in Section 9. These pipelines are prioritized highest with a few exceptions; in discussion with SBMWD staff any pipeline recommended for replacement that is greater than 36" in diameter requires a PDR level study to assess options for rehabilitation, bypass pumping, and other considerations specific to large diameter transmission mains. All other pipes were assigned a rehabilitation or replacement action (based on the decision tree presented in Section 9) and a planning horizon (based on the adjusted risk score). Table 10-8 summarizes the pipe condition recommendations by length and cost for the four planning horizons, while Figure 10-2 and Figure 10-3 show a pie chart summarizing the recommendations by length and cost, respectively.

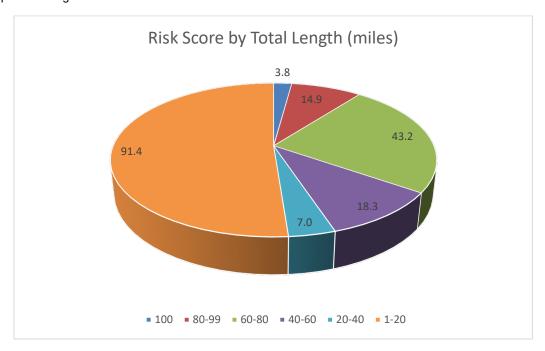
Figure 9-4 Breakdown of Risk Scores

A breakdown of the scoring for pipes with CCTV records is shown in Figure 9-4. Over half the pipe received a score of less than 20, meaning they are of low concern for rehabilitation or replacement. Figure 9-5 shows the location of each pipe according to the overall risk score.
