FINAL REPORT

2019 Sewer Master Plan Update

Prepared for San Bernardino Municipal Water Department

March 2020

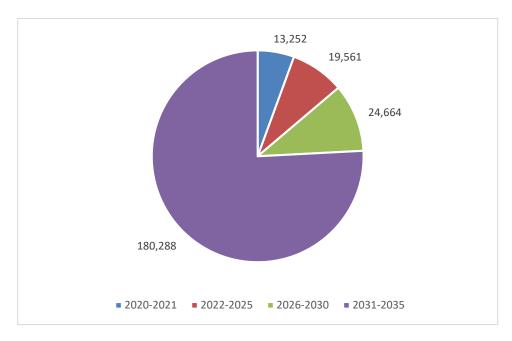
Figure 10-2: Pipe Rehabilitation and Replacement Length (ft.) per Horizon

Using the decision tree shown in Figure 9-3 in Section 9, either CCTV, CIPP, point repair, or replacement was recommended for pipes with CCTV records. If a pipeline had a score of zero or had defects with a grade of 1, 2, or 3, it was recommended for future CCTV and included in the non-CCTV pipes recommendations discussed in Section 9 and in subsection 10.7. Pipelines with grade 5 defects are the most pressing for SBMWD and to properly assign a rehabilitation and replacement action, the videos and reports from the 36 worst pipeline (having 3 or more grade 5 defects) were reviewed and are discussed in Section 9. These pipelines are prioritized highest with a few exceptions; in discussion with SBMWD staff any pipeline recommended for replacement that is greater than 36" in diameter requires a PDR level study to assess options for rehabilitation, bypass pumping, and other considerations specific to large diameter transmission mains. All other pipes were assigned a rehabilitation or replacement action (based on the decision tree presented in Section 9) and a planning horizon (based on the adjusted risk score). Table 10-8 summarizes the pipe condition recommendations by length and cost for the four planning horizons, while Figure 10-2 and Figure 10-3 show a pie chart summarizing the recommendations by length and cost, respectively.

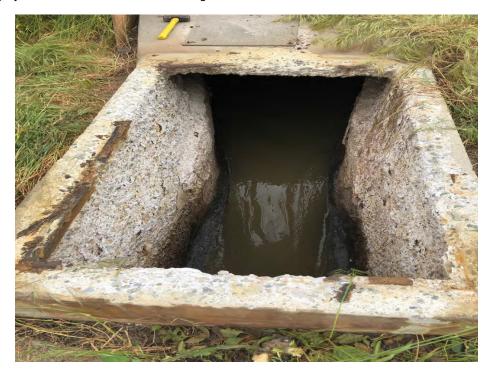
Figure 10-4: Concrete Structure on Pipeline 08700140860134

These pipelines have recent CCTV available and the adjusted risk score is based on CCTV results, with the exception of 08700140860134. That pipeline would be included in the future CCTV recommendation, however, a structure discovered on this pipeline by SBMWD staff warranted detailed study. According to SBMWD staff, the Old Headworks Facility concrete structure located east of the WRP and the Twin Creek Channel and south of Dumas Street shows visible concrete and rebar damage that appears to be Level 4 on V&A's Vanda Concrete Corrosion Index Rating System. This location is shown on Figure 10-4.

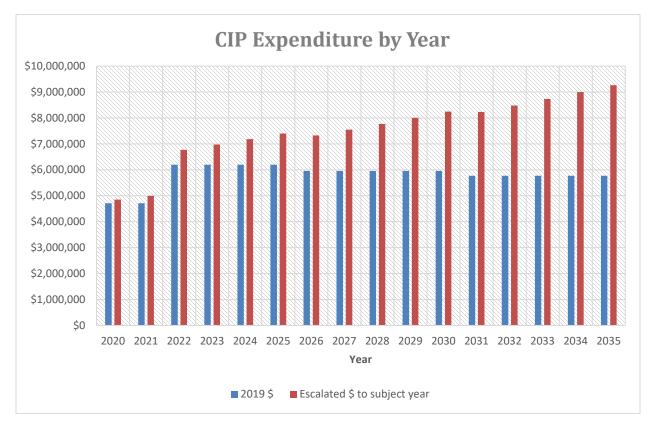
Figure 10-5: CIP Costs per Year

Figure 10-5 and Figure 10-6 summarize the CIP costs discussed in this section by year and by planning horizon, respectively. The total CIP cost is estimated at \$92.9M in 2019 Q1 dollars, and \$120.8M based on a 3 percent escalation year-to year.

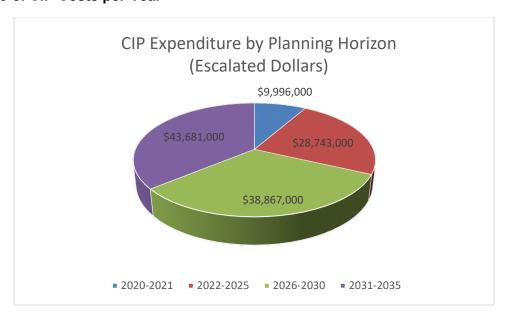
Figure 10-6: CIP Costs by Planning Horizon
