SAN BERNARDINO MUNICIPAL WATER DEPARTMENT

2024 Water Master Plan

FEBRUARY 2025 FINAL REPORT

PROJECT NO. 1743

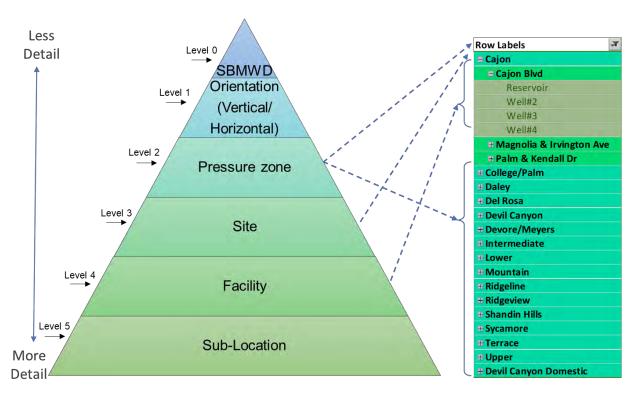
Figure 5-2: Water System Asset Hierarchy

The water system asset register was set up using a hierarchy as shown in Figure 5-2. There are different levels of hierarchy captured in the asset register: Level 0: "Department", Level 1: "Orientation", Level 2: "Pressure Zone", Level 3: "Site", Level 4: "Facility", which in some cases is further broken down into Level 5: "Sub-Location".

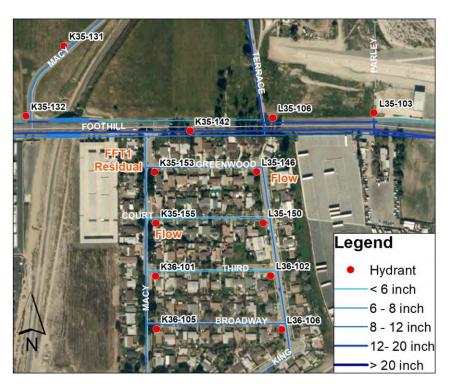
Figure 7-1: Exhibit for Field Test Number 1

Figure 7-1 displays an example of a FFT exhibit. Following the Department's review, all FFT locations were updated and finalized.

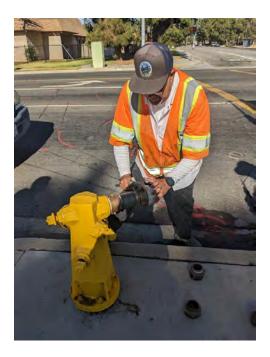
Figure 7-2: SBMWD Staff Preparing Hydrant During Field Testing

Copies of FFT exhibits were distributed to SBMWD staff. Figure 7-2 captures SBMWD staff preparing a hydrant for pressure monitoring during testing. Field test data were used to calculate the flow of water through the open hydrant in each test. These test flows were used in the model calibration process.

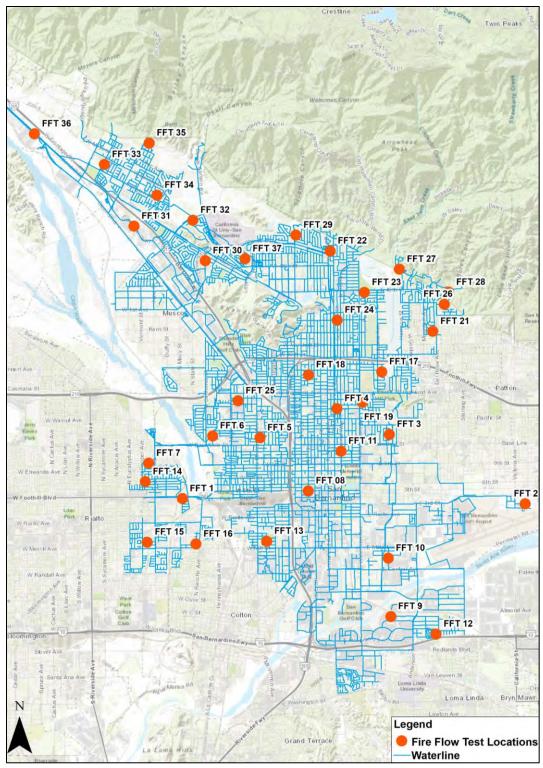
Figure 7-3: Fire Flow Test Locations

Exhibits of all FFT locations, including static/residual and flow hydrants were created for Department review. The field test exhibits are included in Appendix A. The locations of all FFTs are shown graphically in Figure 7-3.

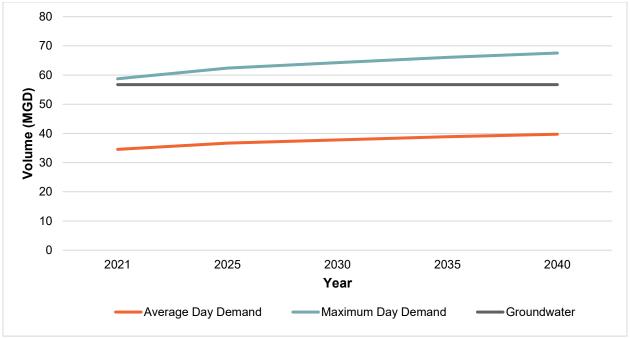
Figure 10-1: Supply Source Capacity Analysis

The analysis indicates that there is adequate water supply to meet both existing and future average day demands. However, the analysis also indicates there is inadequate water supply to meet both existing and future maximum day demands. It is recommended that supply capacity exceeds maximum day demands.

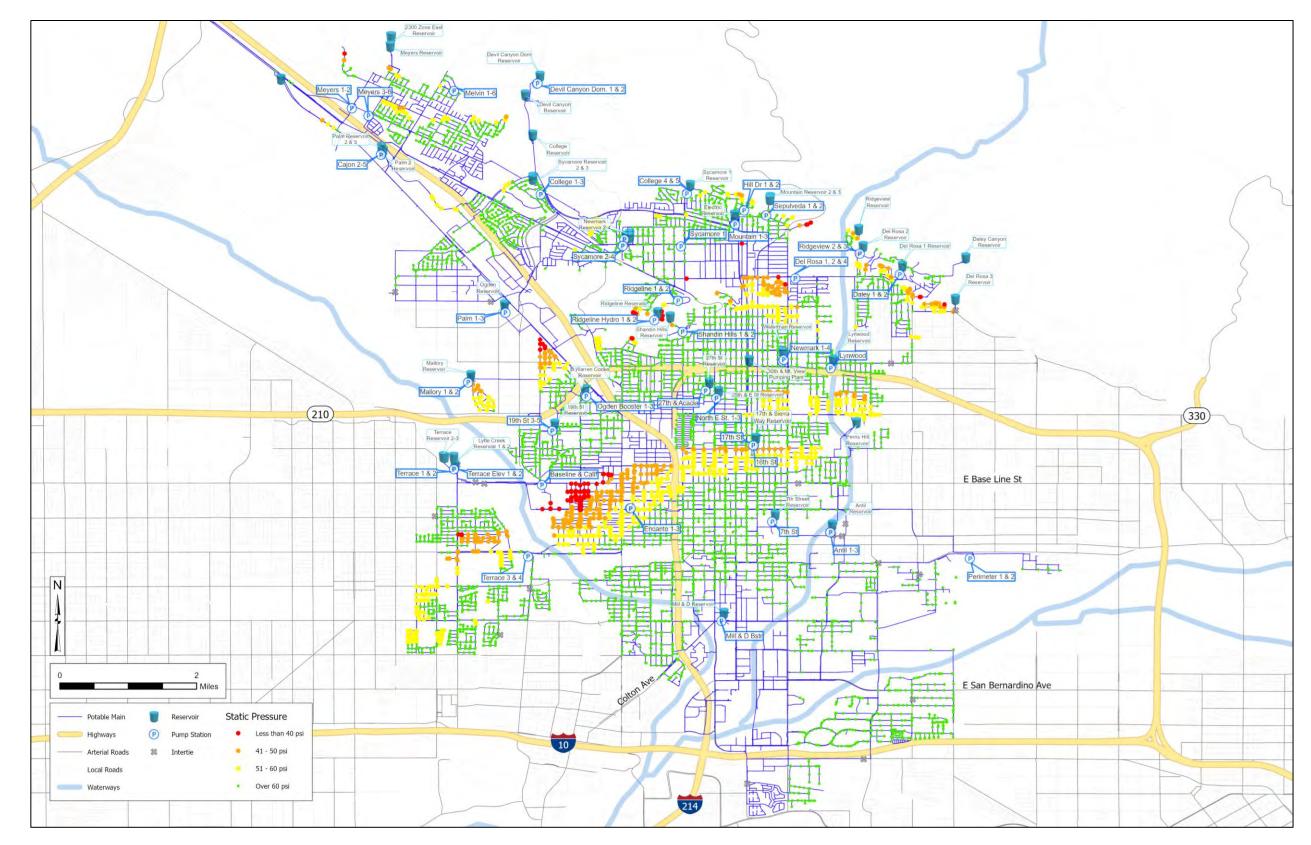
Figure 10-5: Distribution System Static Pressures

Figure 10-5 reflects the static pressure between the zone hydraulic grade line and the elevation. The figure demonstrates potential problem areas based on minimum pressures. If the junctions are red in this figure, then it implies under the best-case scenario, the static pressures without demand are less than 40 psi. Pipe diameter changes will not improve the static pressures. System improvements would require changes to the zone itself, a change to a higher pressure zone, or the creation of a new zone or subzone. In Figure 10-6, the location at North Waterman Avenue and East 40th Street has low pressure but is adequately supplied by the Waterman and Newmark water treatment plants. The pressure issue is related to the elevation. Without a subzone and small booster station, the pressures cannot be improved.

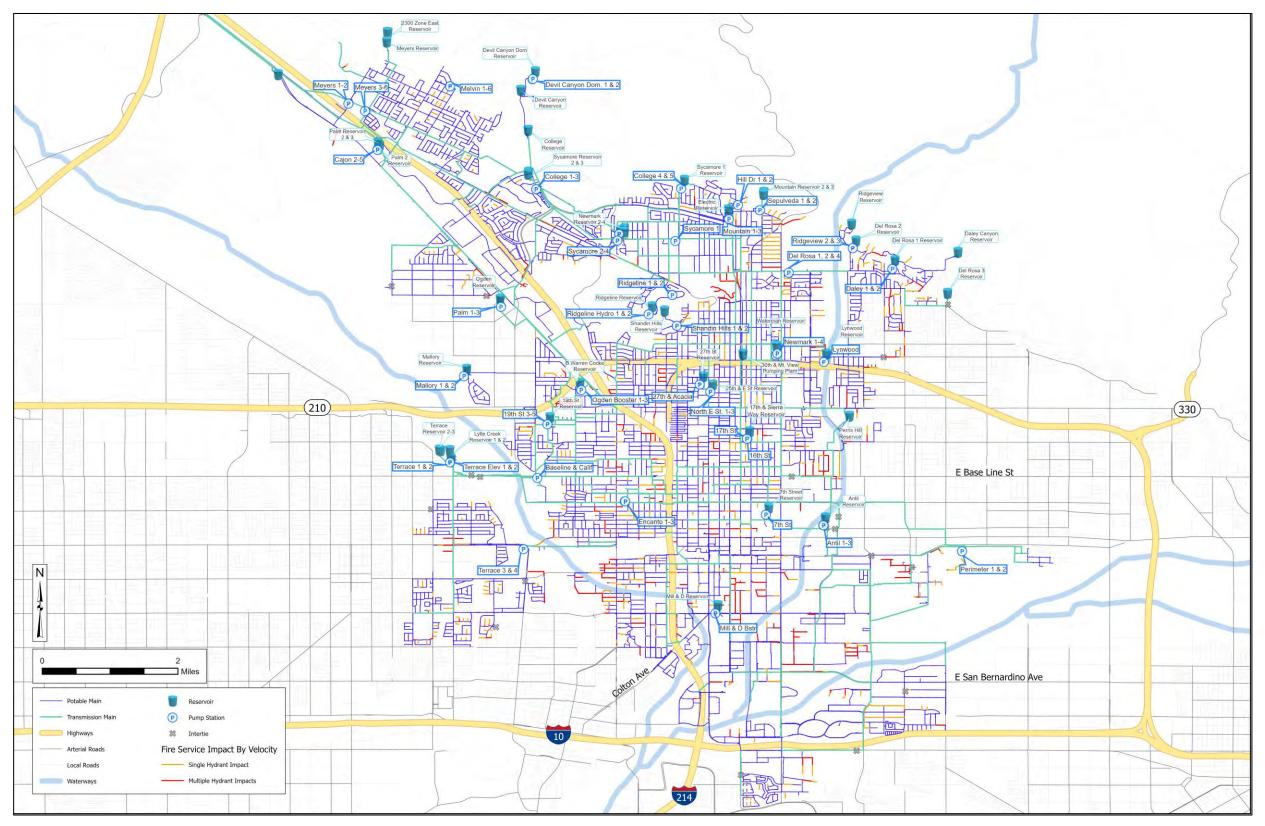
Figure 10-8: Distribution Pipelines under MDD Plus Fire Flow Conditions, Velocity >15 ft/sec

Figure 10-8 illustrates the distribution water lines identified as having greater than 15 ft/sec of velocity during any fire flow event. These results were created through the following steps:

Distribution pipelines impacts in Figure 10-8 reflect the number of hydrants flowing at their needed fire flow that exceeds 15 ft/sec. If the pipe is orange, one hydrant flowing at its needed fire flow caused the

In Figure 10-8, the water lines in orange imply that one hydrant has caused the water line to exceed 15 ft/sec. This will in most cases have caused that hydrant to also be deficient for fire flow. In areas where fire flow is critical but deficient with a high-velocity pipe adjacent to it, we recommend replacing the line with a larger diameter line.

In Figure 10-8, when a line is red, more than one hydrant's needed fire flow has caused the water line to exceed 15 ft/sec. This could still be a localized issue (e.g. two hydrants on a dead-end line), however, an area with a cluster of red lines implies the issues could be more systemic, for example, a waterline that is undersized serving an area. Pipeline improvements are recommended to target these areas for available fire flow improvement.

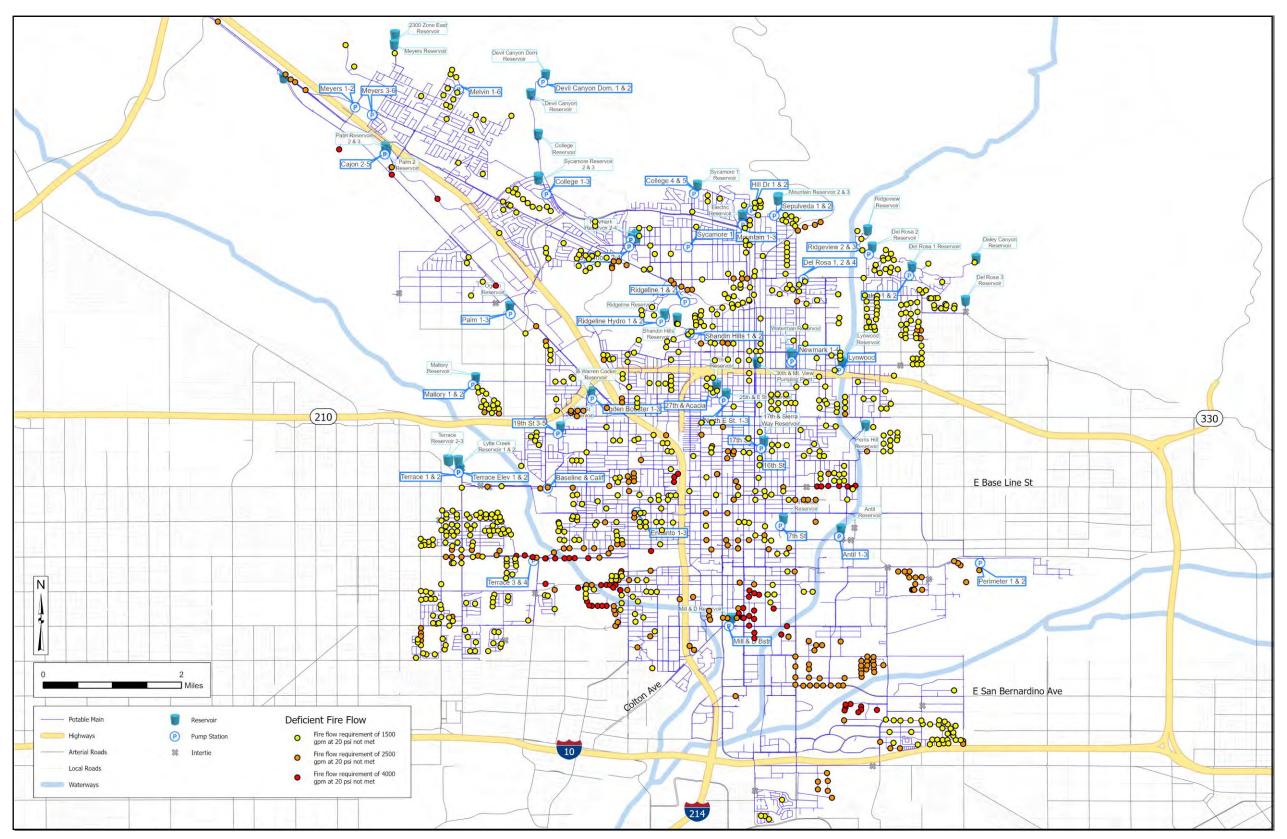
Figure 10-9: Deficient Fire Flows

Figure 10-9 illustrates deficiencies in fire flow availability. The deficiencies in fire flow are generally experienced for four reasons:

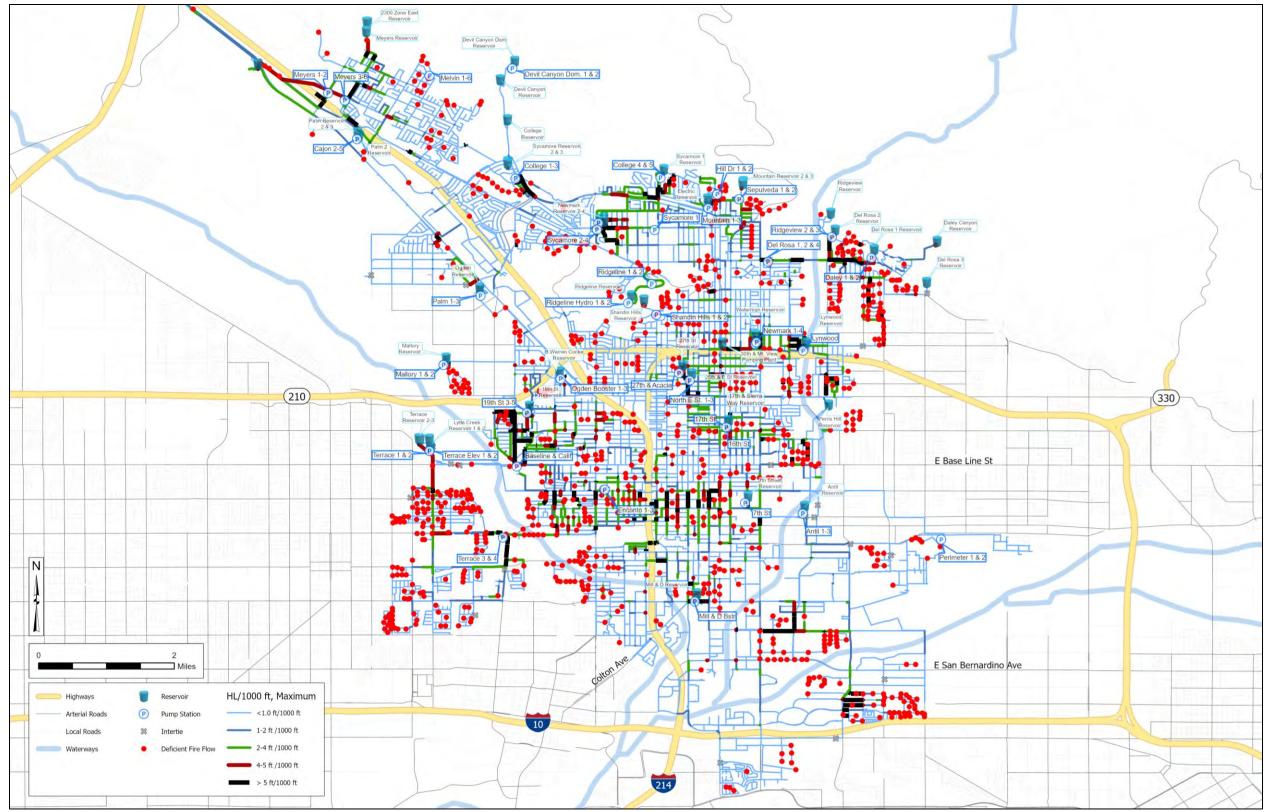
Figure 10-10: Deficient Head loss (ft/1000) for Fire Flows and Head loss

Figure 10-10 is an overlay of head loss in ft/1000 ft of waterline relative to deficient fire flow. There is a relationship between the HL/1000ft and fire flow deficiencies that can be seen in the Lower Zone, Del Rosa Zone, Terrace Zone, and portions of the more isolated sections of the Upper Zone.

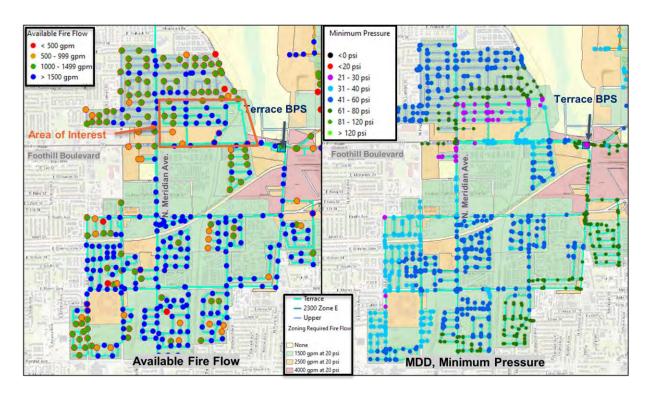
Figure 10-12: Terrace Pressure Zone, Existing Deficiencies

The current analysis confirms that the Terrace Zone and the adjacent portion of the Upper Zone have deficiencies in pressure and available fire flow. Figure 10-12 illustrates the available fire flow versus the fire flow criteria based on zoning and the minimum pressure during the MDD extended period simulation (EPS) run.

The majority of the Terrace Zone has a fire flow criteria of 1,500 gpm at 20 psi, represented by the green zoning polygon/shaded area on the left side of Figure 10-12. The locations that meet this requirement are represented by blue dots. All other fire flows in the Terrace Zone are deficient. The deficiency is larger when fire flow requirement is greater than 1,500 gpm at 20 psi residual pressure. These requirements are represented by orange polygons (2,500 gpm at 20 psi) and the red polygons (4,000 gpm at 20 psi). Large infrastructure improvements would need to be constructed in order to meet these fire flow requirements.

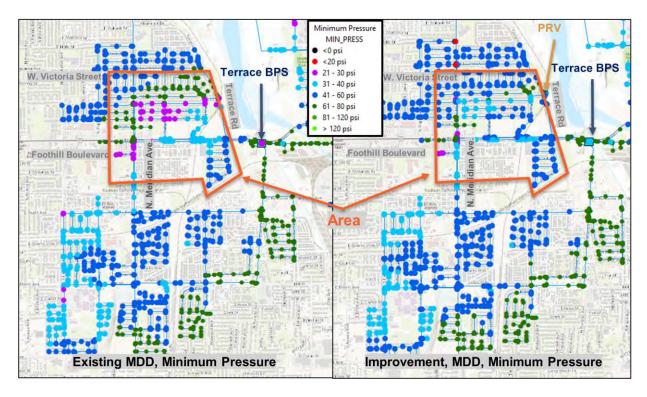
Figure 10-13: Terrace Pressure Zone, Additional PRV

Figure 10-13 illustrates the results using a PRV with a 40 psi setting to send pressure to the area south of West Victoria Street, west of Terrace Road and north of Foothill Boulevard. This lowers the pressure north of West Victoria Street, keeping it within the 40-60 psi range, while increasing the pressures within the area of interest.

The addition of the Terrace Zone north of Foothill Boulevard to the Upper Zone is the simplest solution, requiring simple field adjustments without the operation and maintenance of a PRV station. The results from this analysis are shown in Figure 10-13.

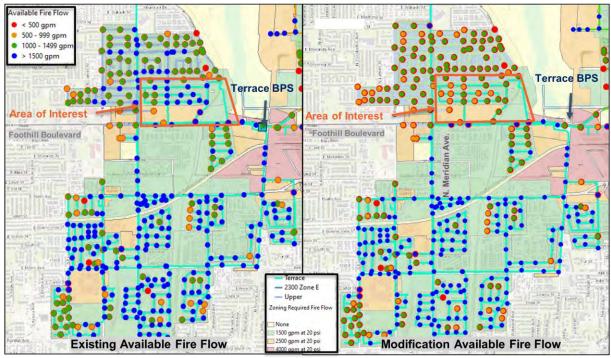
Figure 10-16: Terrace Zone Available Fire Flow, Existing vs. Modification

The conclusion of this analysis is that no system changes are recommended for this area. The pressure realignment creates localized higher pressures in the area of concern, but by isolating the area from the Terrace BPS, there is a large drop in available fire flow, which is not an acceptable outcome.

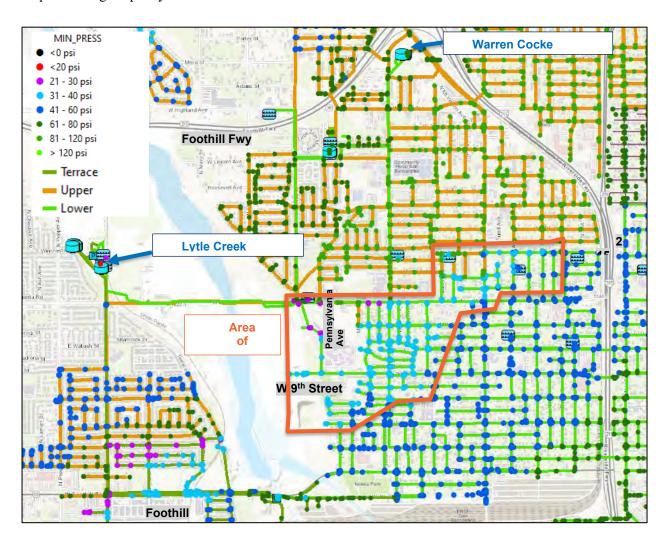
Figure 10-17: Lower Zone Deficiency

The Lower Zone, north of 9th Street and east of Pennsylvania Avenue has lower minimum pressures than the rest of the zone. This section reviews the ability to move this area to the Upper Zone without negatively impacting the ability of the Lytle Creek reservoirs and the B. Warren Cocke reservoirs to keep adequate storage capacity in the Lower Zone.

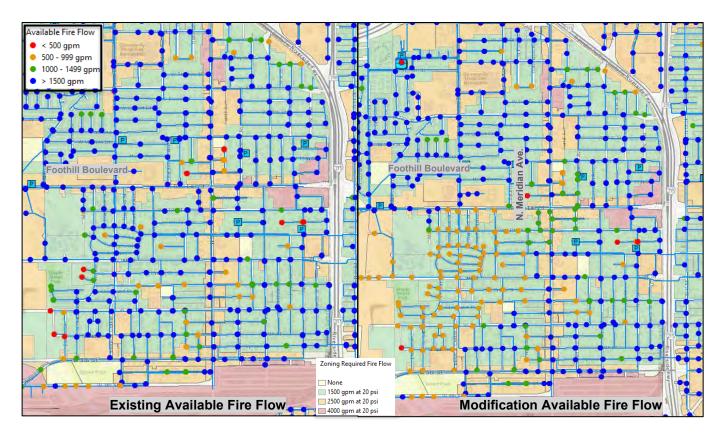
Figure 10-21 Existing Available Fire Flow vs. Available Fire Flow after Modification

The conclusion to this analysis is no system modifications are recommended. Implementing the zone realignment requires several valve closures, which either creates multiple dead ends, or requires additional looping pipelines to be constructed. The proposed project also results in a large reduction in available fire flow. Since the existing minimum pressures are generally in the 30-40 psi range and the area has adequate available fire flow, it is not recommended to make system modifications in this area.

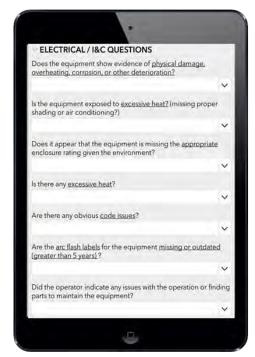
Figure 11-3: Inspection Checklists for Different Asset Disciplines

Figure 11-3 shows a portion of the inspection checklists for mechanical, electrical/I&C, structural, and civil assets, which was utilized during the field condition assessment. The complete checklist for each discipline can be found in Appendix A. The team also captured 360-degree photos from each facility to create a virtual tour of the facilities with an example shown in Figure 11-4.

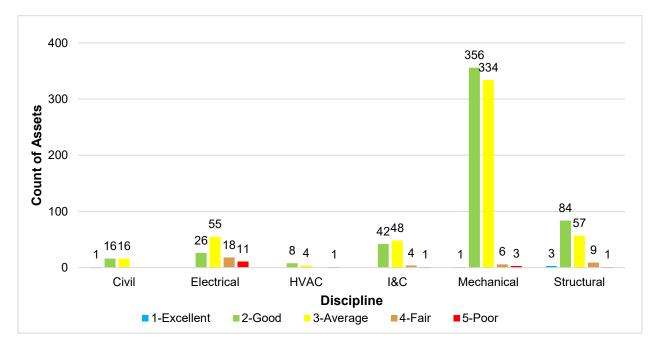
Figure 11-7: Field Condition Assessment Results by Discipline

Figure 11-7 presents a summary of condition assessment results that have been separated into six discipline categories of Mechanical, Electrical, Civil, Instrumentation and Control (I&C), Structural, and HVAC. As is evident in this figure, the majority of the assets belong to Mechanical discipline, and they are mainly in good and average condition. Furthermore, Figure 11-7 highlights a relatively significant number of electrical assets in poor and fair conditions. This is particularly noteworthy, as the Department staff have commented on similar issues with electrical assets in all the Department facilities, with the exception of the Ogden St Facility.

Table 11-3 summarizes the average condition score for each discipline. The average condition score of the electrical assets is 3.1, which is more than the average condition of all the disciplines (2.6). This suggests that there might be a greater problem with the Departments electrical assets Therefore, this warrants a resultant project for a deeper electrical condition assessment for all facilities beyond a visual inspection.

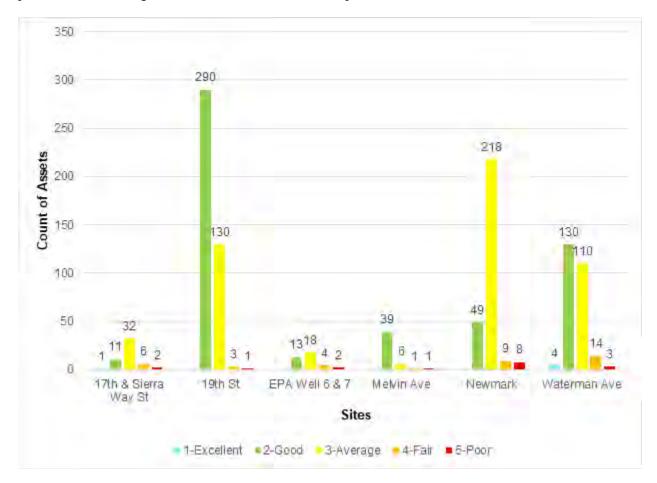
Figure 11-8: Summary of Asset Condition Scores by Sites

The condition assessment results can also be presented by sites as shown in Figure 11-8. As is evident, a large number of the assets in good condition belong to 19th St plant while most of the assets in fair and poor condition belong to Newmark and Waterman Ave plants.

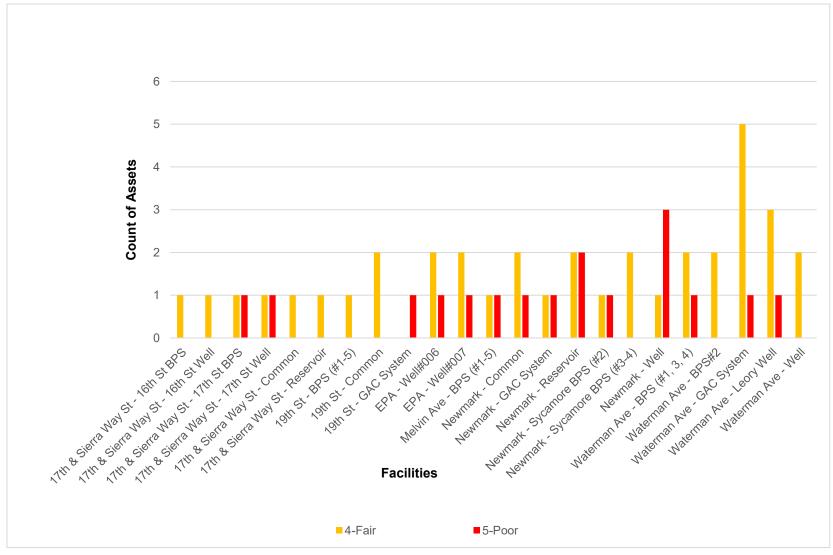
Figure 11-9: Summary of Assets in Fair and Poor Conditions by Facility

One of the primary objectives of the condition assessment is to understand which assets are in poor and fair condition for planning and budgeting purposes. A list of the assets with high condition score or in need of immediate attention can be presented for different disciplines along with a photo and a note about their condition. Table 11-4 lists the thirty-four (34) assets in poor and fair condition under Electrical and I&C disciplines.

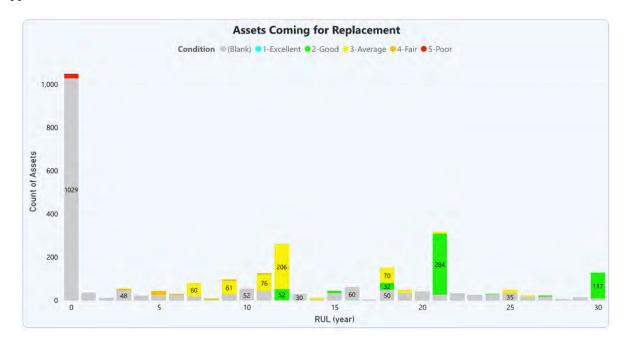
Figure 11-11: Summary of the Remaining Useful Life Results in the Asset Management Dashboard

Figure 11-11 shows a summary of the RUL estimation for the assets in the Asset Management Dashboard. As is evident in Figure 11-11, there are many assets that are at the end of their useful lives (with zero RUL). However, except for the 17 assets that are in poor condition, the rest of the assets are missing condition scores, i.e., were not inspected so the RUL analysis has followed an age-based approach.

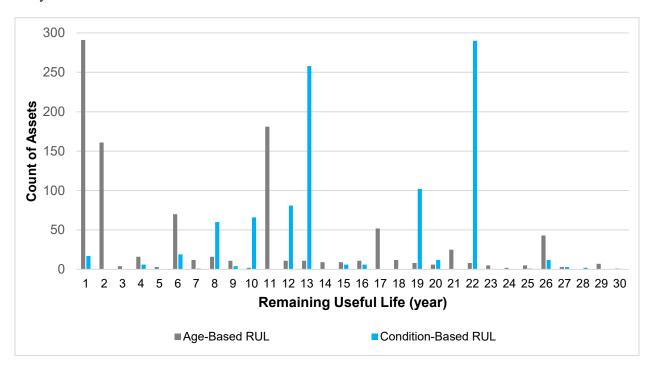
Figure 11-12: Remaining Useful Life Estimation, Condition vs. Age-Based Approach

In order to show the value of condition assessment, Figure 11-12 was developed, which shows the estimated RUL obtained from age-based vs. condition-based approach for the assets undergone a condition assessment. As it is evident in Figure 11-12, age-based approach is very conservative in estimation of the RUL. Many assets are estimated to have shorter RUL under age-based approach compared to the condition-based approach. Thus, it is recommended that the Department verify the condition of the assets which are not visually assessed, to increase the level of confidence in the RUL analysis.

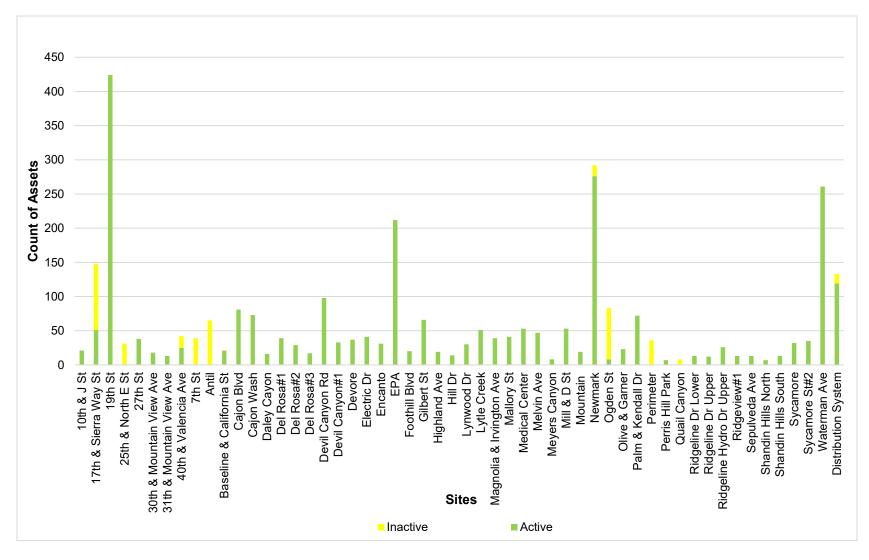
Figure 11-13: Assets with Estimated Remaining Useful Life of Less than 10 years – All Facilities

Figure 11-13 presents the count of assets in each site coming up for replacement within the next 10 years. Out of 3,106 assets inventoried for the Department facilities, 1,472 assets need to be replaced in the next ten years. The color coding in Figure 11-13 shows the condition of the assets coming up for replacement. The assets with No Condition are related to the facilities where condition assessment is not performed. Figure 11-14 provides similar results for the facilities where condition assessment is performed. In the facilities that the condition assessment was performed, 173 assets are coming up for replacement in the next ten years, with 17 assets in poor, 32 in fair, 123 in average, and 1 in good condition. Large number of these 173 assets are related to the GAC systems in Newmark and Waterman plants followed by Newmark well and reservoir.

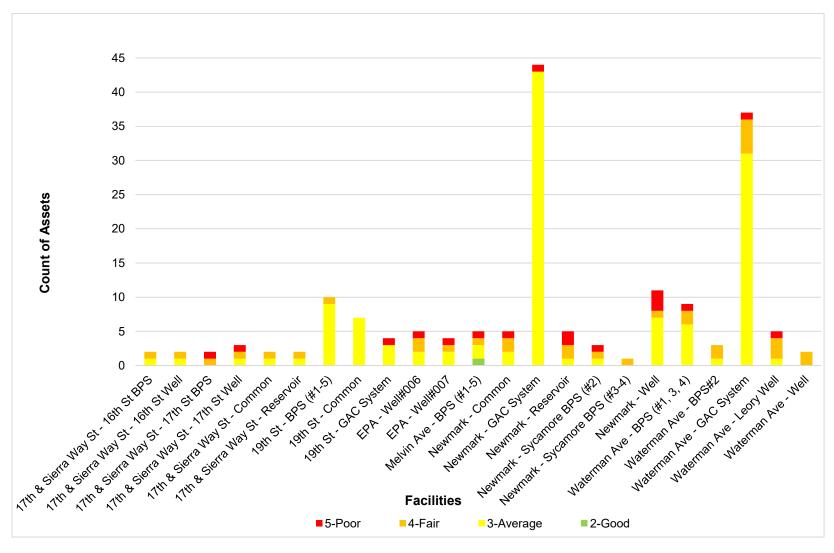
Figure 11-14: Assets with Remaining Useful Life of Less than 10 years - Facilities with Field Condition Scores

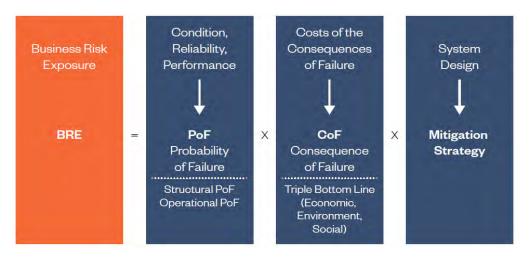
Figure 11-15: Risk Assessment Methodology

Risk of failure (Business Risk Exposure) can be assessed at an asset level and/or at the facility level. Risk is comprised of three major components: probability of failure (PoF), consequence of failure (CoF), and mitigation strategy as shown in Figure 11-15. The probability of failure measures an asset's likelihood of or timing to failure. The consequence of failure evaluates the direct and indirect impacts of a failure. Mitigation strategy or the presence of backup equipment, helps to decrease the overall risks and/or consequence of a failure.

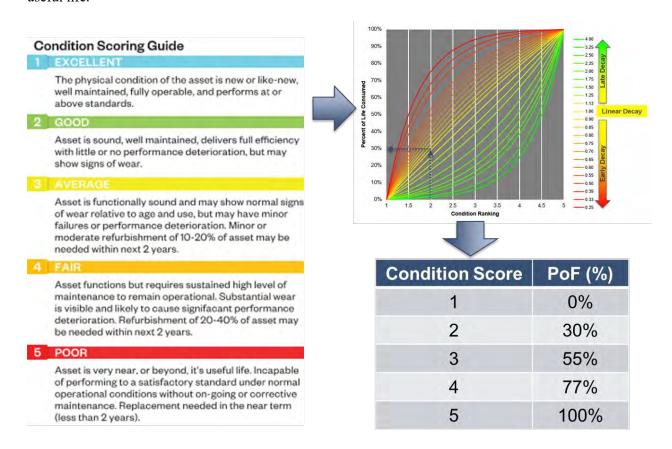
Figure 11-16: Converting Condition Scores to Probability of Failure

The obtained condition score for each individual asset was then converted into probability of failure using the deterioration curve shown in Figure 11-16. For assets with no condition scores, an age-based methodology was followed to calculate the probability of failure using age of the asset divided by its useful life.

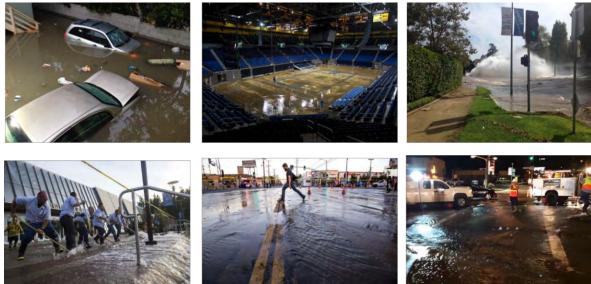
Figure 11-17: Variable Consequences of Failure

When assets fail, the consequences depend on the failure mode, existing mitigation strategies and level of redundancy. CoF can range from a minor inconvenience to a major disruption of customer service, inability to comply with operating permit, and possible endangerment of public health.

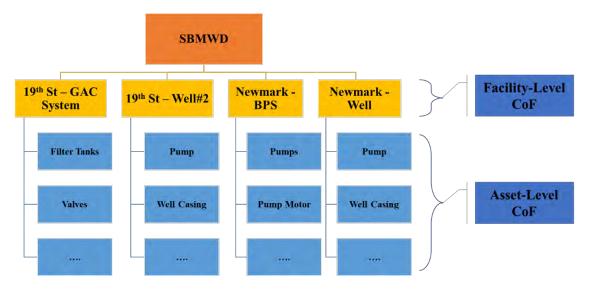
Figure 11-18: Consequence of Failure - Multiple Levels

The CoF assessment methodology considers the triple bottom line factors of economy, environment, and social and it was assessed at both the facility-level and asset-level as shown in Figure 11-18.

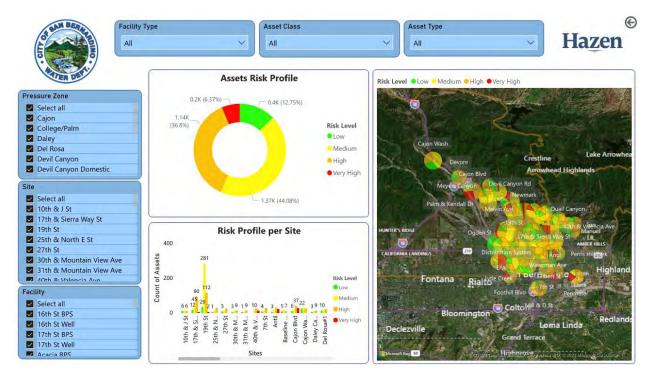
Figure 11-22: Summary of the Risk Results in the Asset Management Dashboard

The following sections summarize facilities' risk assessment results including PoF, CoF and Risk results. The results are presented in multiple ways to facilitate interpretation of the results. Figure 11-22 shows a summary of the risk results for the Facilities' assets in the Asset Management Dashboard (some snapshots available in Appendix B).

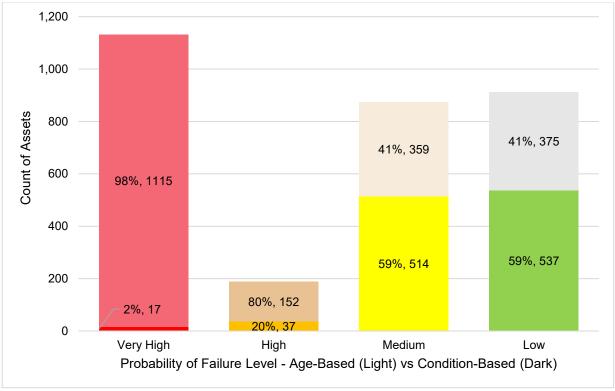
Figure 11-23: Summary of the Probability of Failure Results

Figure 11-23 summarizes the findings of the PoF results by showing the PoF levels and the count and percentages of assets under each PoF level. This figure also differentiates between the PoF results that are based on condition scores versus those that are based on age. The results shows 36% of the assets, (1,132 count) are categorized as very high PoF, and 6% of the assets (189 count) are categorized as high PoF. However, only 2% of the assets at very high PoF level have undergone the field condition assessment. The PoF results showing the high level of PoF are more reliable compared to the very high PoF level, as 20% of the high level PoF estimations are based on condition scores rather than age. Expanding the condition assessment to all the facilities (e.g., using asset photos to assign condition scores) can significantly improve the level of confidence in estimating the PoF results.

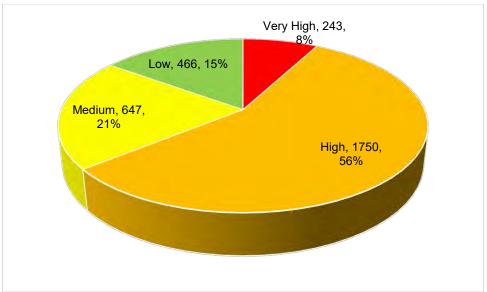
Figure 11-24: Summary of the Consequence of Failure Results

CoF thresholds for very high, high, medium, and low levels were established as shown in Table 11-11 and the CoF was calculated for each asset. Figure 11-24 summarizes the findings of CoF by showing the CoF level and count of assets under each level. As Figure 11-24 shows, 8% of the assets (243 count) are categorized as very high CoF and 56% of the assets (1,750 count) are categorized as high CoF.

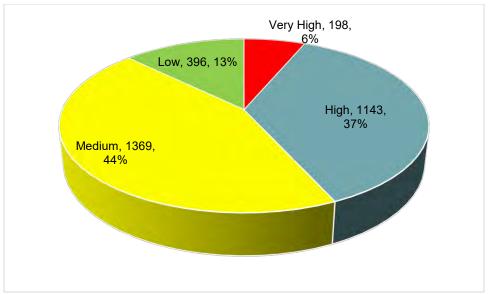
Figure 11-25: Summary of Risk Results

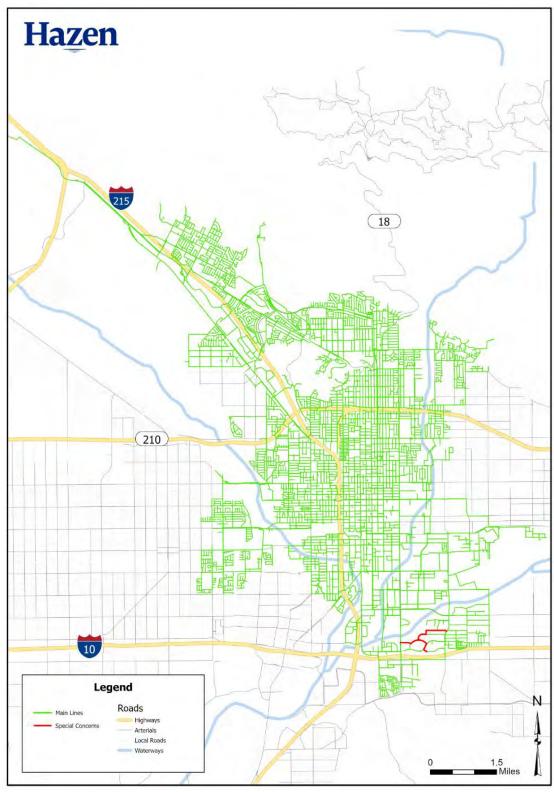
Figure 12-1: Water Pipes and the Pipe Segments with Special Concern

PoF measures an asset's likelihood of failure. PoF scoring methodology for the water pipes (including geothermal pipes and shown in Figure 12-1) includes a set of criteria selected collaboratively by working with the Department staff (Table 12-2). A percent weighting was assigned to each criterion along with a scoring guide to then assign a score of 1 to 5 to each criterion. The final PoF score for each pipe is the weighted average of the scores assigned to each criterion.

Table 12-3 shows the nominal useful life values assumed for each pipe material. For the pipe materials used for geothermal purposes (Temptite, DIP, PVC, AC, CI, STL), useful life is reduced by 20% to account for more corrosive environment. Also, as it is indicated in Table 12-2 and shown in Figure 12-1, some pipe segments toward the southern part of the City with special concern (non-catholically protected DIP and CL&WP susceptible to corrosion due to no installed protection or being surrounded with corrosive soil) are identified by the Department staff to get a higher PoF score. The Department provided leak data for the main pipelines dating back to 2011, which were used to assign break/leak history scores to pipe segments. The provided data was queried to only include leaks associated with main lines and 2,049 leaks were assigned to the nearest pipe segment. Soil corrosivity data from National Soil Survey Handbook was used to identify metallic pipe segments located in corrosive soil.

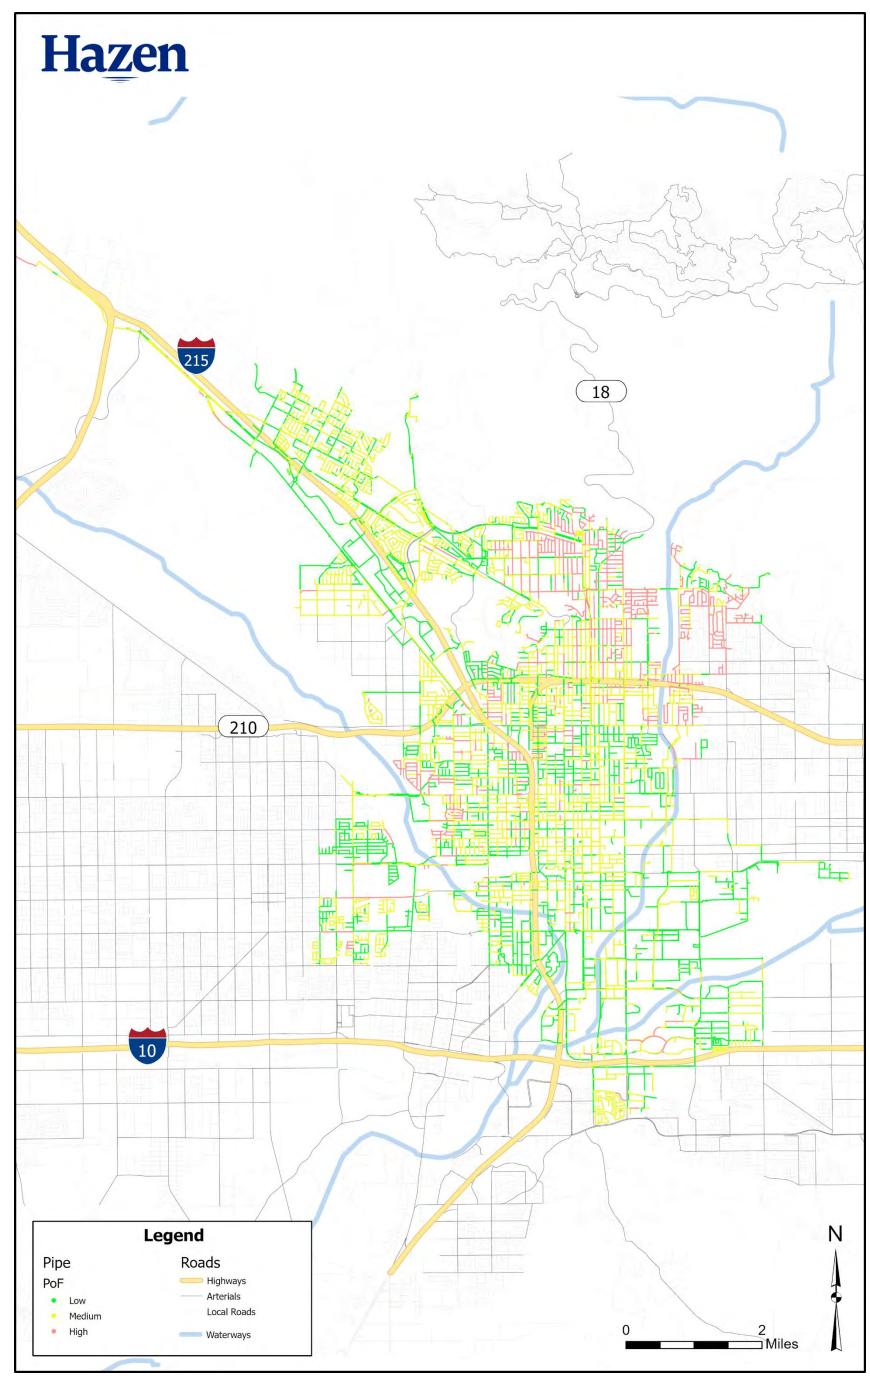
Figure 12-2: Water Pipelines Probability of Failure Results

The scores assigned to each pipe segment for each individual PoF criterion were multiplied by the associated weightings and added together to calculate final PoF score for each pipe segment. Table 12-6 summarizes the pipeline PoF results by showing the length and percentages of pipe segments falling under each PoF score. The PoF levels shown in Table 12-6 is used for visualizing the PoF scores and Figure 12-2 shows a color-coded map presenting the pipe segments within each PoF level.

As Table 12-6 and Figure 12-2 shows, 83 miles (12%) of the water pipelines have high level of PoF and are mainly located at northeast part of the service area.

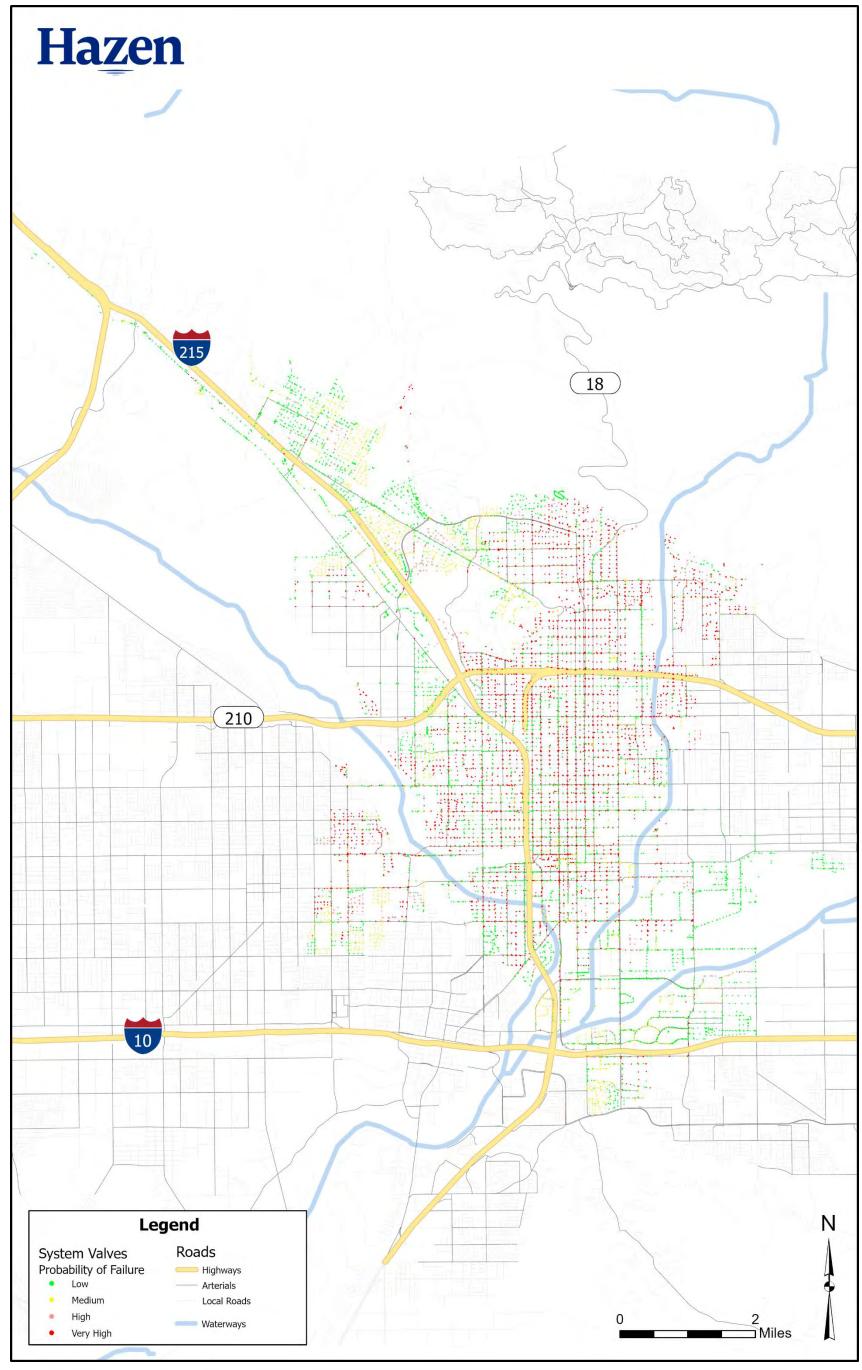
Figure 12-3: System Valves Probability of Failure Results

As discussed in the methodology section, PoF estimation for Horizontal non-pipe assets were mainly based on the age of the assets. The PoF results show 40% of system valves have very high PoF and recommended for further investigation. Figure 12-3 shows a color-coded map presenting the PoF results for the system valves.

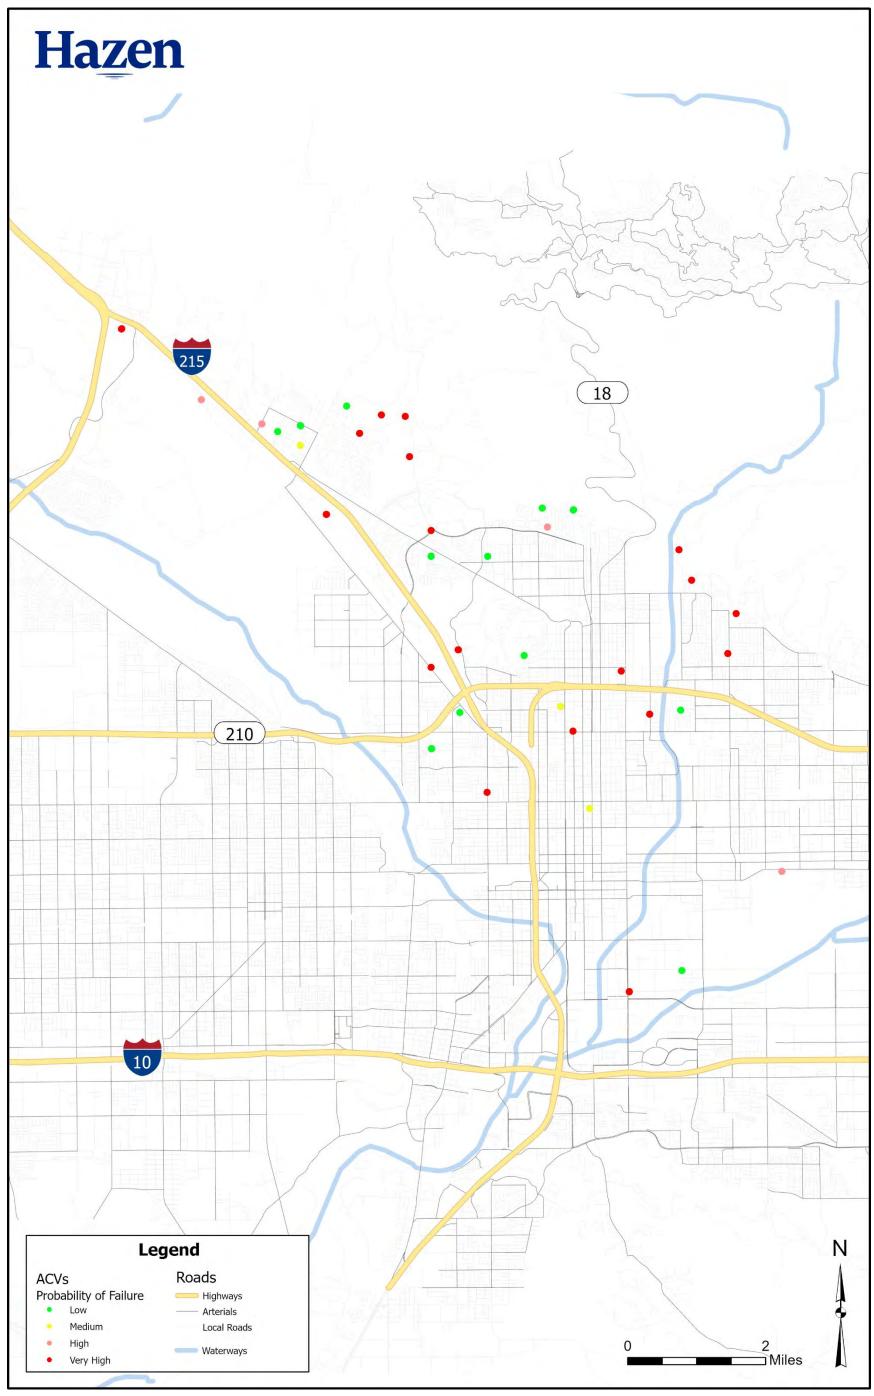
Figure 12-4: Automatic Control Valves Probability of Failure Results

The PoF results show the majority of the ACVs (47%) have very high and (10%) high PoF scores and are recommended for further investigations. Figure 12-4 shows a map of the PoF results for the ACVs.

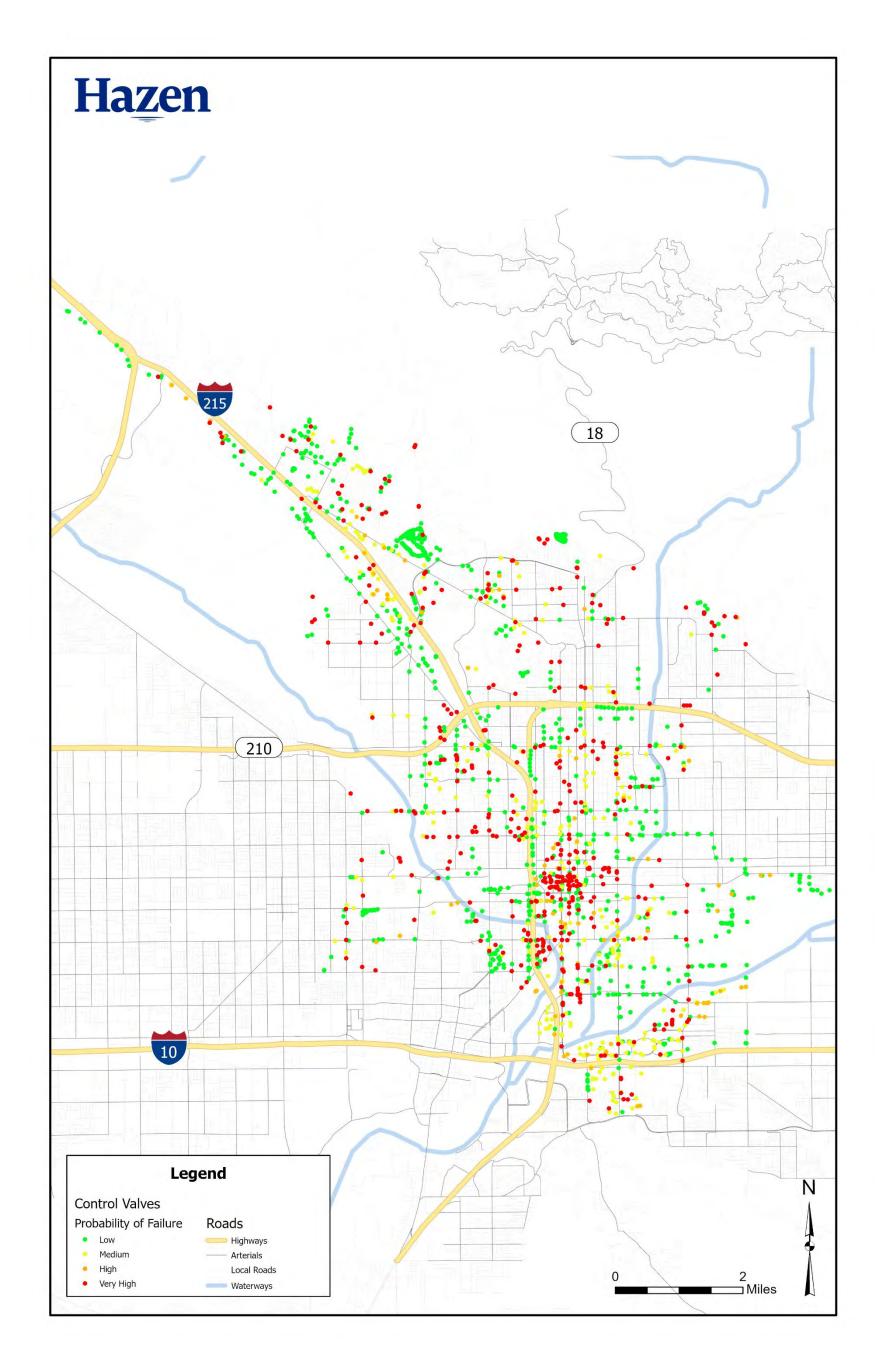
Figure 12-5: System Control Valves Probability of Failure Results

Table 12-9 summarizes the PoF results for the system control valves by showing the number and percentages of system control valves falling under each PoF level. Based on the GIS attribute data in the system control valve GIS layer, system control valves include air release/vacuum, anti-backflow, blowoff, single check, detector check, double check, pressure regulating, and pressure reducing valves. The PoF threshold shown in Table 12-9 is used for ranking the PoF scores and Figure 12-5 shows a color-coded map presenting the system control valves within each PoF level.

The PoF results show 24% and 5% of the system control valves have very high and high PoF scores, respectively. Figure 12-5 shows the majority of these system control valves are located towards the south of the service area.

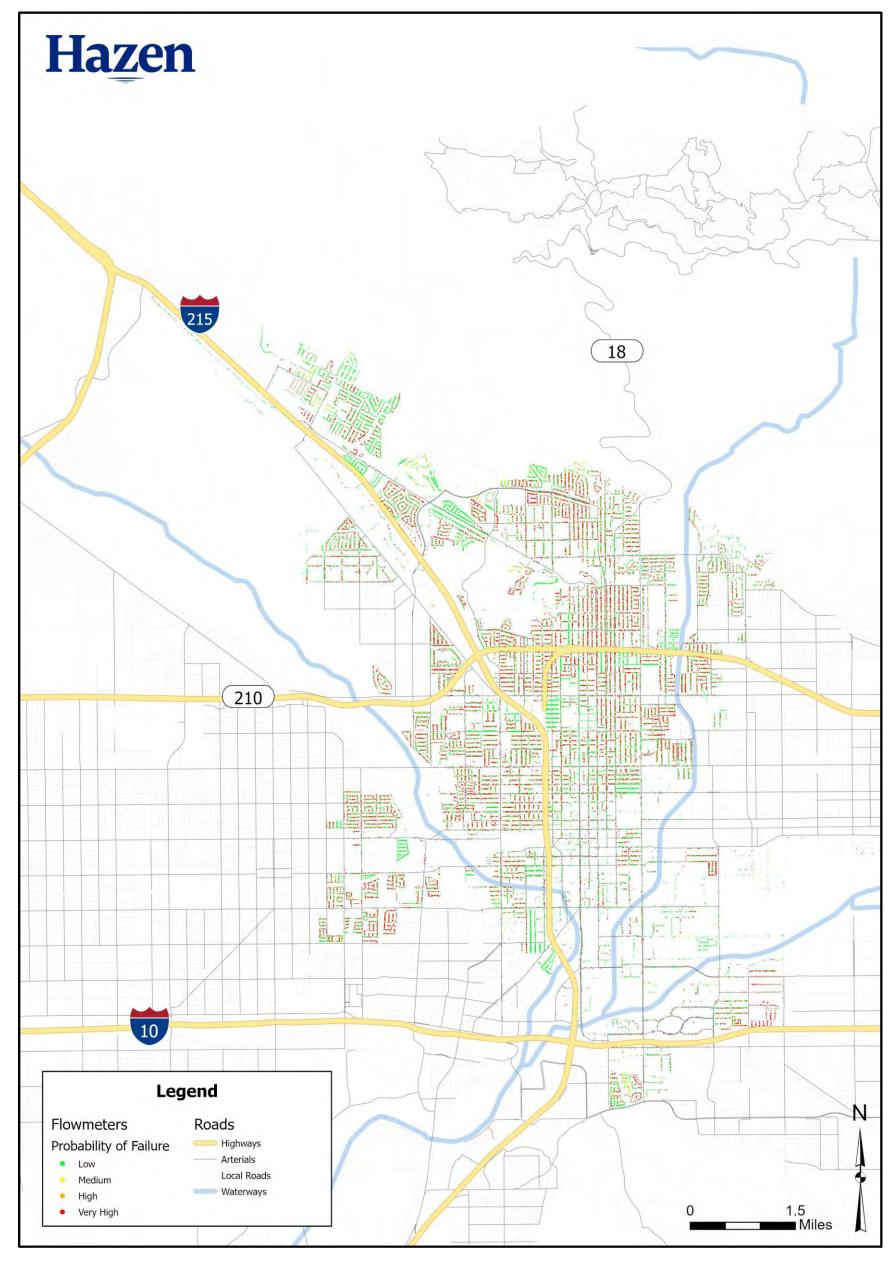
Figure 12-6: Flowmeters Probability of Failure Results

Table 12-10 summarizes the PoF results for flowmeters by showing the number and percentages of flowmeter falling under each PoF level. The PoF thresholds shown in Table 12-10 are used for ranking the PoF scores and Figure 12-6 shows a color-coded map presenting the flowmeters within each PoF level.

The results show 32% of meters have very high PoF score. These meters are scattered throughout the service area.
