SAN BERNARDINO MUNICIPAL WATER DEPARTMENT

2024 Water Master Plan

FEBRUARY 2025 FINAL REPORT

PROJECT NO. 1743

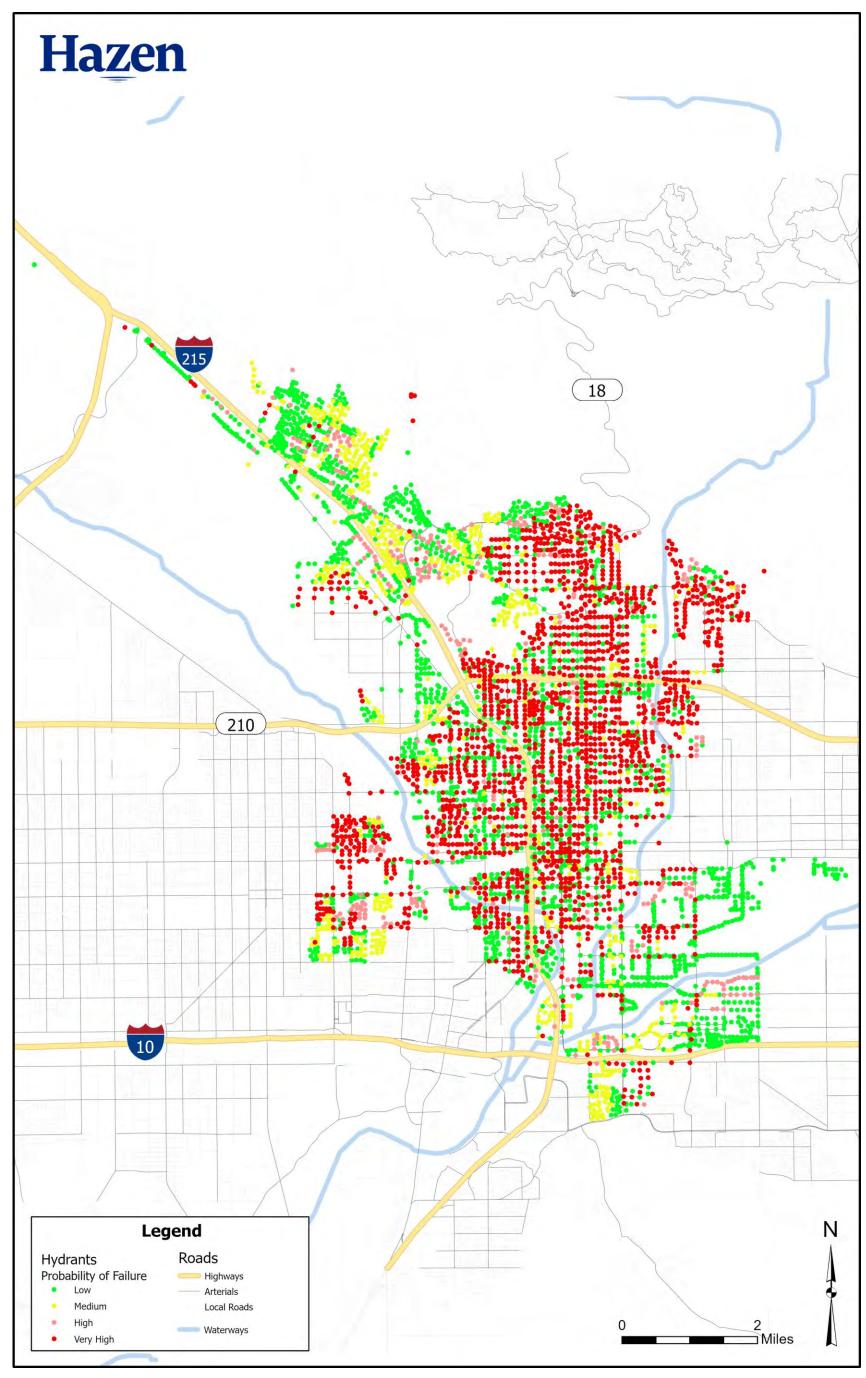
Figure 12-7: Hydrants Probability of Failure Results

Table 12-11 summarizes the PoF results for the Hydrants by showing the number and percentages of hydrants falling under each PoF level. The PoF thresholds shown in Table 12-11 are used for ranking the PoF scores and Figure 12-7 shows a color-coded map presenting the hydrants within each PoF level.

The obtained result shows the majority of hydrants have high (8%) and very high (39%) PoF score and are scattered throughout the service area with higher density in central parts.

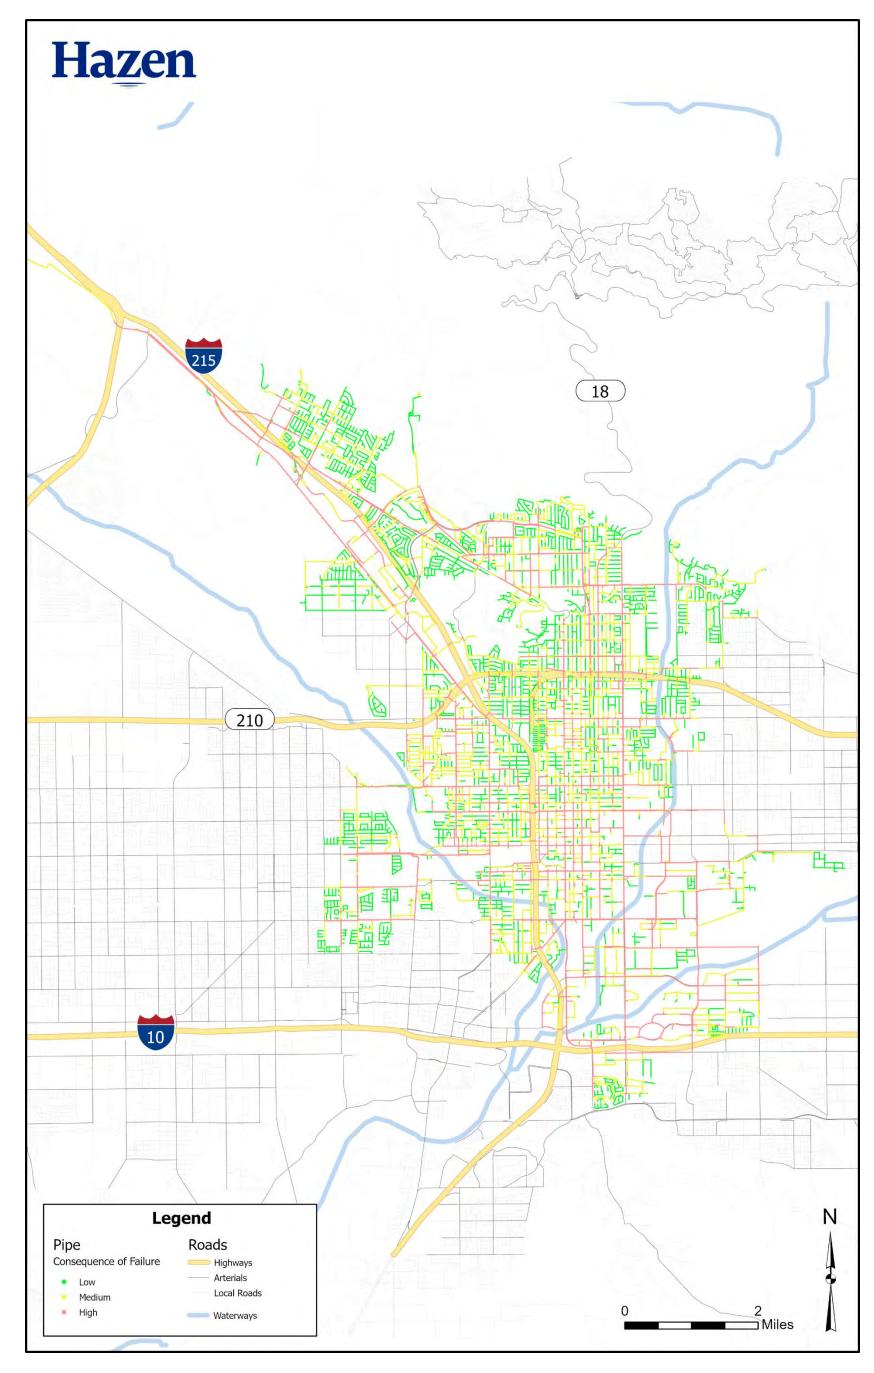
Figure 12-8: Water Pipeline Consequence of Failure Results

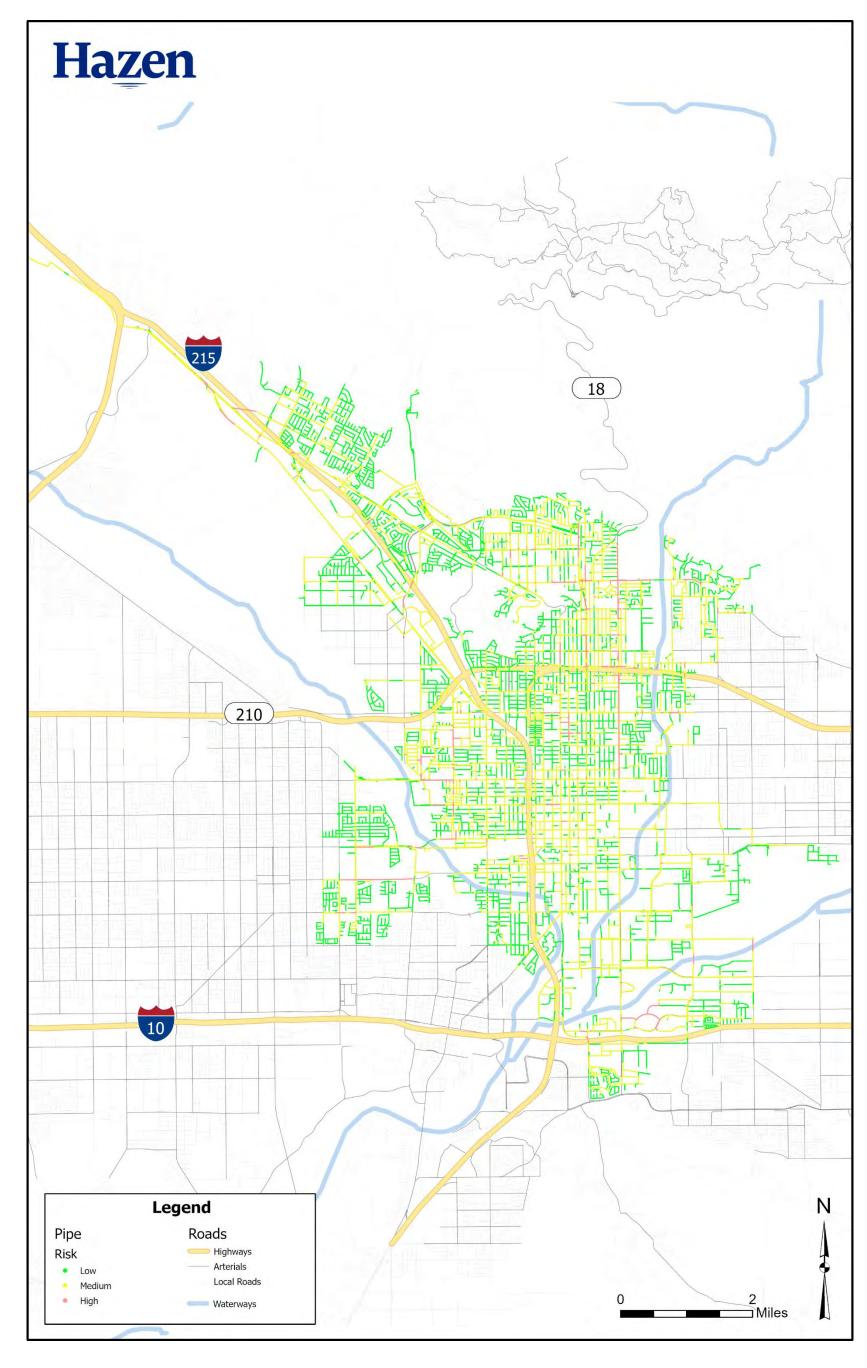
Figure 12-9: Pipeline Risk Results

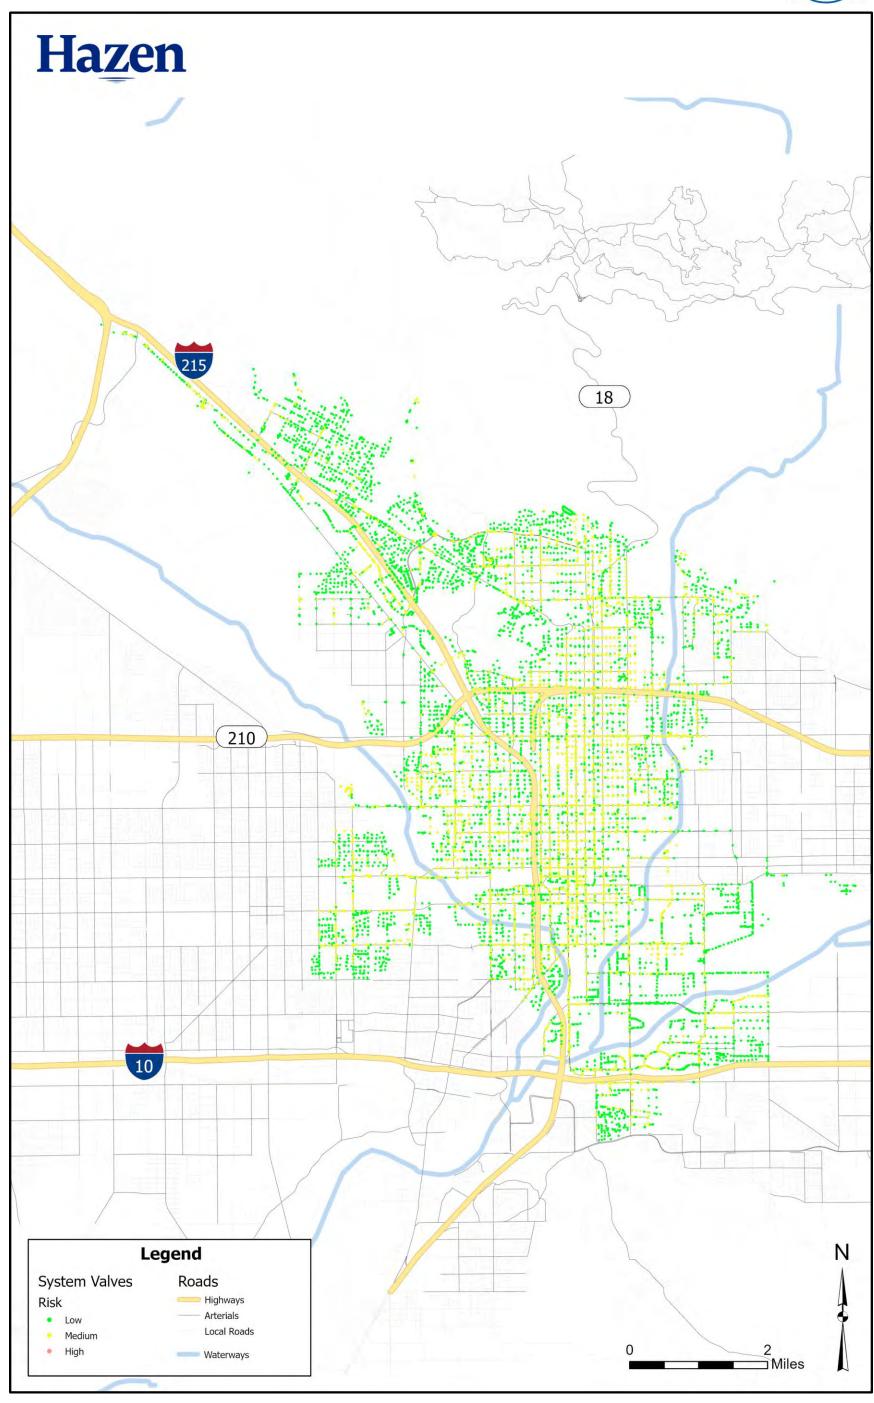
Figure 12-10: System Valve Risk Results

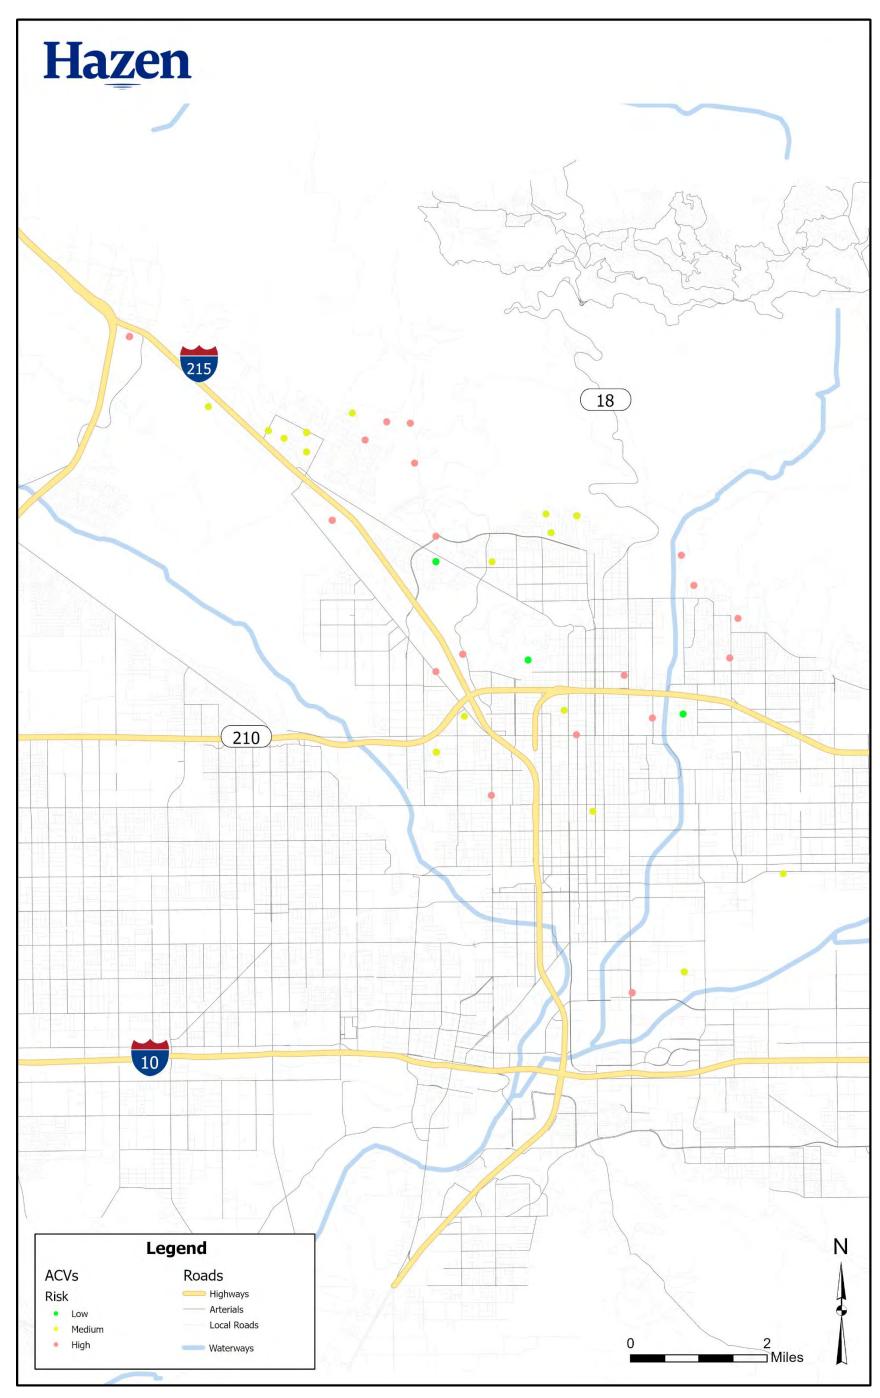
Figure 12-11: Automatic Control Valve Risk Results

Table 12-16 lists the ACVs assessed through either Horizontal assets (in GIS layers) or Facilities' assets (in asset register) and detailed Horizontal assets assessment results. Figure 12-11 shows a map of ACVs with their associated risk levels.

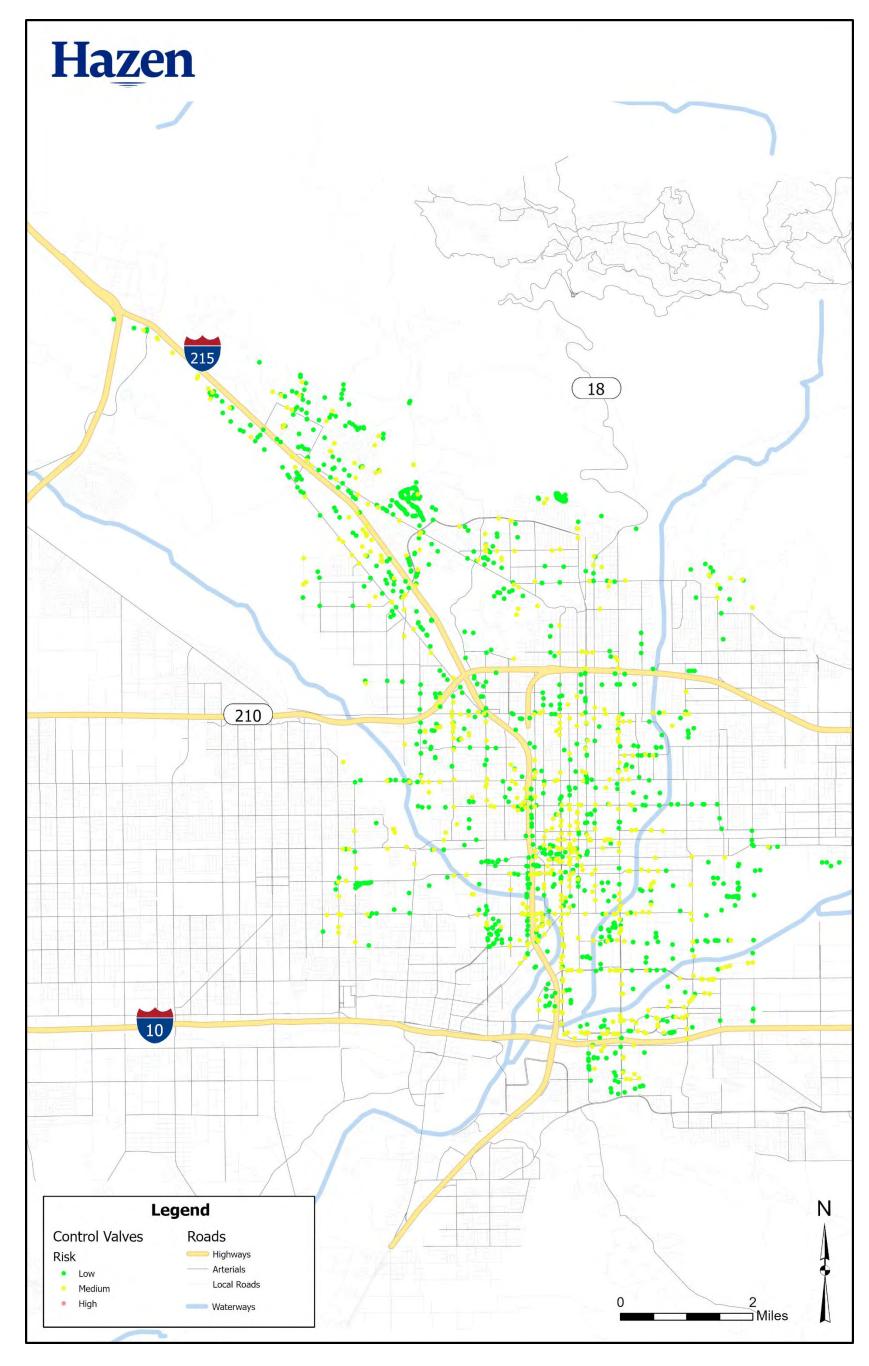
Figure 12-12: System Control Valve Risk Results

Figure 12-12 shows a map of risk levels for system control valves.

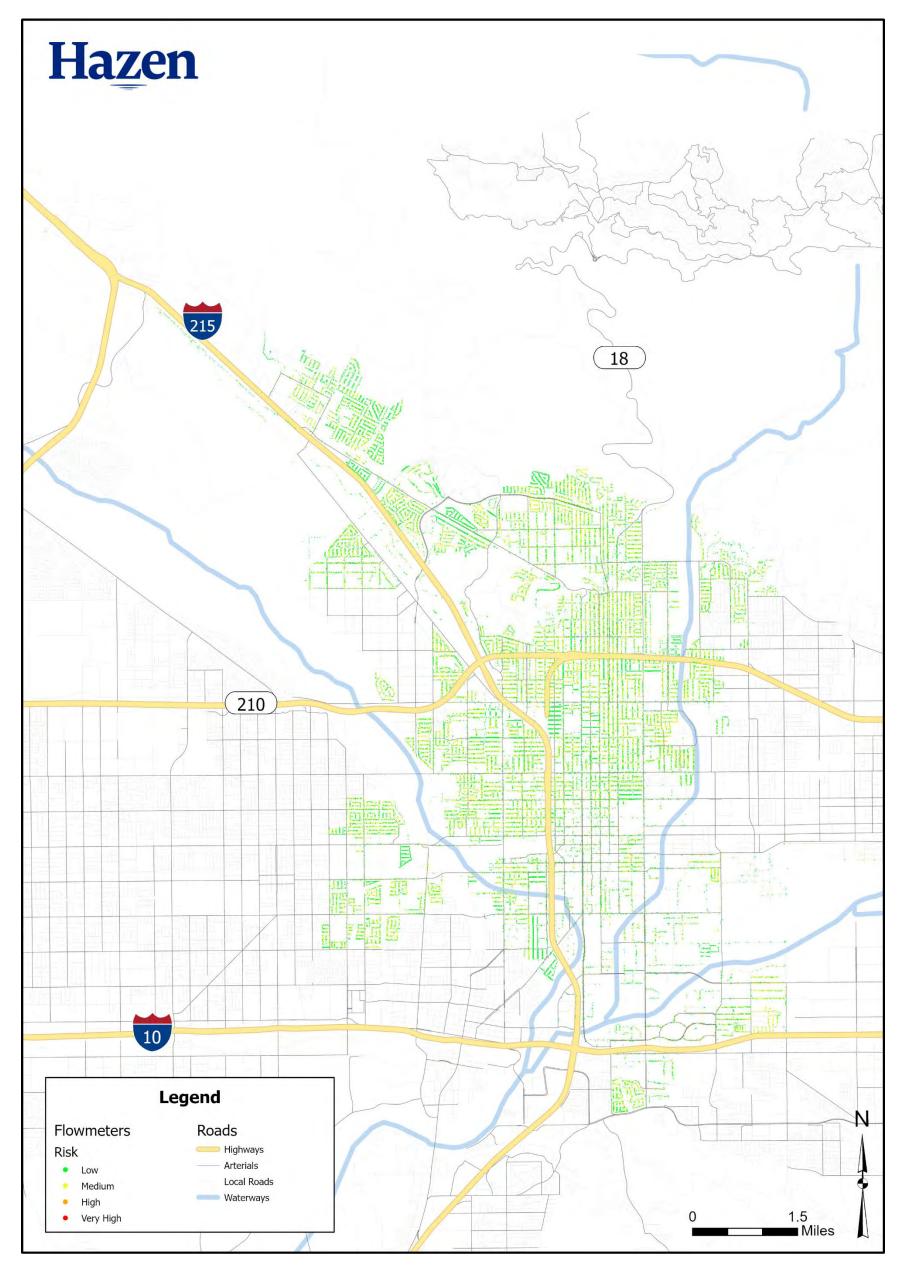
Figure 12-13: Flowmeter Risk Results

Figure 12-13 shows a map of risk levels for the flowmeters. Flowmeters with medium level of risk are located all around the service area with more density on the northwest part of it.

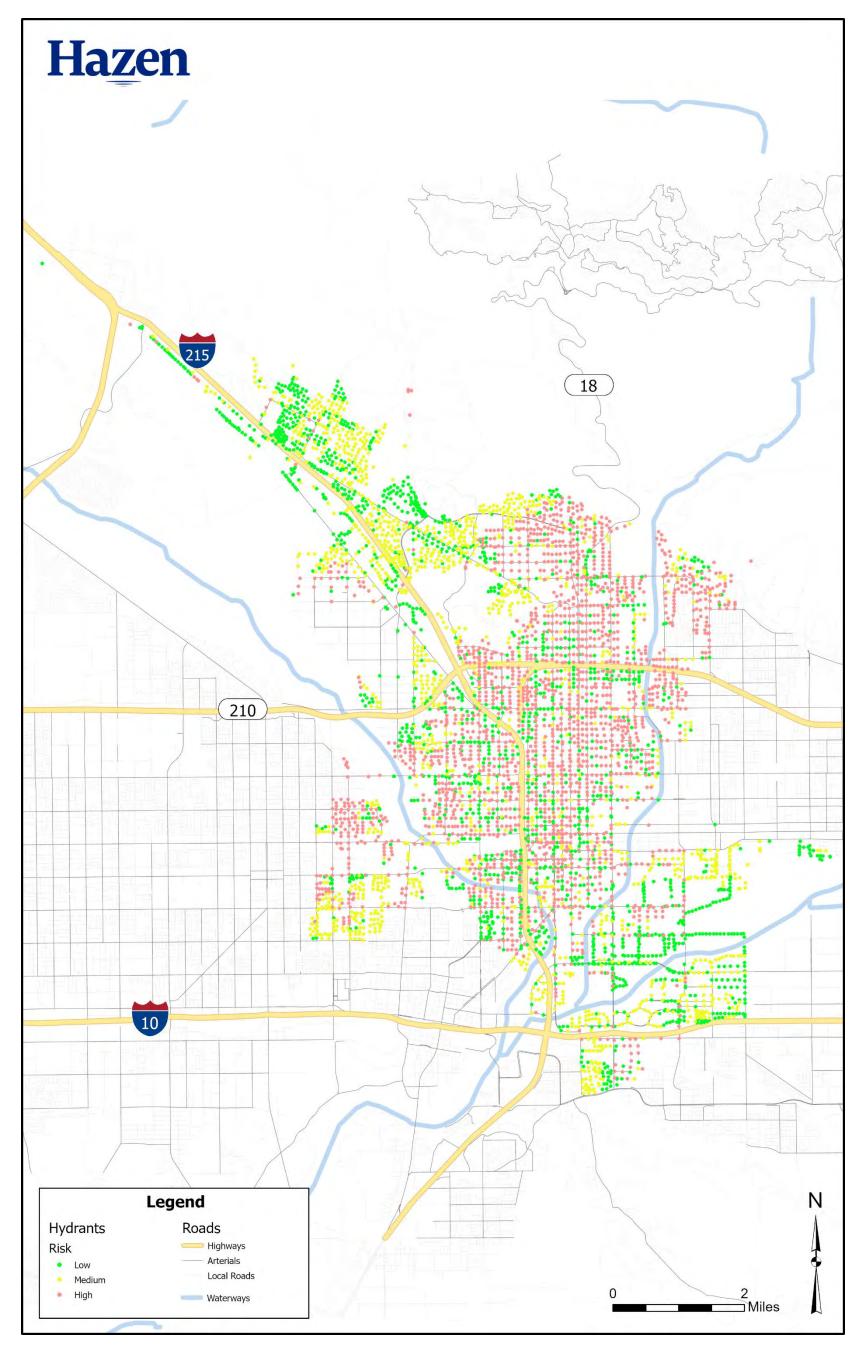
Figure 12-14: Hydrants Risk Results

Figure 12-14 also shows a map of risk results for the hydrants. The hydrants with high risk scores are scattered throughout the service area with a higher density in areas with older assets.

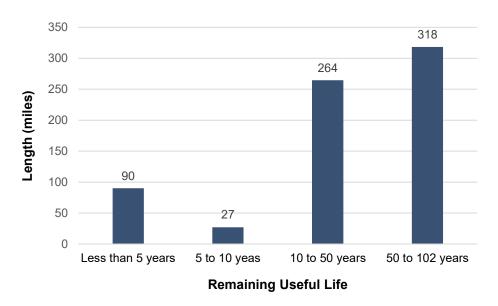
Figure 12-15: Remaining Useful Life of Water Pipes

To project future R&R needs, it is important to estimate the RUL of the Department Horizontal assets. To estimate the RULs, Hazen used the nominal useful lives assumed for the pipelines as shown in Table 12-3. For Horizontal non-pipe assets, similar to what was discussed in section 2.2.3, the customized useful lives shown in Table 12-4 were used. The result of the pipeline RUL is presented in Figure 12-15. As is evident in this figure, 90 miles of pipes (13%) have less than 5 years of RUL and, 27 miles of pipes (3%) are coming up for replacement in 5 to 10 years.

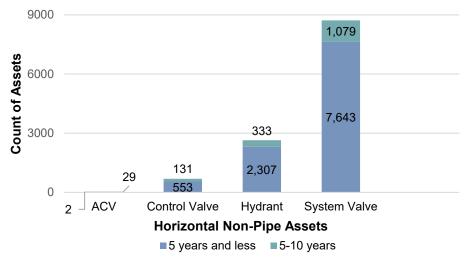
Figure 12-16: Remaining Useful Life Results for the Horizontal Non-Pipe Assets

A more in-depth analysis of the RUL results, presented in Figure 12-16, shows the count of assets coming for replacement in next 5 years in comparison to the count of asset coming for replacement in 5 to 10 years. For example, 2,640 hydrants have less than 10 years of RUL, with 2,307 of them having a RUL of less than 5 years. Regarding the large number of flowmeters compared to other Horizontal non-pipe assets, they are removed from the presented plot in Figure 12-16. The obtained result on the flowmeters shows 20,417 flowmeters have less than 5 years of RUL and 6,655 count of them have 5-10 years of RUL.

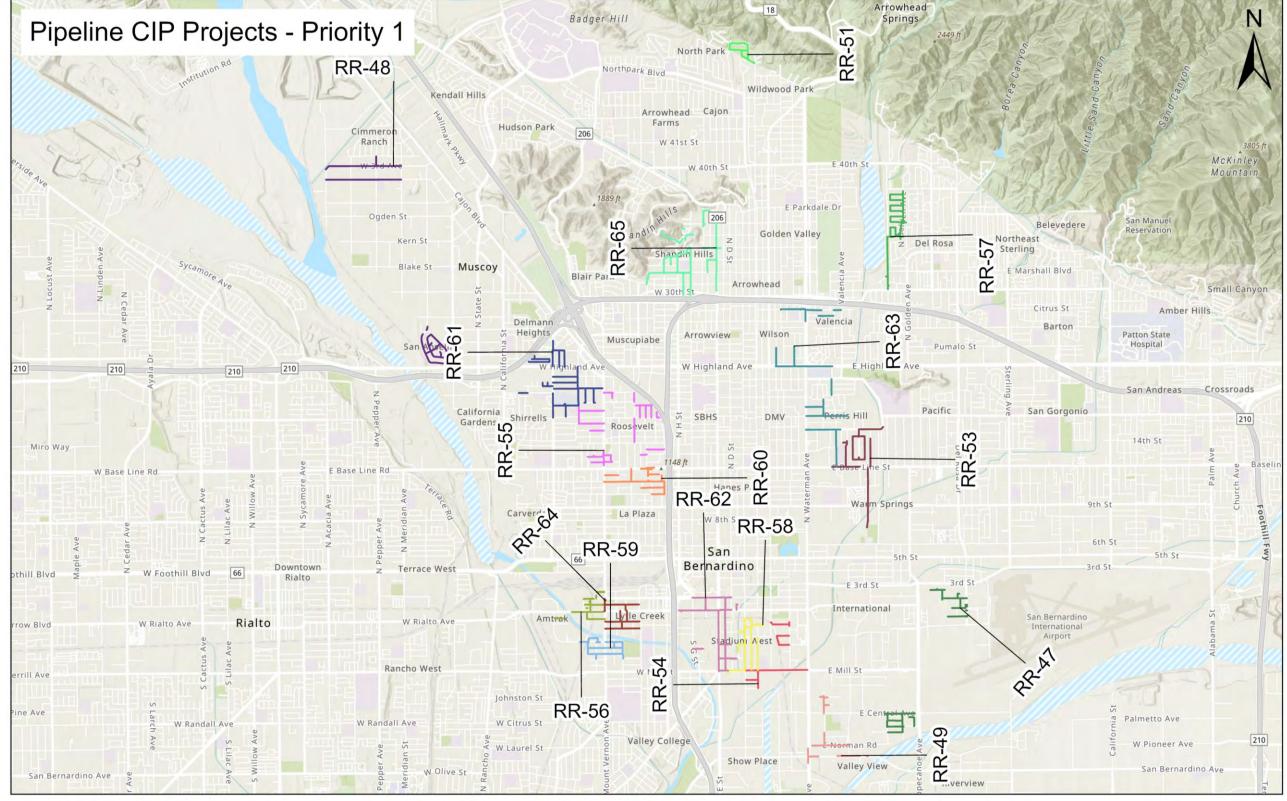
Figure 14-1: Pipeline CIP Projects - Priority 1

GIS layers of the pipeline project sources were overlaid in ArcGIS Pro. Pipelines in the same vicinity were grouped together to form projects within a geographic area. This results in cost effectiveness and minimizes repeated community impacts to neighborhoods and businesses. Pipeline projects can be found in Figure 14-1, Figure 14-2, and Figure 14-3. Pipeline projects were prioritized as follows:

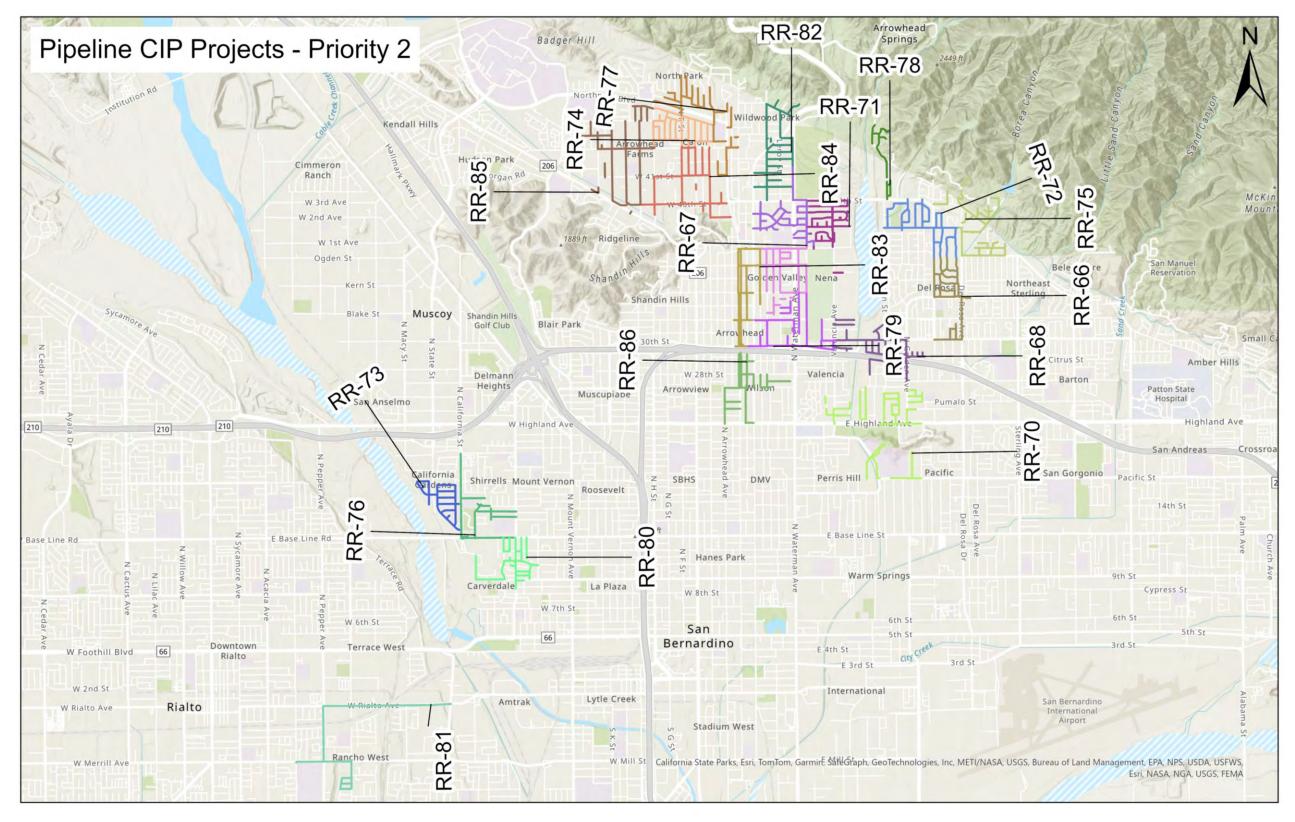
Figure 14-2: Pipeline CIP Projects - Priority 2

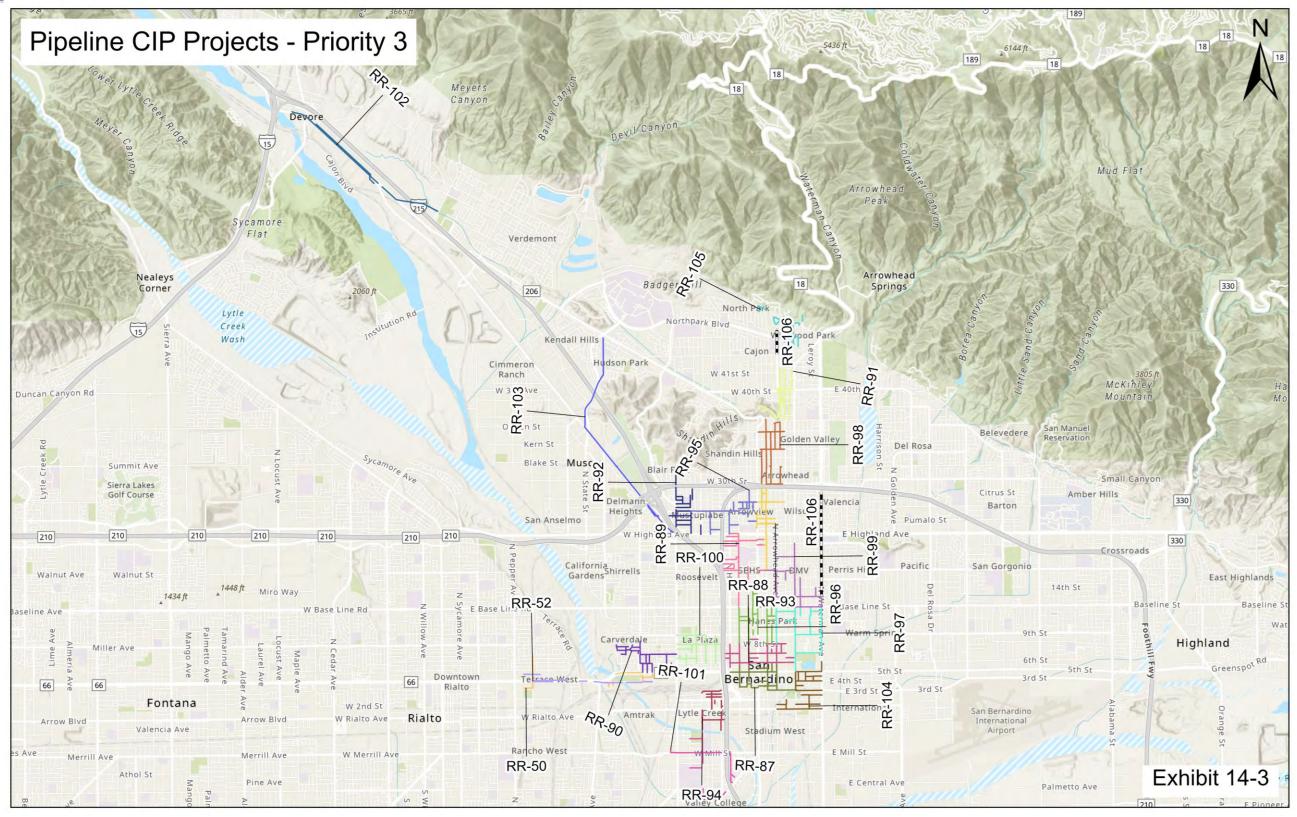
Figure 14-3: Pipeline CIP Projects - Priority 3

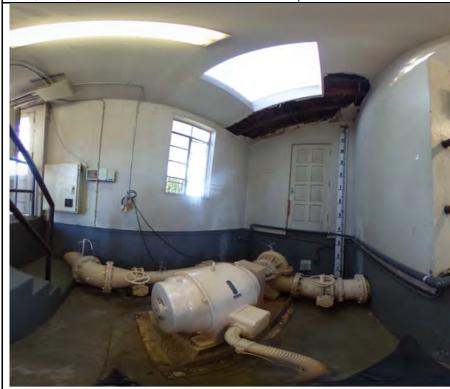
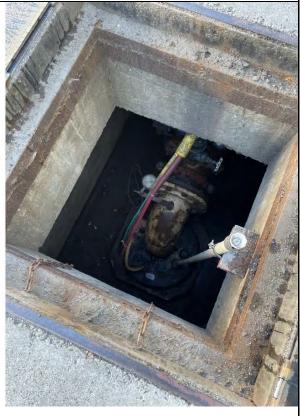
Project Description: This project includes replacing the following components at 17th & Sierra Way St - 16th St BPS.

Booster Pump
Soft Start - 16th St Booster
This project also includes replacing the following components at 17th & Sierra Way St - 16th St Well.
Pump
Soft Start - 16th Well
The 2022 Field Condition Assessment found these items in need of replacement.

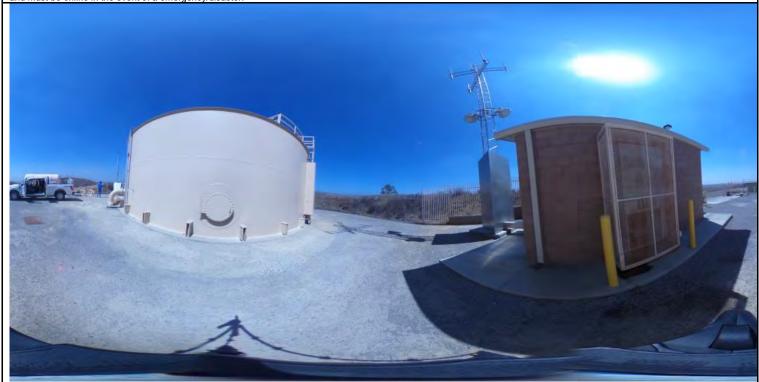
Project Description: This project includes implementation of a new backup generator at the Ridgeline Reservoir Site. The reservoir site includes radio infrastructure that is critical and must be online in the event of a emergency/disaster.

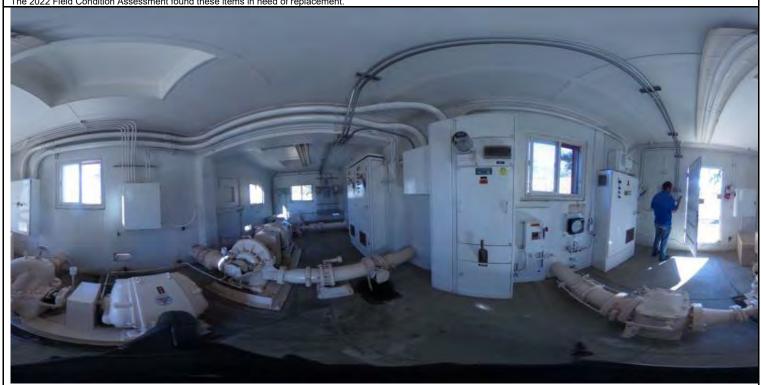
Project Description: This project includes replacing the electrical and mechanical components at Electric Dr - Reservoir. The 2022 Field Condition Assessment found these items in need of replacement.

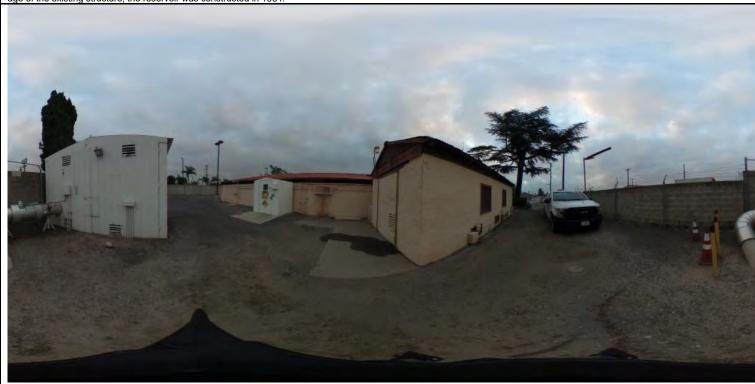
Project Name : Mill & D St - Reservoir Roof Upgrades
Asset Classification: Replacement/Rehabilitation of System Assets

Project Description: Project involves updating the design and construction of the roof replacement of the existing Mill & D St Reservoir. The roof replacement is needed due to the age of the existing structure; the reservoir was constructed in 1934.

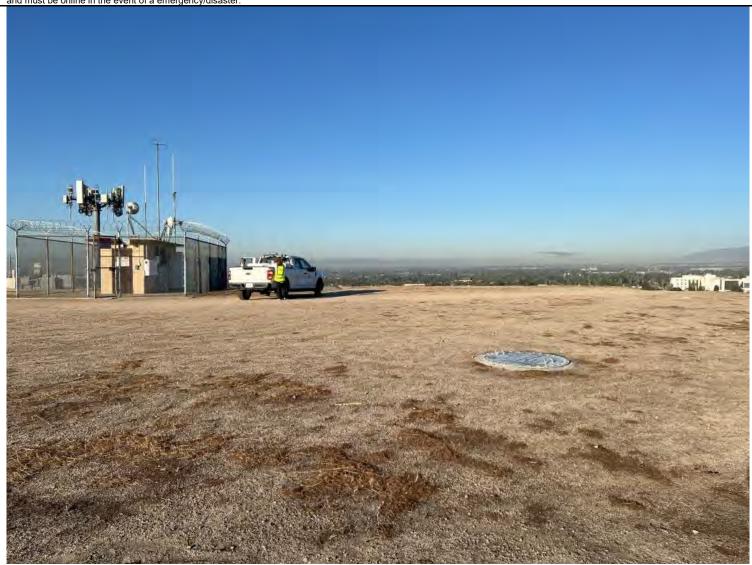
Project Description: This project includes implementation of a new backup generator at the Perris Hill Reservoir Site. The reservoir site includes radio infrastructure that is critical and must be online in the event of a emergency/disaster.

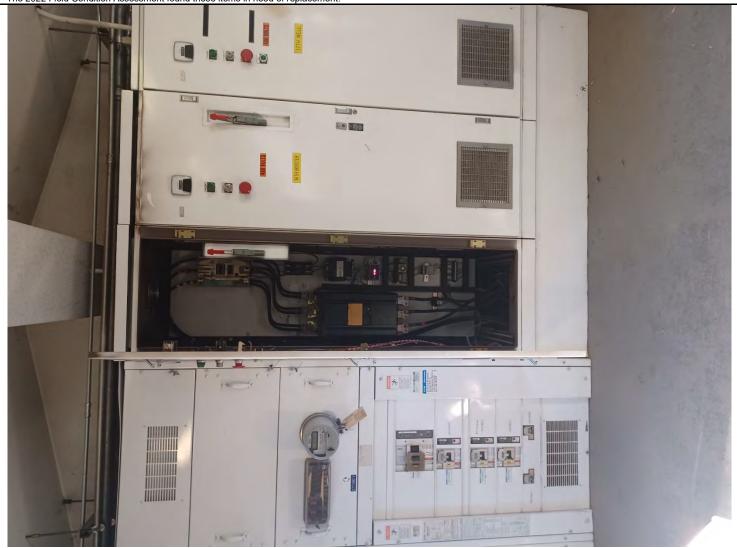
Project Name: 17th St Booster Pump Station Improvements Asset Classification: Replacement/Rehabilitation of System Assets

• Main Control Panel 1 at BPS (17th St)

• Soft Start - 17th Booster
The 2022 Field Condition Assessment found these items in need of replacement.

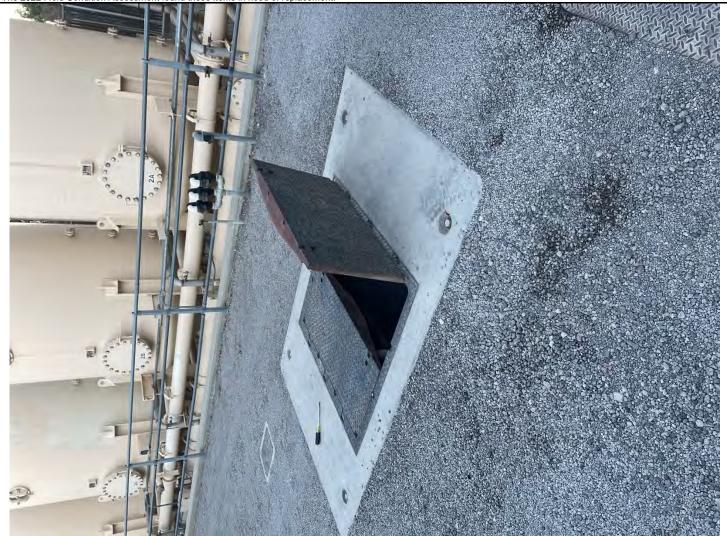
17th St Well Upgrades
Replacement/Rehabilitation of System Assets Asset Classification:

Project Description: This project includes replacing the following components at 17th & Sierra Way St - 17th St Well.
Piping Assembly 17th St Well
Pump in Vault
Soft Start - 17th Well
The 2022 Field Condition Assessment found these items in need of replacement.

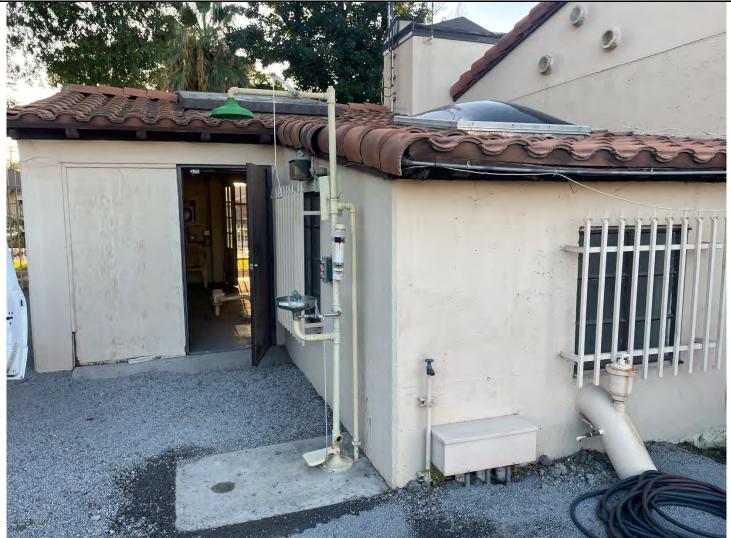
17th & Sierra Way Plant - Common Upgrades Replacement/Rehabilitation of System Assets Project Name : Asset Classification:

• Pump Building - 17th and 16th Pump Stations

• Paving
The 2022 Field Condition Assessment found these items in need of replacement.

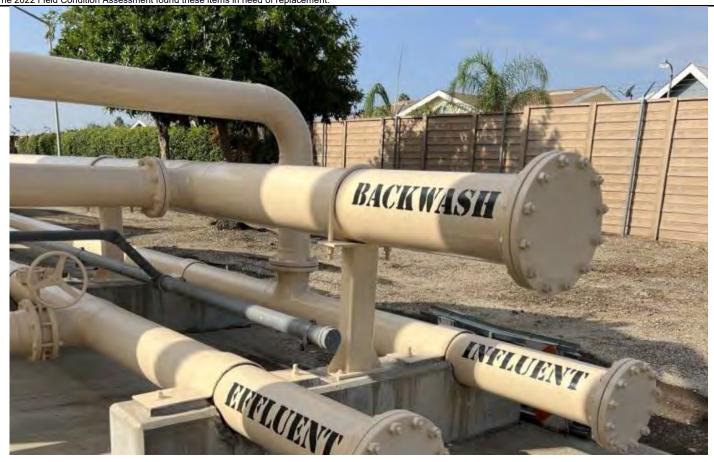
Project Name: 19th St Plant GAC System Improvements Replacement/Rehabilitation of System Assets Asset Classification:

Project Description: This project includes replacing the following components at 19th St - GAC System.

• Backwash Piping Assembly ~1,000 LF
The 2022 Field Condition Assessment found these items in need of replacement.

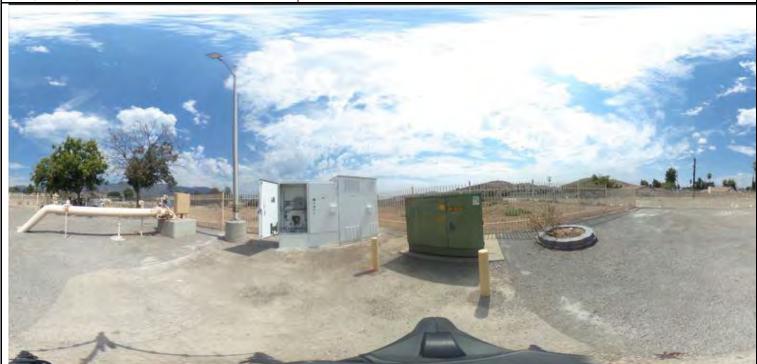
EPA Well 7 Upgrades
Replacement/Rehabilitation of System Assets Asset Classification:

Budget ID No. Project Description: This project includes replacing the following components at EPA - Well #007.

Flowmeter
Isolation Valve Vault
PLC SCADA
Pavement
Motor Starter
The 2022 Field Condition Assessment found these items in need of replacement.

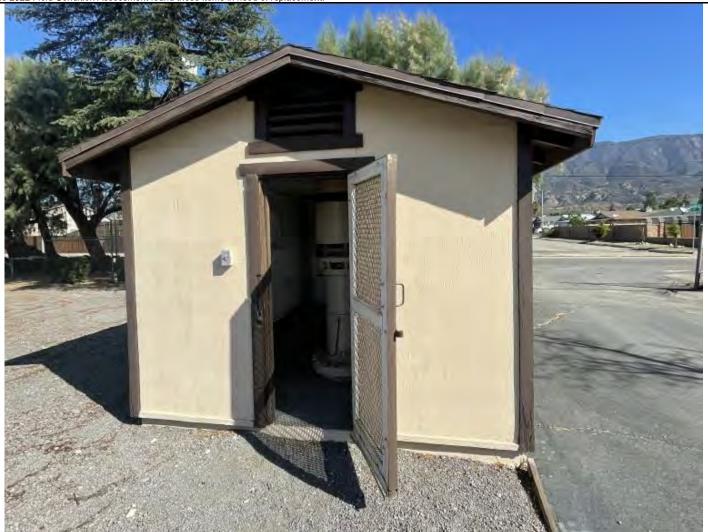
Sycamore Booster Pump Station (#2) Improvements Project Name: Replacement/Rehabilitation of System Assets Asset Classification:

Project Description: This project includes replacing the following components at Newmark - Sycamore BPS (#2).
Pump House 2 Building
Air Release Valve Booster #2
Flowmeter Vault - Sycamore BPS #2
The 2022 Field Condition Assessment found these items in need of replacement.

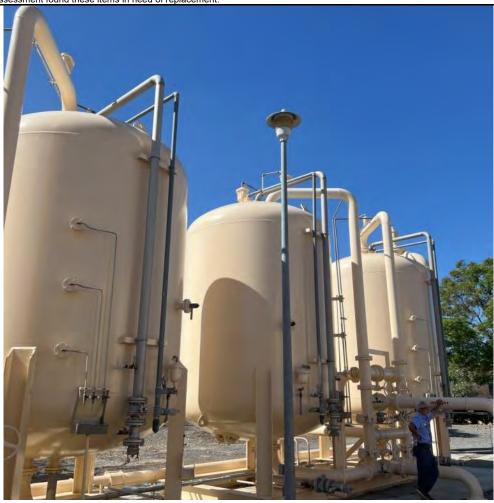
Newmark Plant GAC System Improvements Project Name: Replacement/Rehabilitation of System Assets Asset Classification:

Pressure Transmitter Vessels

The 2022 Field Condition Assessment found these items in need of replacement.

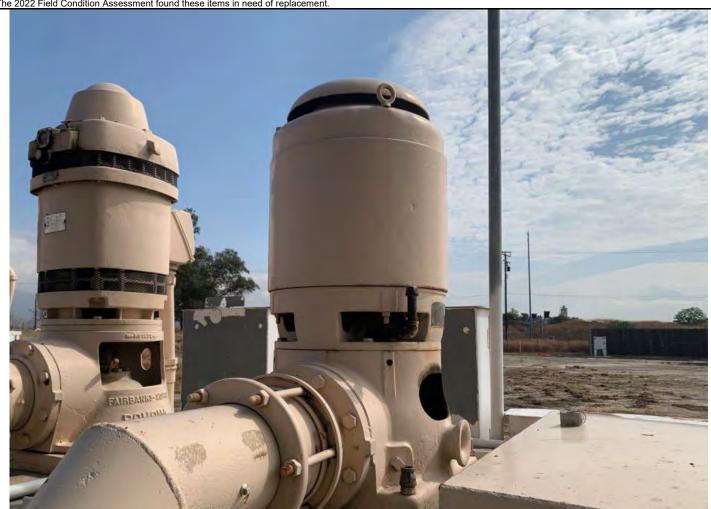
Lytle Creek Booster Pump Station Upgrade Replacement/Rehabilitation of System Assets Project Name : Asset Classification:

Project Description: This project includes complete facility replacement of the Lytle Creek Booster Pump Station. The 2022 Field Condition Assessment found these items in need of replacement.

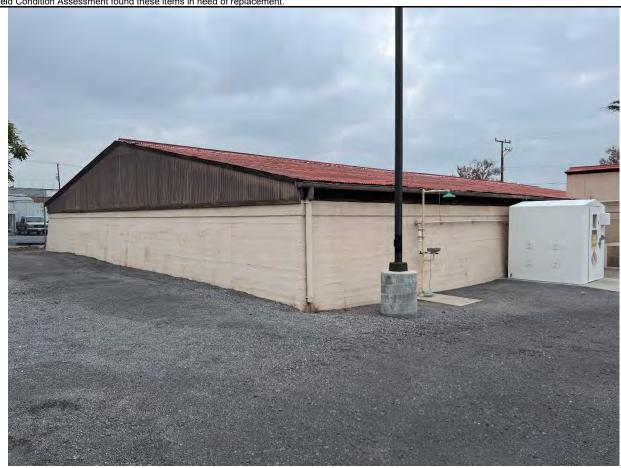
Project Description: This project includes replacing the electrical and mechanical components at Mill & D St Reservoir. The 2022 Field Condition Assessment found these items in need of replacement.

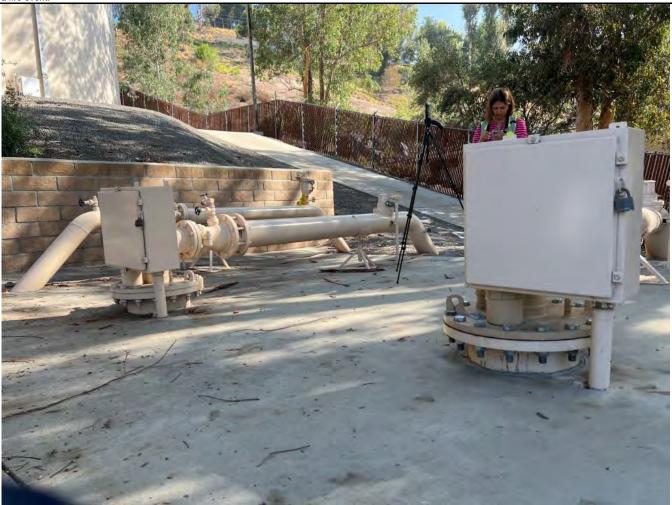
Project Description: The Daley Zone has an HGL of 1775 ft and is one of the pressure zones with the highest HGLs. As a result, the only feasible option for a second supply point is a second pump station. Although feasible, this solution is not practical. A permanent generator at Daley Booster Pump Station is recommended to provide backup power in the event of a power loss. Please note that Del Rosa Booster Pump Stations would need to stay on during a power outage to support Daley Booster Pump Station during a fire event.

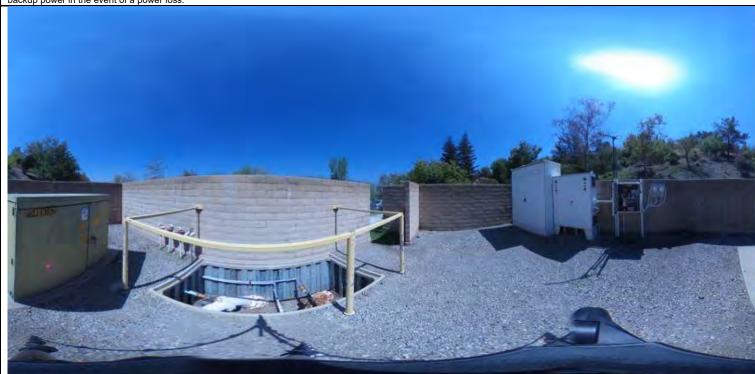
Project Description: The Ridgeline Zone has an HGL of 1751.5 ft and is one of the pressure zones with the highest HGLs. As a result, the only feasible option for a second supply point is a second pump station. Although feasible, this solution is not practical. A permanent generator at Ridgeline Lower Booster Pump Station is recommended to provide backup power in the event of a power loss.

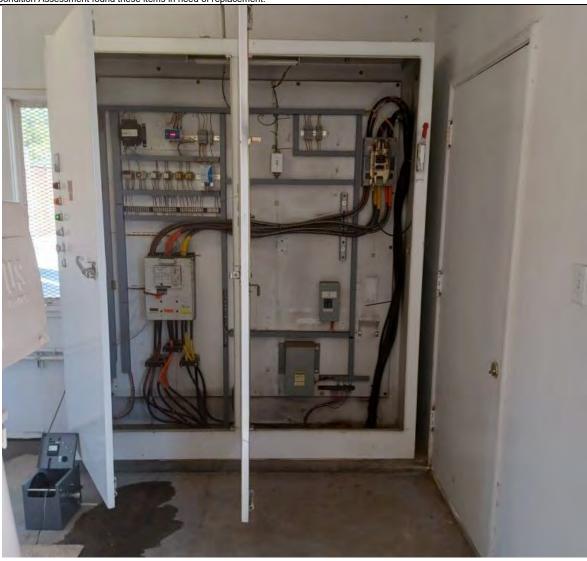
Waterman Ave Well Upgrades
Replacement/Rehabilitation of System Assets Asset Classification:

Project Description: This project includes replacing the following components at Waterman Ave - Well.

• Motor Starter (Soft Start) - Well Pump - ITT
The 2022 Field Condition Assessment found these items in need of replacement.

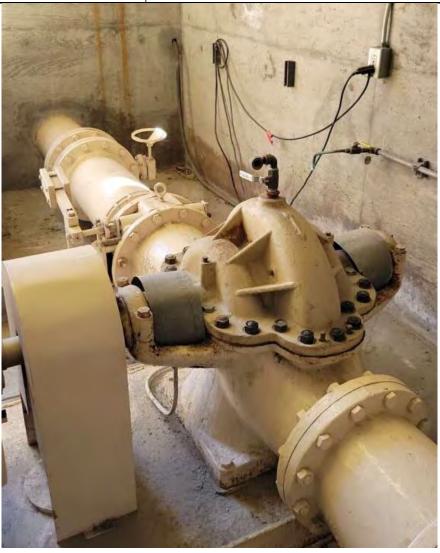
Waterman Ave Booster Pump Station (#2) Mechanical Improvements Replacement/Rehabilitation of System Assets Project Name :

Project Description: This project includes replacing the following components at Waterman Ave - BPS #2.

• Pump #2 - 10in inlet - 8 outlet
The 2022 Field Condition Assessment found these items in need of replacement.

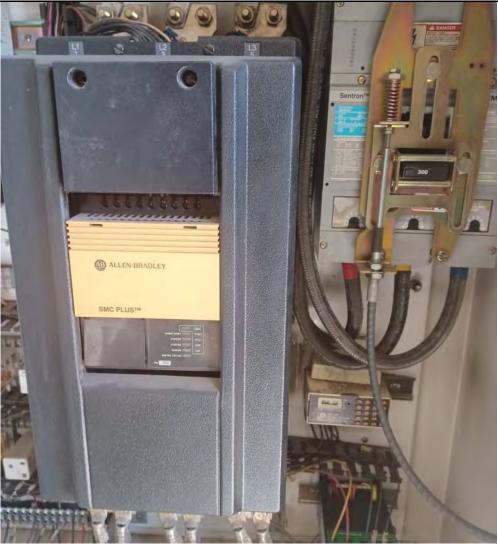
Project Description: This project includes replacing the following electrical components at Waterman Ave - BPS #2.
Flowmeter (Transmitter) (Waterman BP #2)
Motor Starter - Soft Start (Waterman BP#2)
The 2022 Field Condition Assessment found these items in need of replacement.

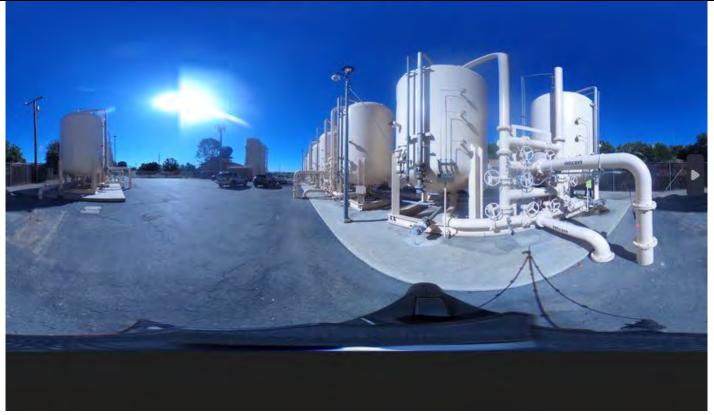
Project Name: Waterman Ave Plant GAC System Upgrades Replacement/Rehabilitation of System Assets **Asset Classification:**

- Nine (9) Flowmeters
- Two (2) Influent Flowmeters
- Motor Control Center
- Sixteen (16) Pressure Transmitter

The 2022 Field Condition Assessment found these items in need of replacement.

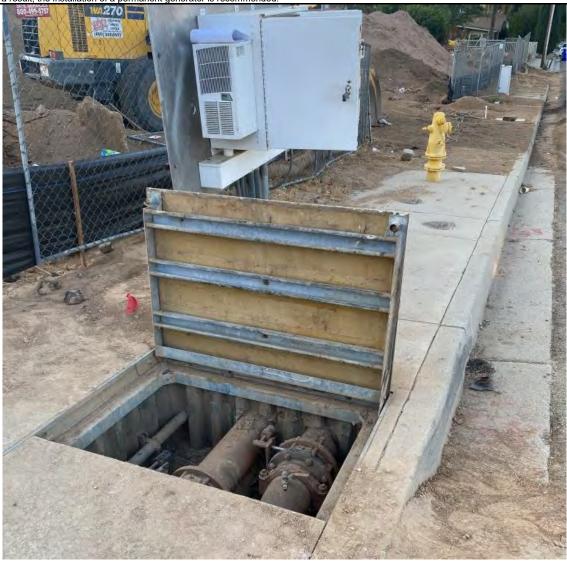
Project Description: Sepulveda Booster Pump Station is the only supply point to Mountain Subzone A. It is important that the station has the capability to be operational during power outages. As a result, the installation of a permanent generator is recommended.

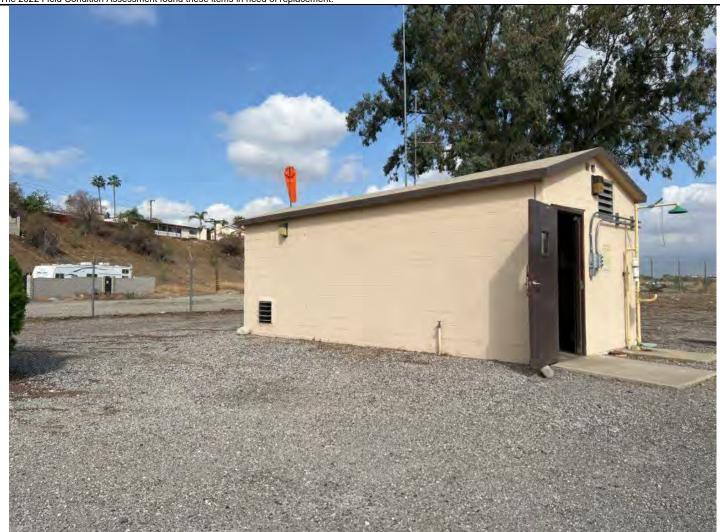
Lytle Creek - Common Upgrades
Replacement/Rehabilitation of System Assets Asset Classification:

Project Description: This project includes complete facility replacement of the Lytle Creek - Common. This includes replacement of the Lytle Creek Chlorine House and Mixing Weir, Vault, West SBCWD Intertie, and Booster Station.
