SAN BERNARDINO MUNICIPAL WATER DEPARTMENT

2024 Water Master Plan

FEBRUARY 2025 FINAL REPORT

PROJECT NO. 1743

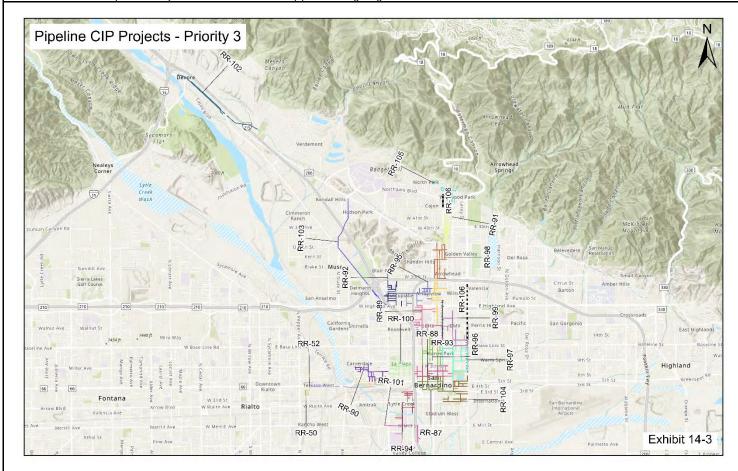
Project Name :
 Water Pipeline Condition Assessment Study

Project Description: Detailed pipeline condition assessment of approximately 9,600 LF of pipe ranging from 24-inches to 30-inches in diameter along N Waterman Ave and Electric Ave. The 2022 Pipe Risk Analysis Assessment shows these pipes as having a high risk of failure.

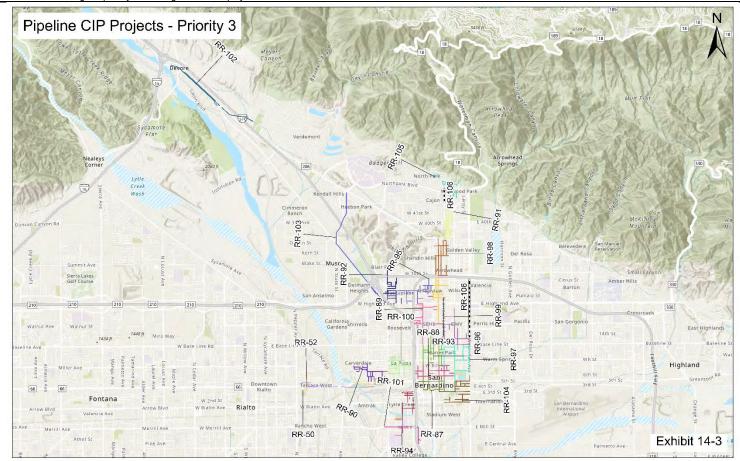
Project Name :
 Water Pipeline Replacement Project 46

Project Description: Pipeline projects were developed based on multiple levels of evaluations and analyses such as available fire flow, maximum velocity, and high risk level. Pipelines in the same vicinity were grouped together to form projects within a geographic area. Projects containing a large number of pipelines with RUL greater than 0 and less than 20 were assigned priority 3. See Figure 14-3 for project location.

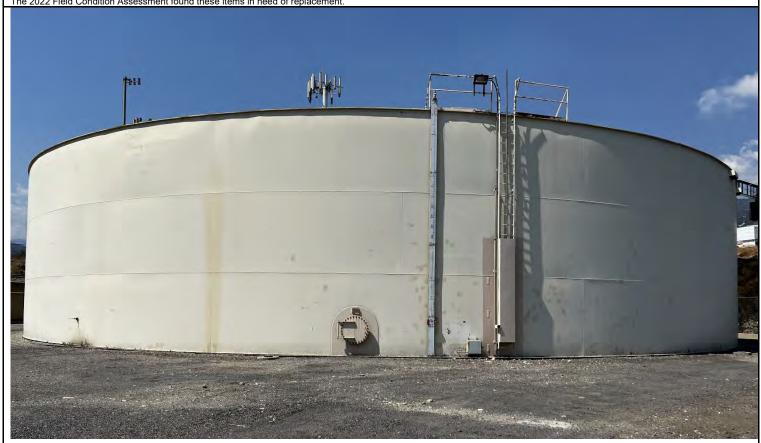
Project Description: This project includes replacing the electrical and mechanical components at Devore Reservoir. The 2022 Field Condition Assessment found these items in need of replacement.

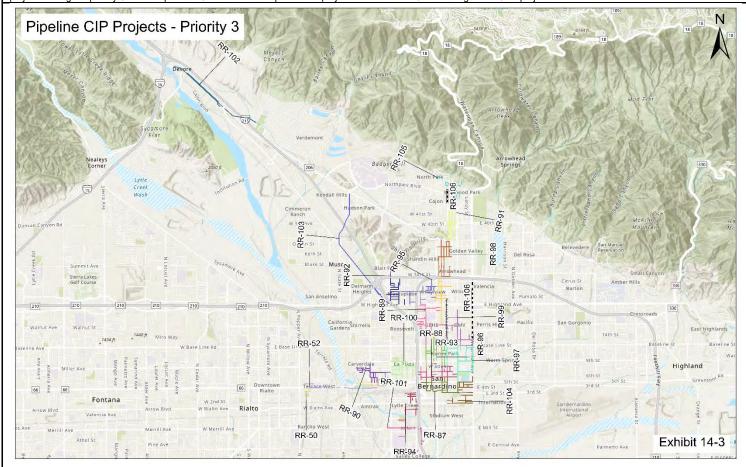
Project Name :
 Water Pipeline Replacement Project 6

Project Description: Pipeline projects were developed based on multiple levels of evaluations and analyses such as available fire flow, maximum velocity, and high risk level. Pipelines in the same vicinity were grouped together to form projects within a geographic area. A large number of pipelines in this project are fire flow deficient. However, this project is assigned priority 3 due to a planned Caltran's street improvement project scheduled for 2024. See Figure 14-3 for project location.

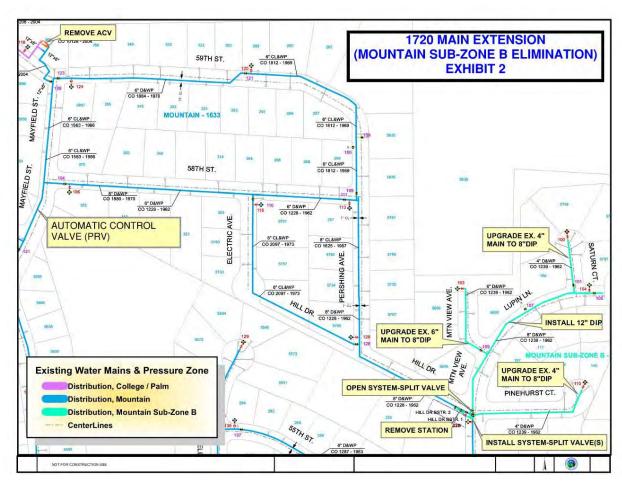
Figure 1: SBMWD Proposed Mountain Zone Realignment

Figure 1 describes the modifications SBMWD has proposed for removal of the Mountain Subzone B. The 58th and Mayfield ACV was deactivated in the model, the Mountain Zone BPS was deactivated and piping around the booster pump station was activated to allow flow into the existing Mountain Subzone B while not allowing flow to go further south down the eight-inch line on Lupin Lane. The proposed ACV in Figure 1 south of 58th Street was not included in the analysis. Figure 4 illustrates the minimum pressures in the Area of Interest after the Zone realignment. Figure 5 illustrates the maximum pressures in the realigned area. The area from the original Mountain Subzone B has pressures ranges from 69 psi to 114 psi. The portion of the Mountain Zone realigned to the College Palm Zone has pressures ranging from 78 psi to 125 psi. The increase in maximum pressure difference is illustrated in Figure 6. The original Mountain Subzone B has a pressure increase of approximately 21 psi. The section of realigned pipes from Mountain to College/Palm has an increase in maximum day pressure greater than 50 psi. Pipes within areas of maximum day pressure with increases greater than 50 psi should be upsized.

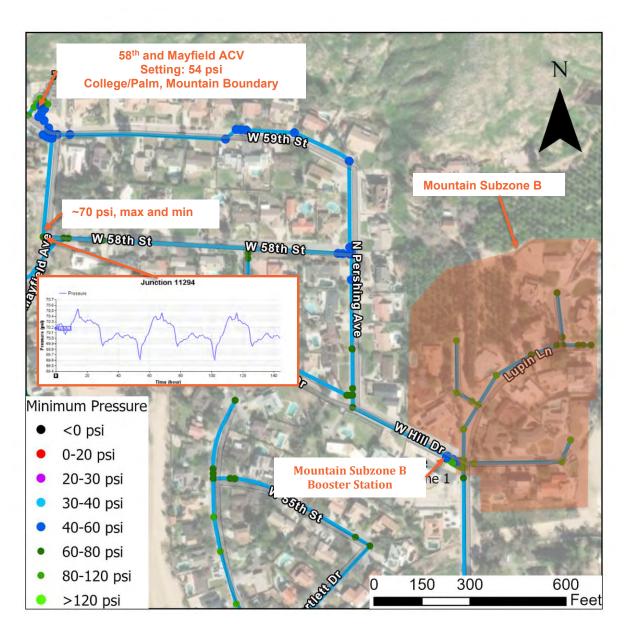
Figure 2: Existing Conditions, MDD EPS, Minimum Pressures at Mountain Subzone B

Existing condition minimum day demand pressures are reflected in Figure 2 and Figure 3. The 58th Street and Mayfield control valve has a setting of 58 psi, keeping pressures within the area of interest consistent across the day. The area of interest represents the portion of the Mountain Zone and all of the Mountain Subzone B that is realigned into the College Palm Zone. The maximum pressure experienced within the area of interest that is currently part of the Mountain Zone (see Figure 3) is 70.5 psi, while the minimum is 45 psi. Mountain Subzone B has pressure ranges from 69.4 psi to 91.3 psi.

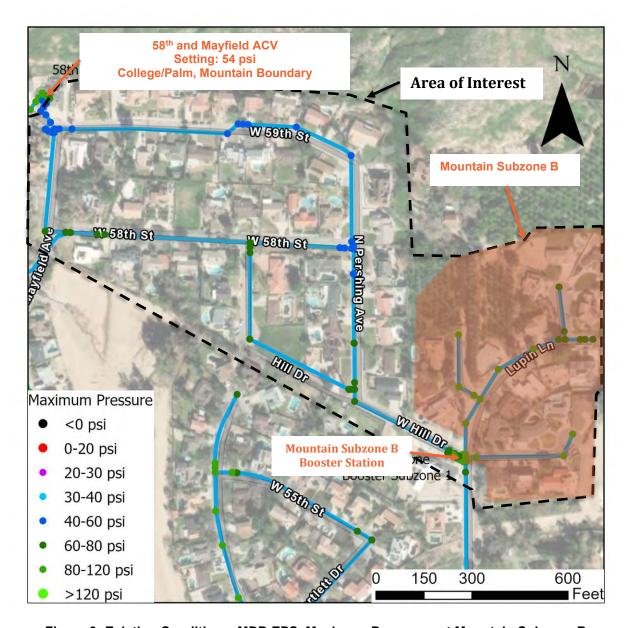
Figure 3: Existing Conditions, MDD EPS, Maximum Pressures at Mountain Subzone B

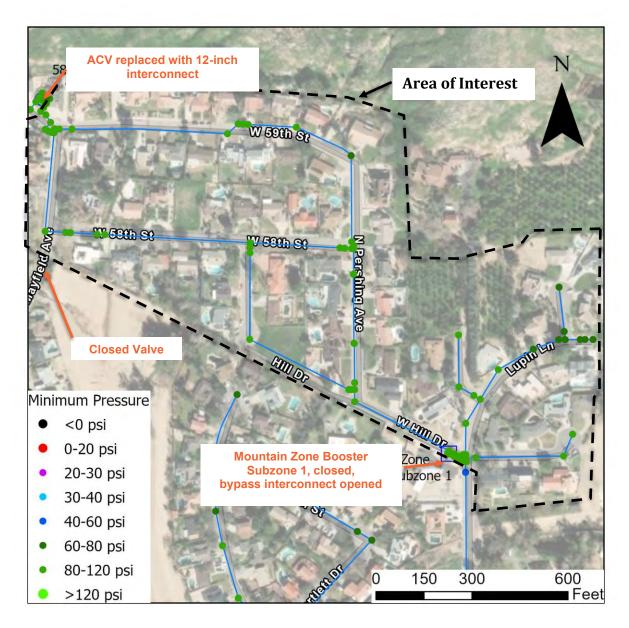
Figure 4: Minimum Pressures in Area or Interest After Zone Realignment

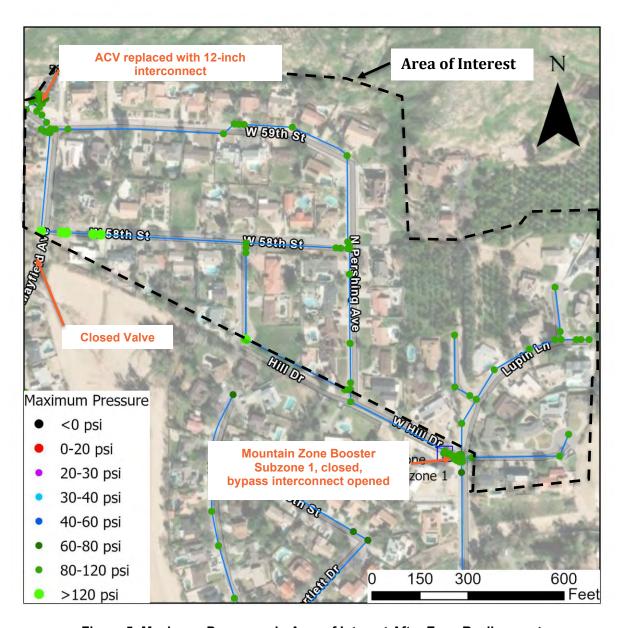
Figure 5: Maximum Pressures in Area of Interest After Zone Realignment

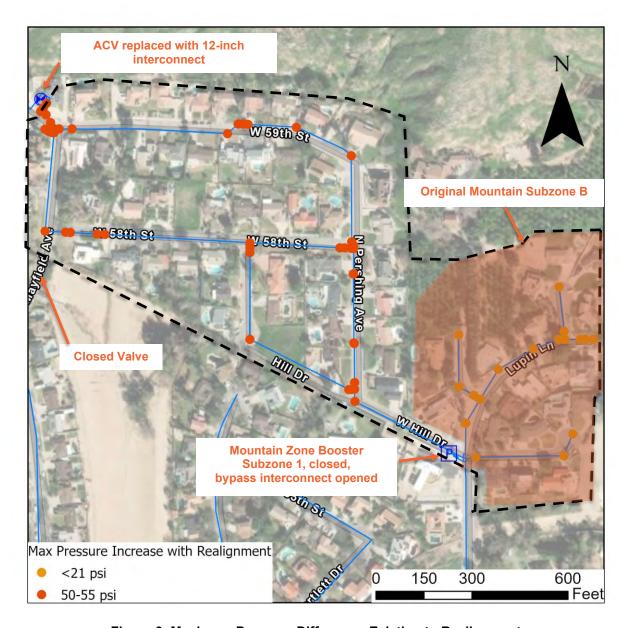
Figure 6: Maximum Pressure Difference, Existing to Realignment

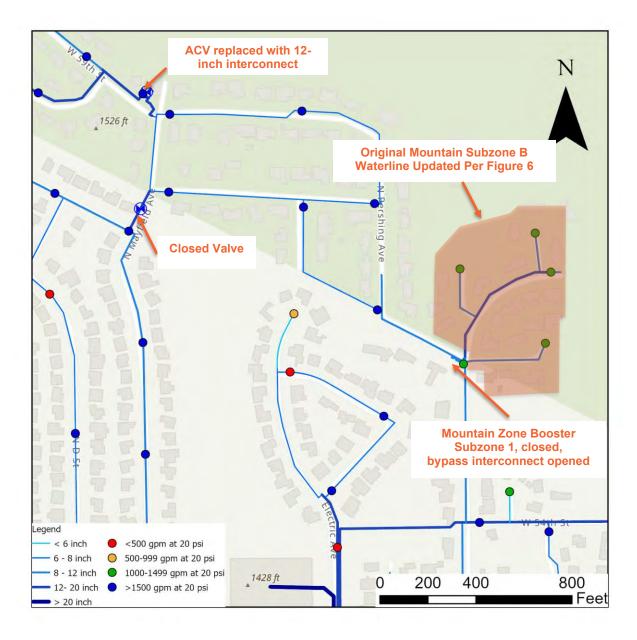
Figure 7: Mountain Zone Realignment, Available Fire Flow

The required fire flow for the Mountain Zone Realignment area of interest is 1,500 gpm at 20 psi. Existing conditions meet the required fire flow everywhere except in Mountain Subzone B. This area available fire flow is deficient, ranging from 500-1000 gpm at 20 psi. The realignment increases the available fire flow 100-200 gpm at 20 psi in Mountain Subzone B. The portion of the Mountain Zone realigned to the College Palm Zone, although meeting needed fire flow, has an overall decrease in available fire flow with this change. This area has changed from having two water lines feeding it to one, with the internal lines being 6-inch. See Figure 7.

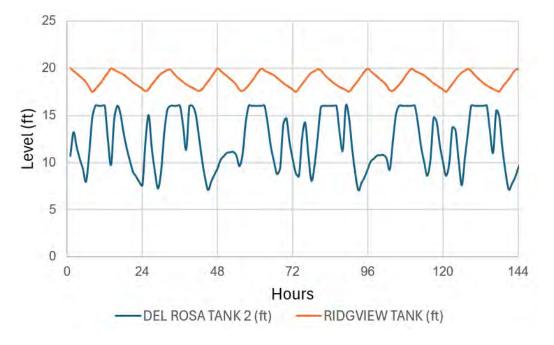
Figure 3-1: Tank Operations – Existing Scenario (without AHS)

With the additional 500 gpm of demand, the Ridgeview Tank doubles its cycle time from two times per day to four times per day. Figure 3-1 illustrates the existing scenario, while Figure 3-2 illustrates the change in tank operation.

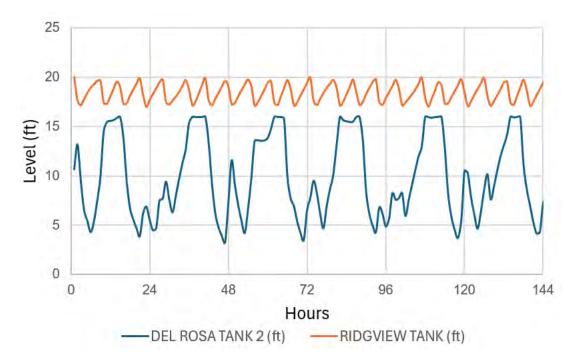
Figure 3-2: Tank Operations - with AHS Demand

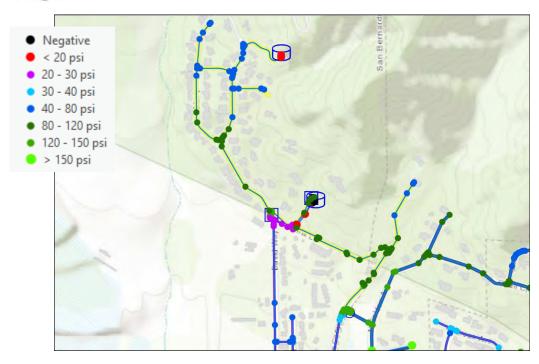
Figure 5-1: Minimum Pressure - Existing

No significant changes in minimum pressures arise in the addition of AHS demands, as shown by Figure 5-1 and Figure 5-2.

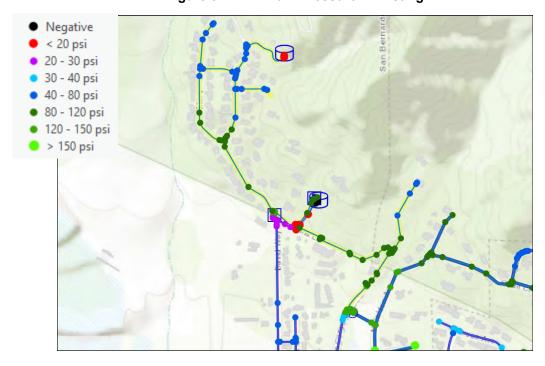
Figure 5-2: Minimum Pressure – with AHS

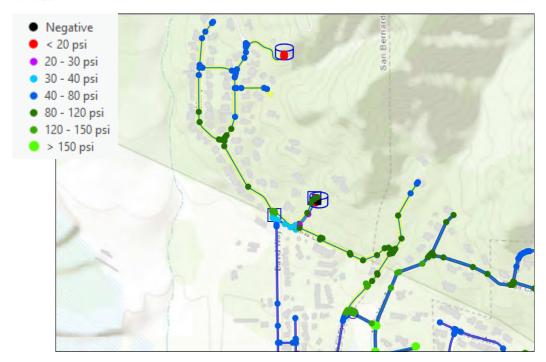
Figure 5-3: Maximum Pressure – Existing

No significant changes in maximum pressures arise in the addition of AHS demands, as shown by Figure 5-3 and Figure 5-4.

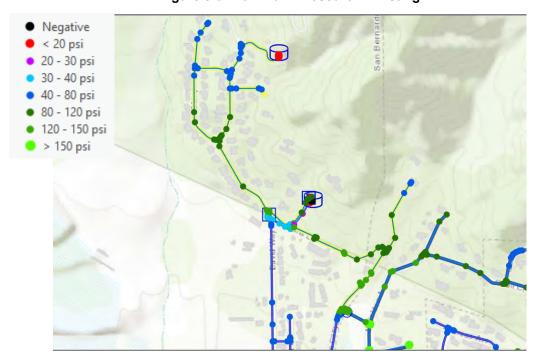
Figure 5-4: Maximum Pressure – with AHS

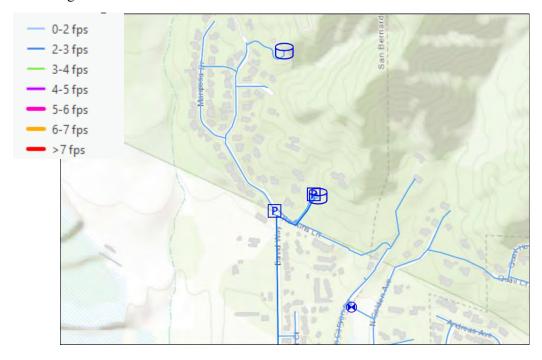
Figure 5-5: Maximum Velocity - Existing

Pipe velocities increase but are still within an acceptable range (less than 10 ft/s), as shown in Figure 5-5 and Figure 5-6.

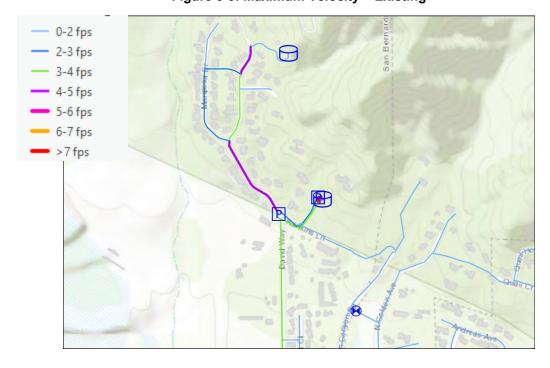
Figure 5-6: Maximum Velocity – with AHS

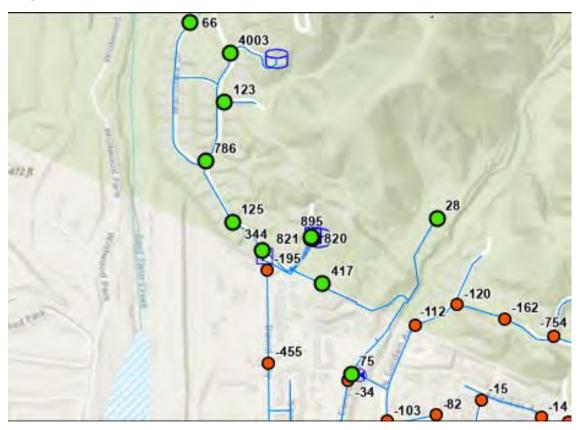
Figure 6-1: Change in Available Fire Flow with AHS

With the additional AHS demands and the proposed Ridgeview Pump Station improvements and pipeline improvements identified in the Kimley Horn Report modeled, the changes in available fire flow are insignificant. Decreases in fire flow availability are seen in adjacent zones; although, the available fire flow decrease is either by negligible amount, or there is still ample available fire flow. Figure 6-1 illustrates the fire flow summary, with green indicating an increase of available fire flow and red indicating a decrease in available fire flow.

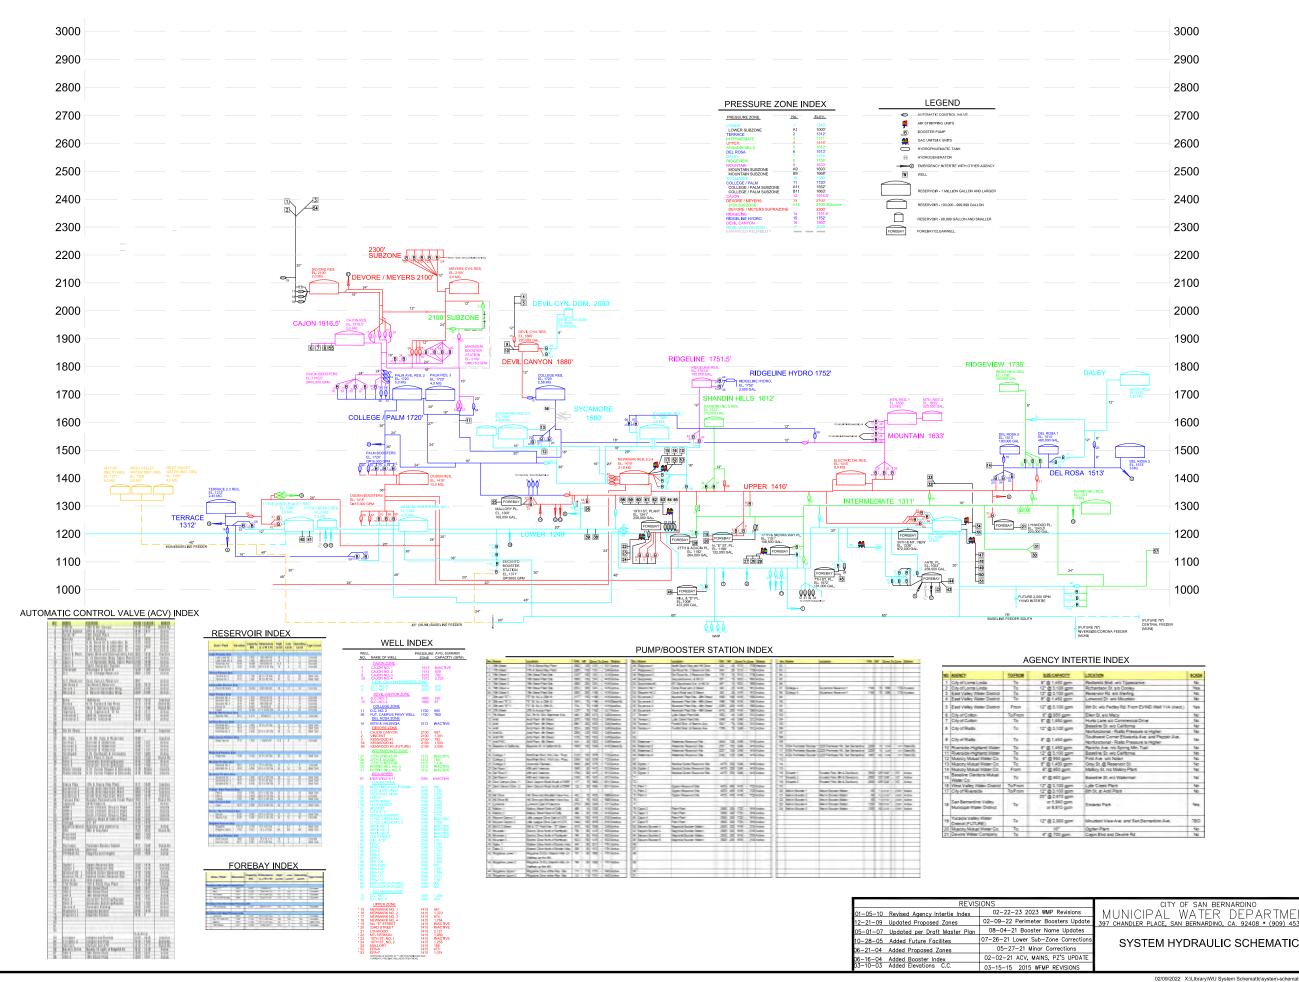
Appendix G: Water System Hydraulic Schematic

SBMWD SYSTEM SCHEMATIC
